## The Façade and the Rose-Window of Troia Cathedral (Apulia, Italy)

**ABSTRACT:** The façade of Troia Cathedral is tilted around a horizontal hinge, of seismic origin and passing through the rose-window. As a consequence, the rose-window is heavily damaged and deformed out-of-plane. In this paper, cognitive and diagnostic investigations are presented on the materials and the elements of the rose-window (GPR, thermography, sonic and ultrasonic tests, ambient vibration survey), together with a structural diagnosis.

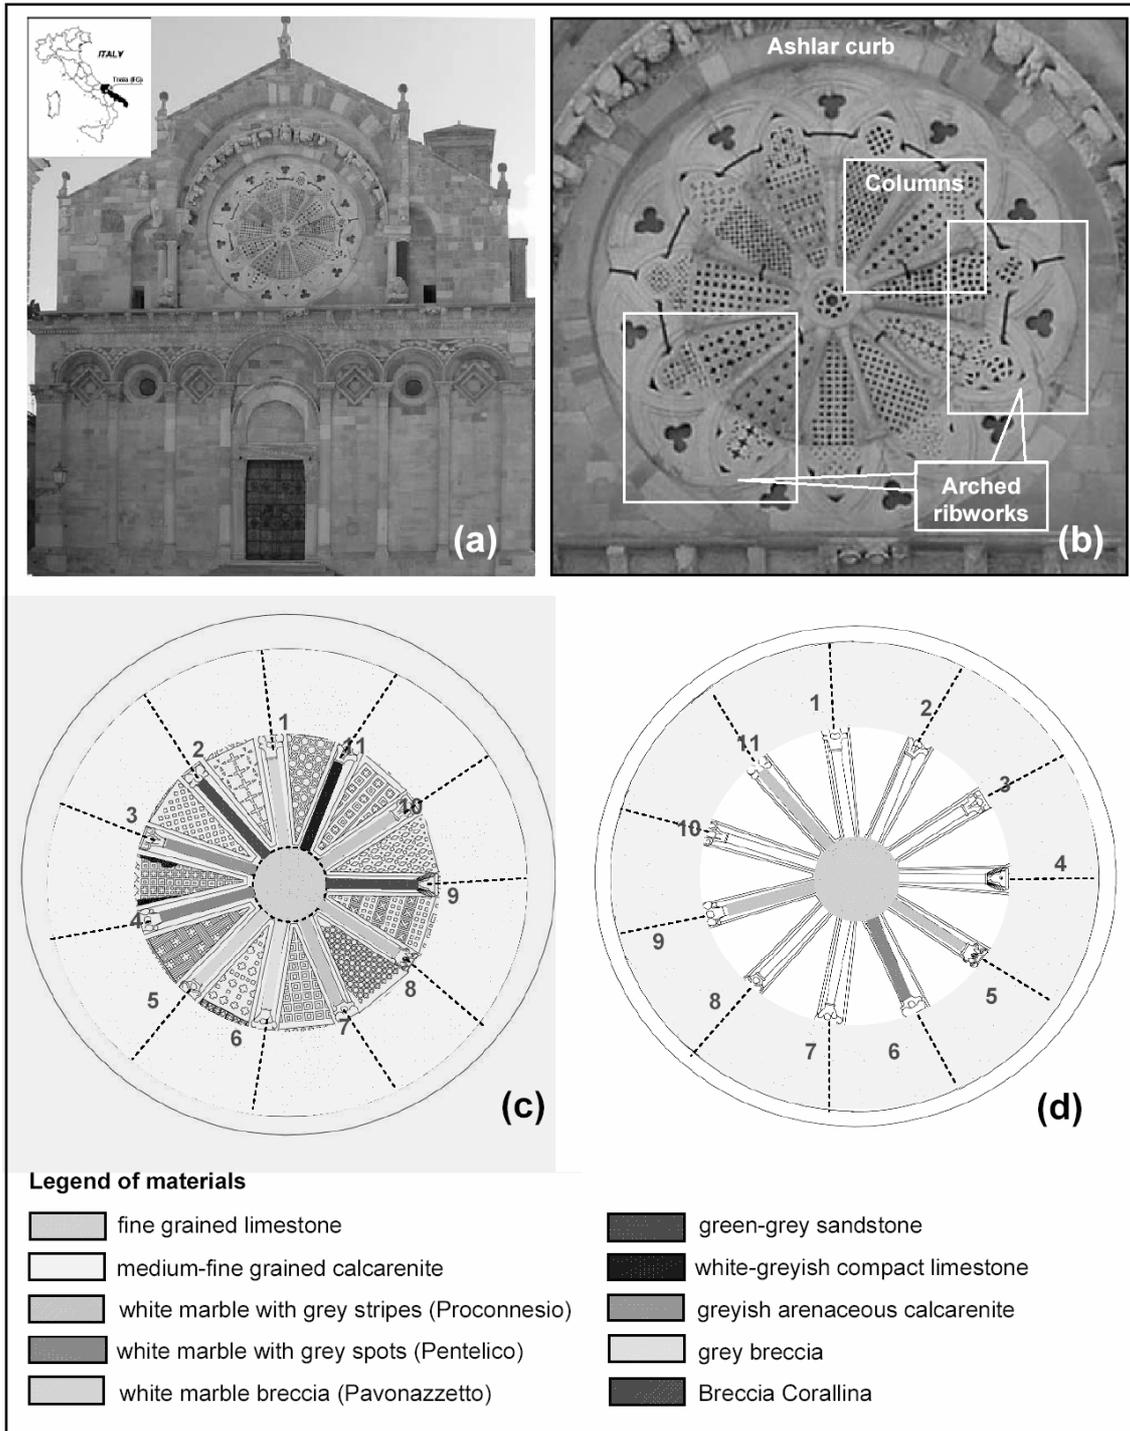
Figure 1 : Façade and rose-window of Troia Cathedral

The main damage of the façade consists of a rotation around a horizontal “hinge”, approximately 9.50 m above the base. The top of the façade is nearly 30 cm out of plumb. The origin of the rotation is clearly seismic, even though it was not possible to determine the date and the intensity of the event.

The rotation of the façade induced heavy deformations and damages in the rose-window, which is displaced outwards in the upper part, and inwards at the centre. Disconnections and rotations of the capitals, as well as compression failures of the columns may be observed. Relative displacements, up to 1 cm, may also be observed at the joints between the arched ribworks. An out-of-plane restraint was set up, presumably in the nineteenth century, consisting of two horizontal tubes, anchored to the ashlar and connected to some columns and arched ribworks through metal elements.

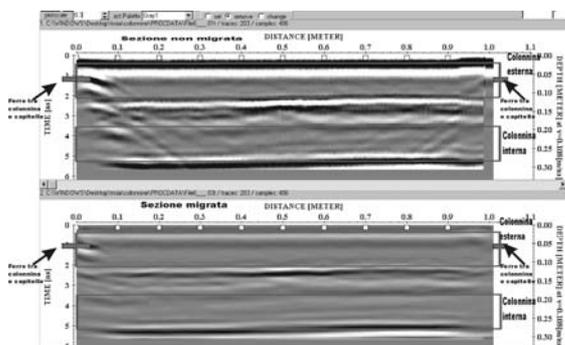
In this paper we discuss the results obtained on the most significant architectural elements. Fig. 2 shows the unmigrated (top) and migrated radargrams (bottom) relating to column 6, for which a velocity of 0.108 m/ns was estimated. Three reflections at 2, 3.4 and 5.4 ns are referable to interfaces between the different materials. In particular, a 3 to 5 cm thick layer of inhomogeneous material separates internal and external columns. In this space the carved panels are joined together by rubble and mortar. Thus, the total thickness of the three-layers medium (external column - inhomogeneous material - internal column) is about 26 cm.

Moreover, two semi-hyperbolas with apex at 0.05 m and 1.2 ns, on the two ends of the external column, could be associated to the edge of an iron anchor bolt linking the column with the capital. The anchor bolt penetrates in the column for about 5 cm, as marked in the migrated section.

Figure 2 : Top: unmigrated radargram of column n. 6. Bottom: migrated radargram with estimated velocity of em waves 0.108 m/ns.

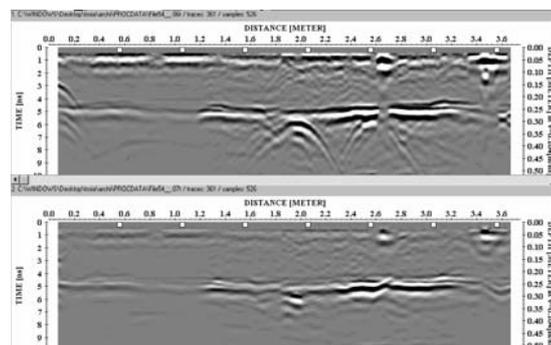
Fig. 3 is relating to the intersecting arched ribworks between columns 5 and 3. The radargram shows two different responses to the electromagnetic wave: the former between the abscissas 0-1.84 m, the latter between 1.84-3.68 m. This fact denotes the presence of two different materials. Moreover, diffraction hyperbolas at both ends reveal the presence of anchor bolts of about 10 cm linking the intersecting arched ribworks with the capital.

Figure 3 : Top: unmigrated radargram of the arched ribwork between columns n. 5 and n. 3. Bottom: migrated radargram with estimated velocity of em waves 0.104 m/ns.

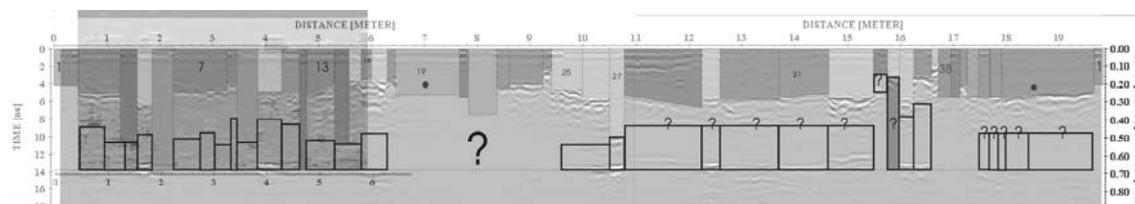
Fig. 4 shows the interpreted curb structure superimposed on the composite radargram obtained merging the topmost halves of the migrated sections from the external and the internal side.

In summary, the curb structure is a sandwich composed by two external rows of ashlars and an heterogeneous intermediate layer in the masonry core, probably composed by rubble. The two external rows are joined by a large number of diatons, especially in the lower part of the rose-window.

Figure 4 : GPR results on the circular ashlar curb: interpreted curb structure superimposed on the composite migrated section from both sides, outlining the ashlar's geometry and materials, and highlighting a more heterogeneous masonry core.

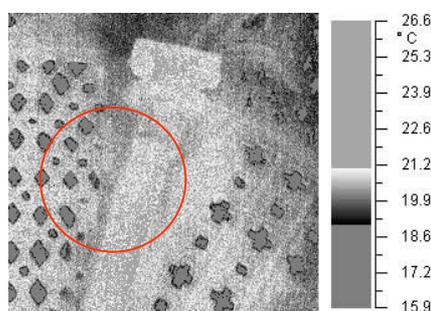
- cracks on the columns;
- surface cracks not visible;
- conservation treatments composed by mortar near the joints between the columns and the oeil-de-boeuf;
- superficial iron elements which join capitals to intersecting arched shape ribworks or to columns (Fig. 5).

Figure 5 : Thermal variation induced by a metal element connecting column and capital.

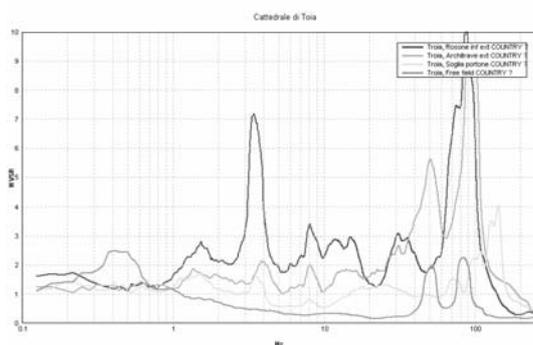
The measurements on the façade and the rose-window were performed with a digital tromometer (Micromed Tromino), that hosts in a single, small case 3 seismometers, a 24-bit digitizer and the data storage unit. For all the measurement points, 6 recordings were acquired, lasting 1 min each. The sampling frequency was 512 Hz. The signals were detrended and filtered in the range 0.1-256 Hz. After the transform in the frequency domain, the ratio between the horizontal and the vertical component was calculated in order to estimate the fundamental frequencies. The HVRS analysis identified separate fundamental frequency for the two orthogonal directions (in-plane and out-of-plane). On the façade, two frequencies were identified, at 3.2 and 8.0 Hz, with amplitude increasing with height, as expected for the fundamental mode (Fig. 6).

Figure 6 : HVSR of the façade at different heights.

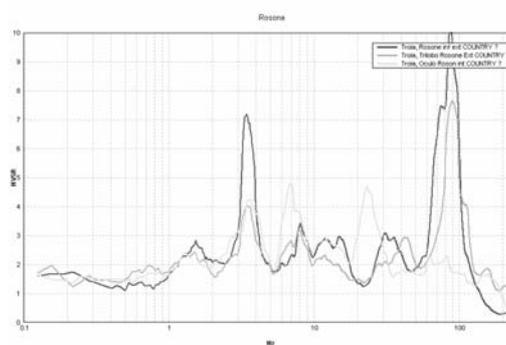
The measurements carried out on the rose-window (oeil-de-boeuf, arched ribworks and connection with the façade) show a different eigenfrequency (Fig. 7). While the façade frequencies are still visible, a separate frequency emerges at 22 Hz. This mode has greater amplitude at the center of the rose-window and decreases towards the connection with the façade, as expected for a 2D plate fundamental mode.

Figure 7 : HVSR of the rose-window.
