## Structural assessment of earthen walls and techniques for onsite consolidation and conservation

Sandeep Sikka

*Superstructures (Architects + Engineers), New York, USA*

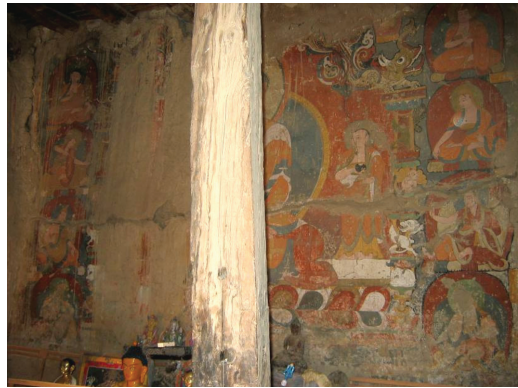
Figure 2. Horizontal crack in the load bearing wall of the semi-subterranean structure.

building swells after gaining moisture, which exerts horizontal pressure on the load bearing walls. The rear wall of the *Gya-Pag-Pai Lhakhang* is unable to resist the horizontal shear stress along the floor level outside, resulting in a major horizontal structural crack. (See figure 2).

A drain 2.5 meters wide placed exactly 1.5 meters away from the buildings was dug along the load bearing walls of the two semi-subterranean temples.

The depth of the drain was kept 8 feet (about 2.4 meters) that was decided according to the internal floor level. The bottom surface of the drain was kept at least 2' below the internal floor level of the temples so that all the water is drained out without any possible danger of seepage into the surrounding area.

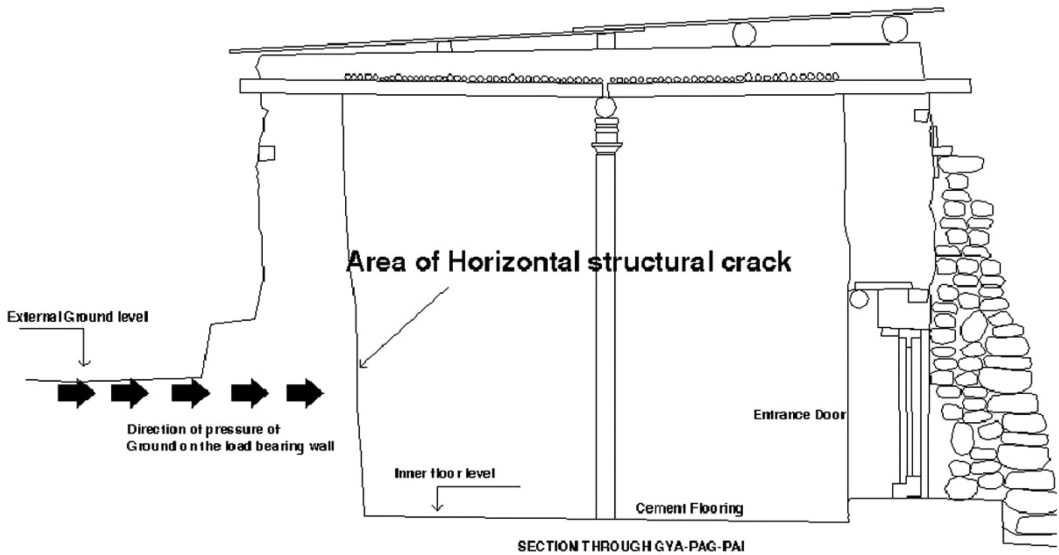
Due to inadequate length of the wooden spouts added recently on the adjacent building's roof and in absence of any proper drainage facility from the roof of the *Gya-Pag-Pai*, the rainwater and water from the melting snow drain next to the load bearing walls at the rear of the temple. Consequently the water seeps into the building walls and foundation causing enormous damage to the water-soluble un-reinforced masonry. In addition to this the site of the temple complex slopes down along the east-west direction and consequently the excess water draining from the village on the higher level towards the rear of the temple contributes excessive moisture to the ground adjacent to the load-bearing wall. As a result the soil outside the

Figure 3. Thrust created by the expanding ground due to moisture gain next to the wall results in a horizontal crack.

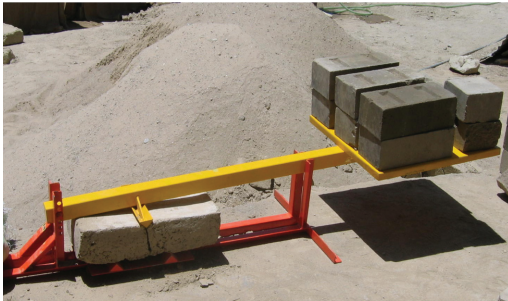
Figure 4. The samples were tested for their Flexural Strength through an apparatus designed specifically for testing the adobe in the field; using compressed earth block units of 7 kg.

An apparatus designed specifically for measuring the strength of the adobe in the field was used for determining the 3-point flexural strength (See figure 4). The 3-point loading was applied using series of compressed earth blocks each weighing 7Kg. The particle size analysis (see figure 7) of the local soil and clay indicated that the percentage of sand content in the soil was far more than the required quantity. Therefore to increase the strength it is essential to increase the quantity of the binder in appropriate proportion. The mix thus prepared with various binders like cement, lime and locally available clay for extra strength were then put to test. Four kinds of adobe samples were then prepared with relatively dry mixes, wet compacted inside the moulds and were left to dry for four weeks.

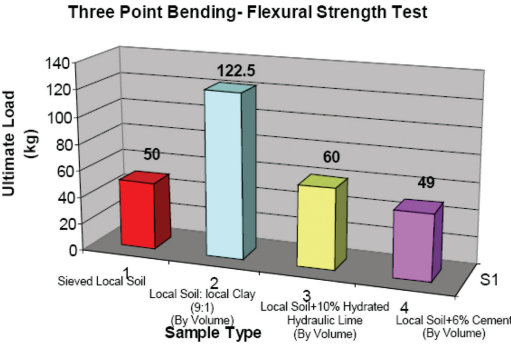
It was observed that the addition of 10% local clay or 10% lime as a binder significantly increases the strength of the adobe. Further tests with varied proportion of clay and lime can be tested before the manufacture of adobe for conservation work. The stabilizers and additives, which perform well for increasing the strength, may or may not perform well against water erosion. To generate a solution for the stabilization of the adobe with appropriate stabilizing materials against the increased precipitation, a scientific study of the samples of the various adobe formulated from the local soil and clay with different stabilizers were tested on site for their resistance against moisture. These blocks were then tested on site for their performance against general weather conditions and water. The final mix design should also impart strength, as they have to take the load of the roof at the same time.

Figure 5. Results of strength test conducted on four samples of adobe on site.

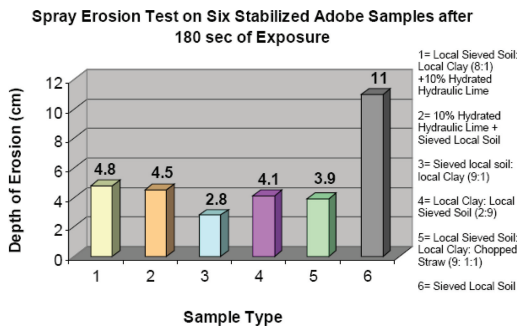
Addition of local clay 10% by volume increases the resistance of adobe against water erosion. Addition of chopped straw also significantly increases the cohesion and resistance to water.

Figure 6. Result of spray erosion test conducted on six stabilized adobe samples.

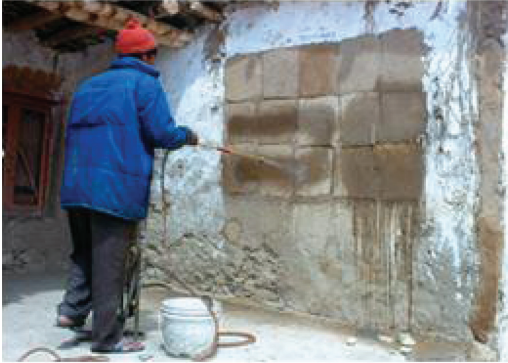
Figure 8. Fifteen plaster samples tested on-site for water erosion.

the depth of water penetration till the substrate. It was found that the plaster mixes stabilized with lime had a penetration of water <6 mm into the surface.

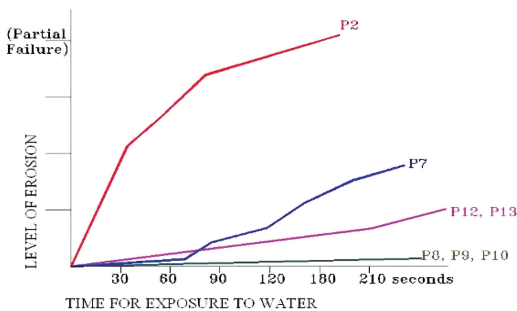
Figure 9. Results of water spray erosion test.

The selected mixes as shown in the graph (P8, P9, P10) after the tests are not only stable against moisture but at the same time porous enough to facilitate evaporation of moisture which is trapped behind so that the internal painted surface on the other side is not affected. The strategies thus derived after interpretation of the above results for the surface protection of these historic earth structures against the changing climate are not only practical and economical, but at the same time address the re-strengthening of thousand years old local traditions.

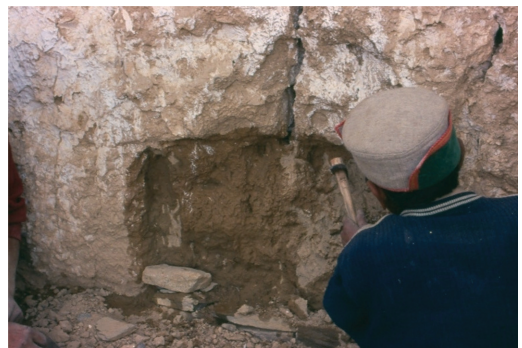
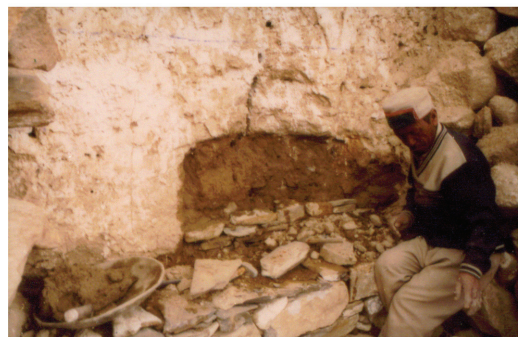
The cracks and crevasses developed in the *Karjung Lhakhang* are the areas of the potential weakness in the load bearing walls need to be repaired and stabilized to provide structural continuity. The crevasses are mostly along the cracks and in such case stitching would be a sympathetic alternative to strengthen and retain most of the original masonry.

Figure 12. The structural cracks have been raked and the masonry is reinforced again with thin slate tiles.

Hence, widening of crack was avoided and the stitch material was inserted into the masonry by making small slits into the adobe blocks in zigzag manner alternately to bridge the crack to achieve extra strength.

Study of ancient adobe blocks at Nako temple complex indicate the use of varied size of course aggregates and slate stones to gain extra reinforcement and strength. Thin Slate tiles are locally available, lightweight and have been used extensively for the construction of traditional houses. It is well known, learnt and documented by several locals and professional in the Himalayan region that if the slates tiles are well laid horizontally in layers inside a masonry wall, performs well during an earthquake. According to the survey conducted in 2003 the stone masonry structures with such horizontal band of slate tiles were affected less during earthquakes of 1975 in the region as compared to similar stone masonry structures without such band. Slates tile and local fiber reinforced lime-stabilized mud-mortar as filler was therefore selected as stitch material for cracks. The tiles were laid into the slits horizontally and voids in-between were then filled with mortar. This was repeated up to the top of the crack. Addition of fibers in the mortar mix reduced shrinkage and created better cohesion. The stitched portion of the wall was then rendered with lime stabilized mud plaster discussed above. A stabilized soil with lime and jaggery grout previously tested in the lab for its performance was injected from the inner painted surface to fill up rest of the void along the remaining width of the wall.
