The restoration of the foundation in the north side of the temple of Apollo Epikourios

K. Papadopoulos

Technical Team for the Restoration of the Temple of Apollo Epikourios, Bassai, Greece

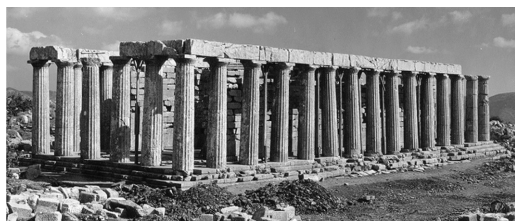
The temple is one of the best preserved buildings of classical antiquity (Fig. 1). However, it presents many severe structural damages: foundation deformations, stone-blocks fractures in the steps, and significant tilts of the columns. Furthermore, its material has deteriorated extensively due to the extreme weathering conditions that prevail during winter time in the area (the temple's altitude is 1130 m a.s.l.). All those problems of the monument have diminished significantly

Figure 1. The temple of Apollo Epikourios, before the beginning of the restoration work, from NW.

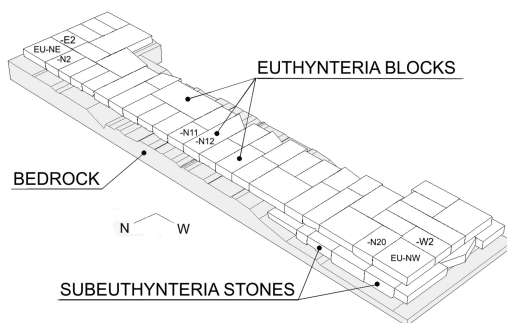
Figure 3. The euthynteria stone-blocks in the north side of the temple (isometric sketch).

The north euthynteria of the temple consists of rectangular shaped blocks in two rows, which were laid as headers (Fig. 3). Twenty-one blocks are in the façade row, with varying width and with common length and depth about 0.68 m and 0.28 m, respectively. A pair of double-lengthened blocks (EU-N16, EU-N19) appears in the west part. The corners terminated with nearly square shaped blocks measuring 1.15×1.12 [m]. The sizes of the back row blocks vary significantly; consequently, the vertical joints run in random patterns. Clamps connected the façade blocks only in the top face, close to the north edge.

The subeuthynteria course in the temple's north side begins below the sixteenth from the east euthynteria façade block (EU-N16), (Fig. 3). It consists of irregular sized cut stones (Fig. 4), some of which (most probably) came from an earlier monumental building and

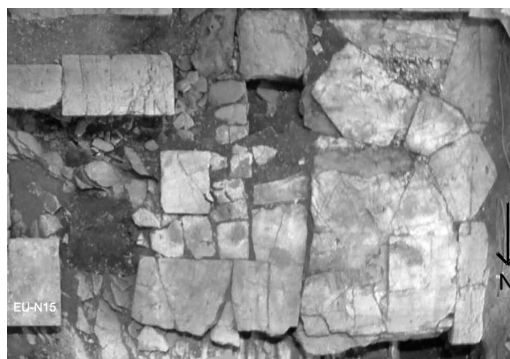
Figure 4. The subeuthynteria stones in the north-west corner of the temple (down view).

For the consolidation of the subeuthynteria course in the north-west corner of the monument, trenches 1.0–1.5 m wide were excavated across the north and south limits of the course, both in its external and internal sides. It should be noted that for the excavation of the west external trench a part of the artificial fill, consisting of clay and stones of irregular shape and size, had to be disturbed; however, the trench width was kept the minimum necessary, and the removed stones were replaced in nearby positions. The trenches extended down to the bedrock, and underneath the course for a width of 0.50 m.

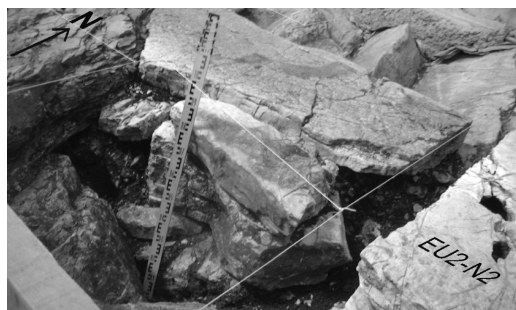
Figure 5. The stones inside the bedrock cavity and the reused, reshaped block in the north limit of the cavity (view from SE).

The cavity found in the bedrock below euthynteria (Fig. 5) is roughly semi-spherical in shape, with depth reaching 85 cm and volume about 2.5 m^3 . Its center is beneath the back face of the sixth from the east euthynteria façade block (Fig. 7). Inside the cavity a group of stones were found, placed one on top of the other, occupying the northern third of the cavity. The stones are of various sizes and irregular shapes. The rest volume cavity was filled with clay. Although the stones have settled, the highest altitude of the top stone is close to the altitude of the proximate bedrock, indicating the initial group elevation. It is obvious that the structural function of the stones is to form a subfoundation ‘pillar’ for transmitting the building loads to the rock. In the north limit of the cavity, parallel to transverse axe of the temple a reused block is laid, based partly on rock and partly on clay.

The consolidation of the group of stones inside the bedrock cavity was accomplished with the construction of a wall in the remaining empty cavity space. The wall was built with stones from the local area and stabilized clay as binding material.

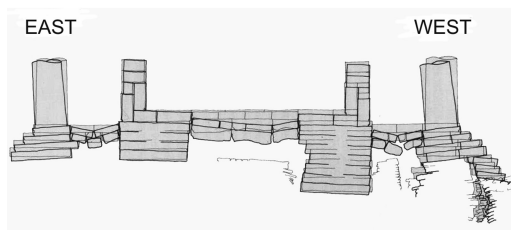
In previous study (Papantopoulos 1995), it was suggested that in the east part of the temple foundation failure occurred, mainly, because some clay material was washed away from rainwater, evoking the above euthynteria blocks to settle. In the west part failure

Figure 6. Sketch presenting, in exaggeration, the deformations in the foundation of the temple (Papantopoulos 1995).

was caused by the gradual slide of the artificial fill down the slopping rock, which dragged along the above foundation. Those assessments were based on measurements of settlements in different parts of the monument and observations about the foundation construction, which were made in trenches excavated in few selective positions around and inside the building.

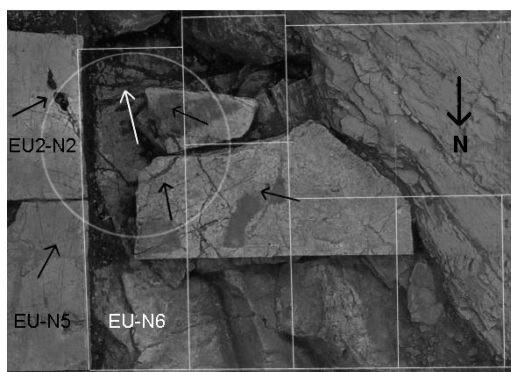
Figure 7. The top stone of the group inside the bedrock cavity, the proximate subfoundation reused block and the neighbouring euthynteria blocks (down view). The black arrows indicate the inclinations of the stone, the fragments of the reused block, and the blocks. The white arrow shows the direction of column N2 tilt. All arrows are pointing at the lower parts of the cavity.

For the consolidation of the subfoundation stones found in the north side of Apollo Epikourios temple, the five scattered stones and the top stone of the group inside the cavity were removed and structurally restored; meaning the fragments of the stones were connected using threaded titanium bars and white cement paste, according to the technique developed in the restoration work of the Acropolis monuments (Zambas 1988, Vintzileou & Papadopoulos 2001). Then, the stones were conserved and repositioned. In the cases where the stones did not fully based on bedrock, the void between the stones and the rock was filled with stabilized clay. The stones were repositioned horizontally, with altitudes resulted from observations about the altitude variation of the proximate bedrock surfaces.

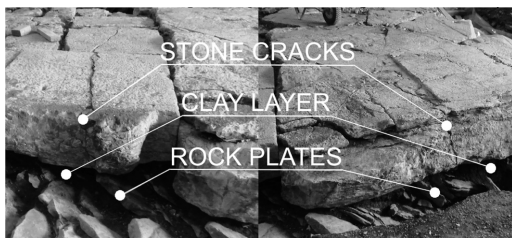
Figure 8. The large corner subeuthynteria stone (right) and its side stone to the east (left). View from north. It is obvious that the stones have settled, inclined toward the slope in the west, and that their cracks are at the contact points with the rock.

(ii) The stones based on thick clay have settled significantly, inclined in every case toward the side where the below clay layer was thicker. This was very clear in the euthynteria blocks placed above the bedrock cavity (Figs 7, 9 right). (iii) The blocks based partly on bedrock and partly on clay were fractured across the base condition differentiation line, with their fragments based on clay suffering the larger settlements. The latter was quite obvious in the reused block placed beside the group of subfoundation stones (Fig. 7), and in the north stones of the subeuthynteria course (Fig. 8).

Thus, the data strongly indicate that, during the centuries, a gradual reduction of the clay layer led to the settlements of the foundation stone members. The reasons for the clay layer diminishing were the washing away of material from rainwater (which started passing into the temple, after the collapse of the roof), and the creeping flow of clay toward lower parts of the bedrock, under the loads of the building and with the decisive cooperation of rainwater. The gradual clay escape was toward the lowermost parts of the cavity (Fig. 7), through the fissures and the discontinuities of the bedrock, and down the slope in the west side (Fig. 8).

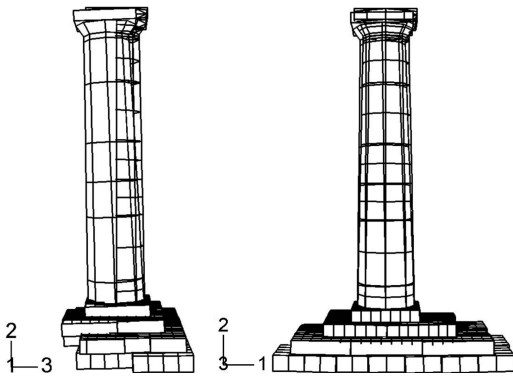
The numerical analysis resulted, as it was expected, both significant displacements and rotations of all the model members and material failures in the blocks of the steps. The deformed model is presented in Figure 10. It is quite obvious that the steps have settled significantly, and that the column, carried along by the steps, has subsided and inclined toward SE, that is toward the position of the bedrock cavity in the monument (Fig. 7). Specifically, the analysis predicted maximum column deviation from the vertical position

Figure 10. The deformed model, from east (left) and north (right). It is clear the intensive column inclination toward the position of the cavity in the bedrock.

by 23.6 cm to the south and by 7.7 cm to the east. In-situ the column was measured tilting 26.5 cm to the south and 5.0 cm to the east.

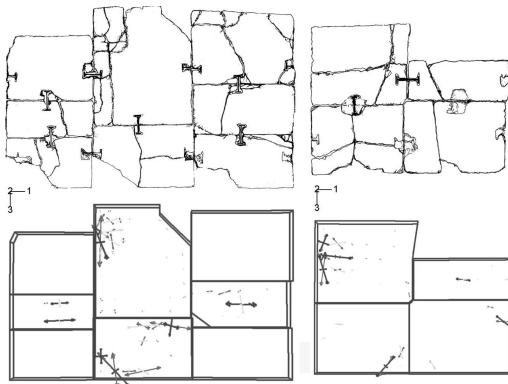
Figure 11. Up: The blocks fractures (as documented in-situ) in the first (left) and in the second (right) step. Down: the relative numerical results.

The computed material failures in the blocks of the first two steps and the respective documented blocks fractures are shown in Figure 11. The comparison indicates that the majority of the blocks fractures were reproduced by the analysis at the same or nearby positions.

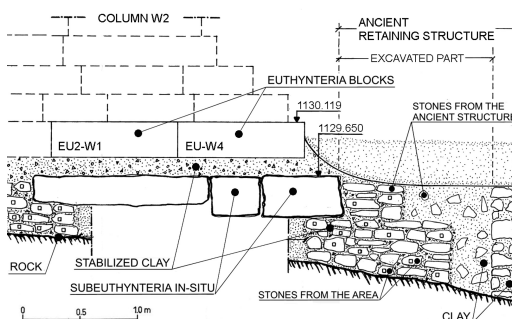
Figure 13. The consolidation of the subeuthynteria course. Cross section parallel to the transverse axe of the temple.

In the trenches, walls were built to support and retain the course (Fig. 13). The walls were built with some of the stones removed from the ancient structure,

stones from the local area distinguished by indicative sign, and stabilized clay as binding material. The remained empty spaces of the trenches were filled with clay and the rest removed stones.

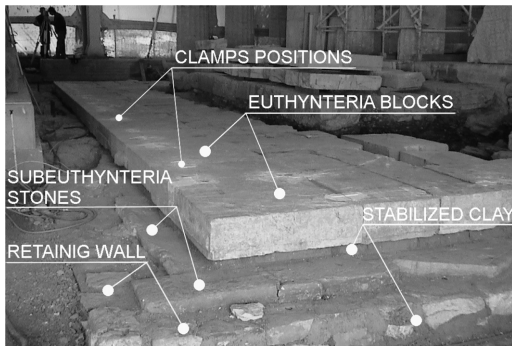
Figure 14. The restored foundation in the north side of the temple, from NW.

For the restoration of the foundation in the north side of the temple 45 euthynteria blocks were restored and repositioned (Fig. 14). The restoration of the temple north foundation was completed with the reconnection of the euthynteria façade blocks using new titanium clamps. The new clamps are designed to improve the monument seismic behaviour, without inducing blocks fractures (Papadopoulos 2007).
