The diagnosis and arresting of settlement within Westminster Hall in the Houses of Parliament, London

J.D. Miller

MA CEng MICE MStructE Membre CNISF, Technical Director, Gifford

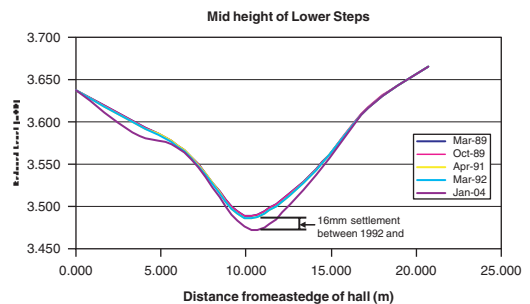
Research also yielded invaluable details of settlement monitoring work from the 1940's, drawings showing some construction details of the nineteenth century steps and proposed repairs in the 1960's. As consultants we were in the rare position of having movement monitoring of sorts for a period of some 60 years, about half the life of the present steps. Amongst other information, the early research gave four sets of data on floor settlement over a total period of around 60 years. It was clear from this that the movement of the steps showed no signs of stopping, with an additional 16 mm of settlement in the centre of the floor being recorded between 1992 and 2004 (Figure 2).

Figure 2. Deflected profile of the steps from East to West.

This historical monitoring was assessed and suggested historical and ongoing settlement of approximately 1 mm a year.

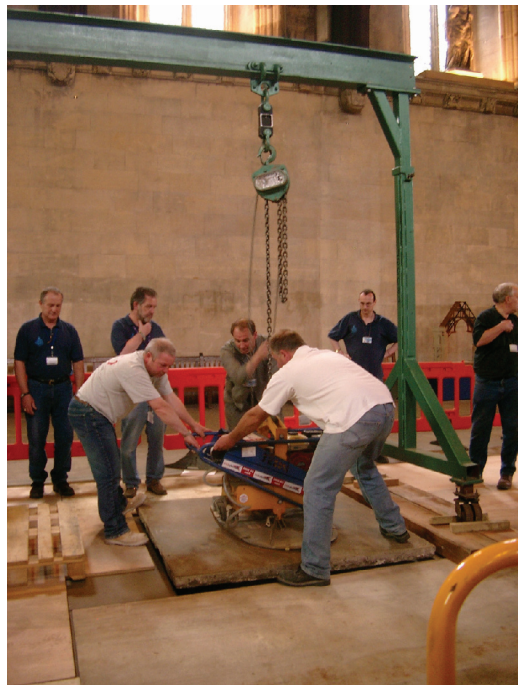
the flags were carefully cut free using hand tools and where necessary, after careful reflection a small disc cutter. It was found important to completely free the joints otherwise spalling started to occur at the edge of the flag. A single stone flag was successfully freed and relaid in the middle of the area of settlement, revealing Smirke's construction of dwarf sleeper walls and oversite concrete slab below (Figure 3).

Figure 3. Trial lifting of the stone flags.

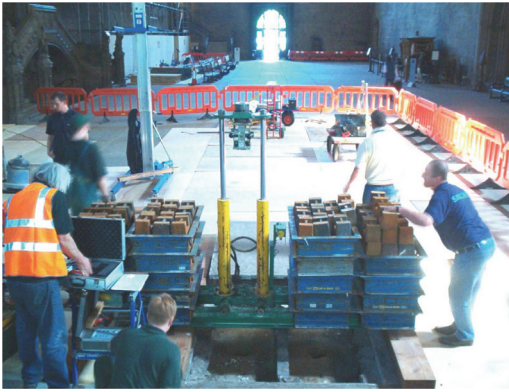
Figure 4. Dynamic Probe and MOSTAP sampling rig.

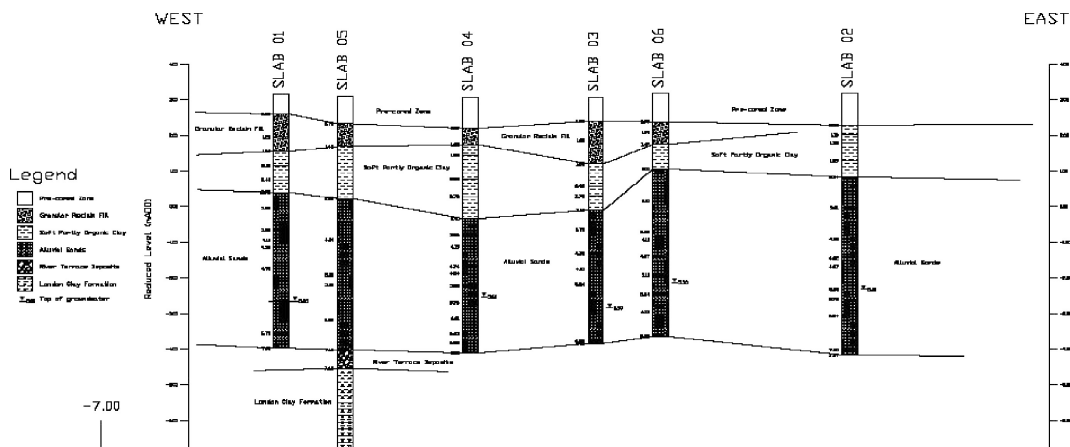
The results showed that material at a depth of between roughly 1 m and 3 m below the floor at the base of the steps comprised very weak alluvial clays with some organic content and varying in thickness. It is this local area of weak clay alluvium that is gradually compressing, and causing settlement, the problem is exacerbated by the additional load due to a large stone candelabra support structure of considerable weight. Further to the North, this material became firmer, giving way to terrace silty sands and sandy gravels (Figure 5).

The diagnosis was, therefore, that the floor and steps were likely to be settling because of the weak and organic materials present locally below, with constant internal shearing of the soil resulting in continuous movement.

Figure 5. Geotechnical section showing layer of very weak alluvial clays.

The chosen approach, presented in the final sketch plan submitted to the Client, was the third of these. The lower flight of steps and brick wall supports was dismantled down to over site slab level and mini piles installed with ground beams to create solid foundations to the steps. Under the floor initially it was proposed to strengthen the ground using dry soil mixing whereby a dry lime-cement mix is mixed into the weak layer of alluvial material to stiffen it. However, this presented practical problems and would have damaged the archaeological potential in this stratum. The final design strengthened the deep ground strata below the floor by carefully injecting columns of stiff grout under pressure in a controlled method to provide lateral compaction to the deep strata, known as compaction grouting (Figure 6). The archaeological remains, located principally in the top 1–3 m of material were not extensively damaged by injected grout as it was injected here at hydrostatic pressure, in effect creating piles passing through the layer. So the impact on the archaeological potential was limited and known. The depth and pressure of the grout columns were carefully controlled to reduce the increase in stiffness of the ground adjacent to the unstrengthened area of floor.

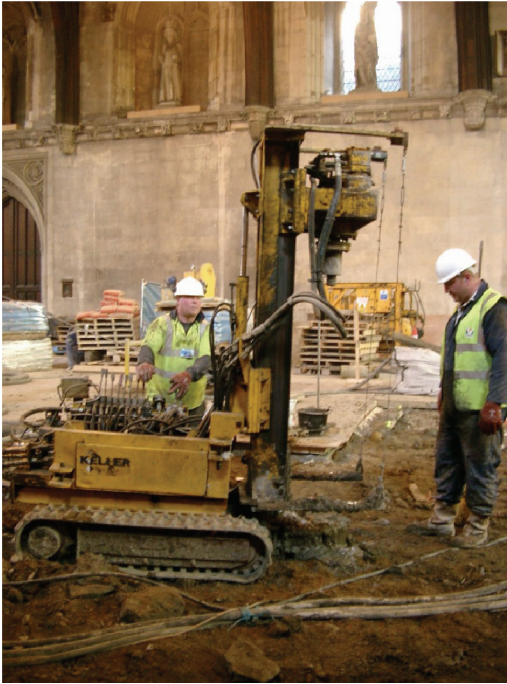
Figure 6. Rig for insertion of compaction grouting tubes.

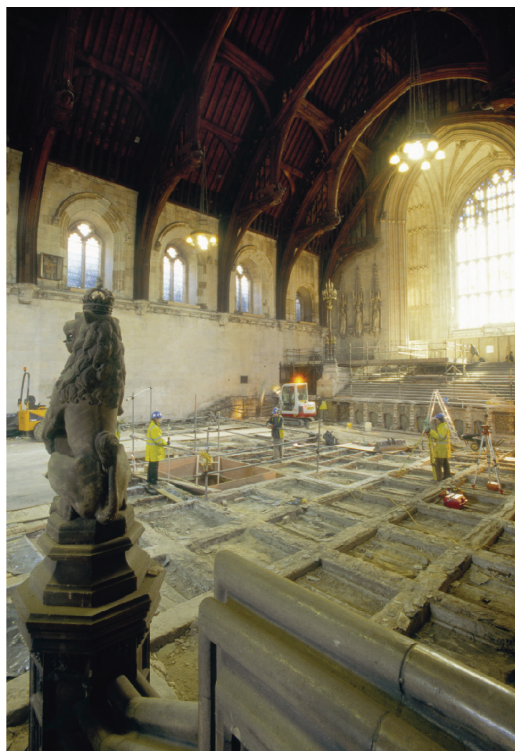
Figure 7. View towards South end of the Hall during archaeological mitigation work.
