Istanbul – Fatih, Millet Library / Feyzullah Efendi Madrasah restoration

ABSTRACT: The Feyzullah Efendi Madrasah, built in Fatih, Istanbul in 1700, is a small complex with a library, school, fountain for ablutions and two other fountains. In the 1999 earthquake, the madrasah was severely damaged and cracks appeared in its foundation, main walls and domes. The restoration of the building was carried out between 2000 and 2007, the ground under the building was firmed up, foundations, domes and walls were consolidated, the cracks in the walls and domes were stiffened using an injection method. This complex was used first as a madrasah / faculty and then as a library. In this paper, the damage caused by the earthquake and the problems of the new function given to the building is investigated. As for the restoration, the repair methods to be applied were examined while estimating to what extent the historical value of the building was preserved.

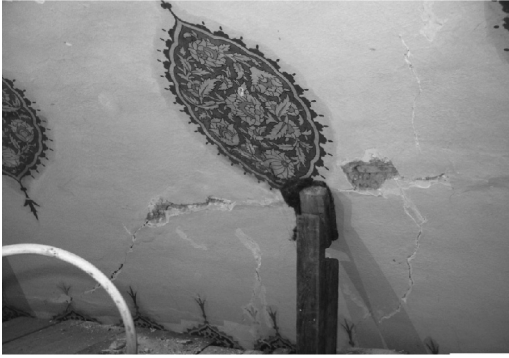
Figure 9. The dome crack of the main building, before restoration (Archive of the Istanbul Survey and Monuments Directorate).

The Marmara earthquake resulted in significant damage to the building. In both structures consisting of masonry walls, a series of cracks and deformations in the surface materials were seen. Removing the plaster from the surface of the buildings, revealed deep cracks in the arches, domes and in the bearer walls, particularly in the madrasah building, this damage was determined to negatively affect the support system, and the bearer walls had moved from their plane (Akcan, 2001), (Figure 9). Also it was determined that these cracks in the walls and domes might possibly extend as the foundations (Akcan, 2001).

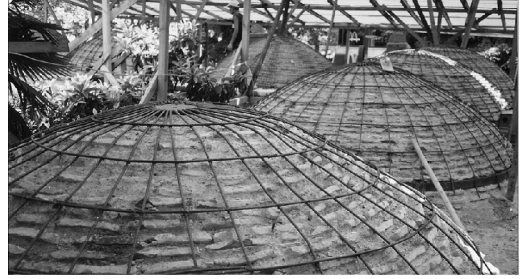
Figure 10. The consolidation method of bar-mat on the dome, main building, restoration stage.

the madrasah building. The foundations, walls, domes and portico arches of the badly damaged building were strengthened with metal construction reinforcement and the foundations were converted into a raft foundation system (Figure 10). However, the dimensions and places of the material that the metal construction would create and the relations with the main walls were not clarified and the behavior of this system in future earthquakes was not investigated (Ahunbay, 2001). The plaster at the repair stage while being rasps, the cracks which occurred in the dome and walls were investigated; however, it was not investigated whether or not the historical value of the plaster would carry them. In addition the wooden posts that carried the temporary roof constructed to protect the building were seated without taking into account any measures for cracks (Ahunbay, 2001) and this was one reason why the damage to the building increased.

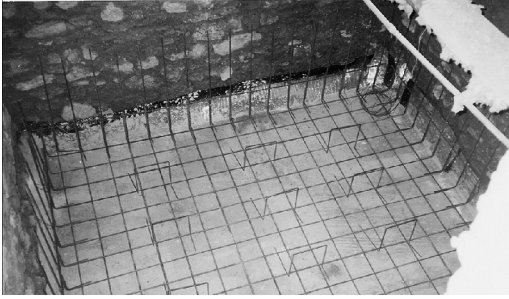
Figure 11. The application of the raft foundation for madrasah.

Foundation strengthening: The foundations of the madrasah building and the main building were strengthened using stainless steel. The floors of the madrasah rooms were dug down nearly 3.50 meters before cement was poured on the holes in order while the hardcore layer, rubble concrete and iron reinforcing bars was put in place (Figure 11). So it was provided that the madrasah rooms would sit on a raft foundation extending nearly 2.00 meters below and 1.50 meters above the surface level.

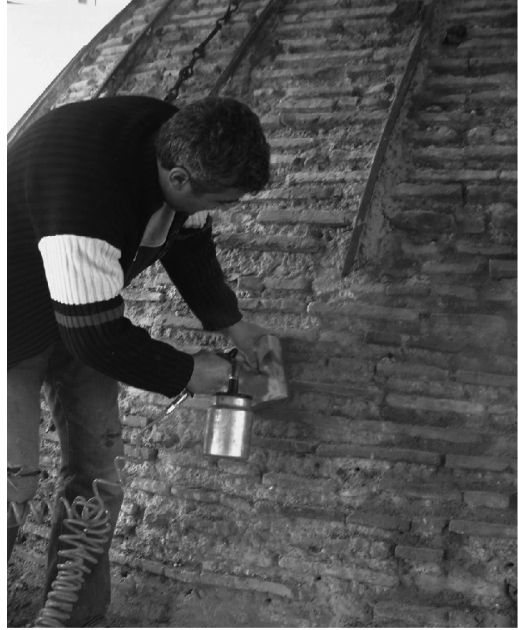
Figure 12. Injection method for the consolidation of the cracks, restoration stage (Archive of the İstanbul Survey and Monuments Directorate).

Strengthening the walls, arches and domes: Splicing was applied to the cracks on the walls and domes of the madrasah rooms and on the portico arches and domes. At the same time strengthening work was undertaken with the injection method (Figure 12). In this method, the cracks are filled by injecting into the cracks a grout made of brick powder, limestone/küfeki powder, marble powder, sand and hydraulic lime. To further stabilize the structure, injection holes 24 mm

in diameter were opened at a depth of 20–50 cm in the masonry wall surface at intervals on average every 50 cm. and in the brick domes on an average of 20 cm; the domes and walls were stabilized as the injected grout was pumped through these holes.

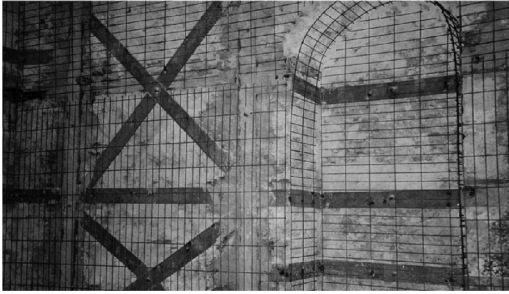
Figure 13. The application of NPU 120 profiles of the madrasah walls, restoration stage.

In the damaged walls of the madrasah building, in the portico arches and domes, a metal construction was used, consisting of hoops and sashes (Figure 13). In this application in order for there to be the perpendicular elements within and without, they were placed in the masonry walls, tying each one to the other at specific intervals. The channels opened in the walls of the madrasah rooms while NPU 120 profiles were being mounted were surrounded with thin plates and while the steel matting was being laid the walls were strengthened. In the repair of the damaged domes, metal elements were aligned horizontally and perpendicularly on interior and exterior surfaces of the domes. The madrasah and portico domes and the arches that carried the domes were strengthened with steel matting that was laid inside and outside.

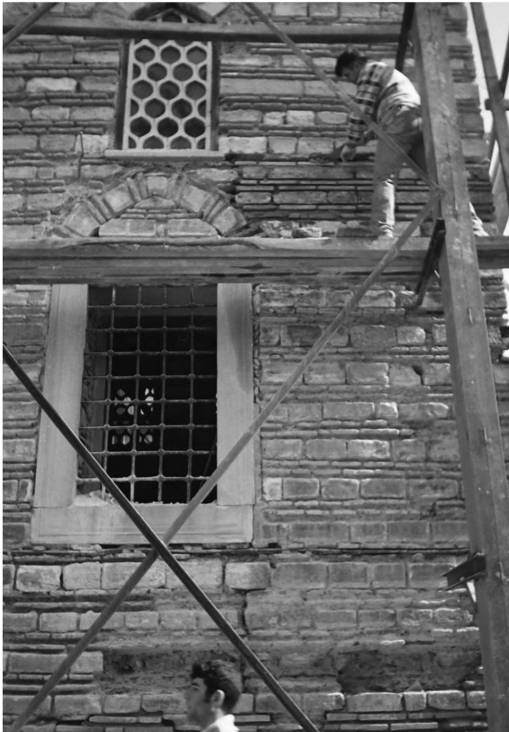
Figure 14. The application of bar-mat on the madrasah walls, restoration stage.

Strengthening the stones and joints : After it was demonstrated that the main walls of the main building had been damaged, they were strengthened in part by filling the cracks with an injected grout. Prior to this work being carried out, a portion of the stones that were damaged were removed and the missing parts

were reconstructed using new stones. Khorasan mortar was used in the joint intervals (Figure 14).

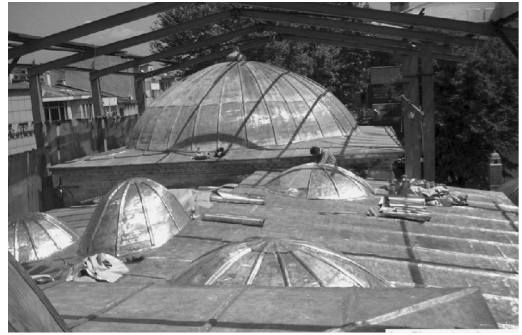
Figure 15. Laying of the lead boards on the dome, restoration stage (Archive of The Protection Council of the Natural and Cultural Properties).

the work of strengthening the domes and renewing the spike eaves, a mud mortar made of soil, hay and water was spread over the brick dome was spread over the dome 5 cm thick, providing heat insulation and protecting the lead plates. After the mud plaster had dried, the new lead plates were installed, covering the brick dome, beginning at the edge of the dome and extending up to the finials on the top (Figure 15).

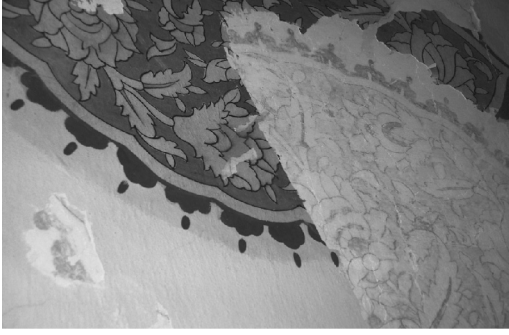
Figure 16. Detail of a main motif, before painting repair (Archive of the İstanbul Survey and Monuments Directorate).

Painting Repair: All the painted decorations on the walls of the main building, on the domes and vaults were repaired in accordance with the data obtained from the research. After the existing decorations were documented with photographs, rasp work was carried out in order to reveal the main motifs (Figure 16). Following the rasp work the main motifs were found beneath 6–8 layers of dye and these motifs were transferred to translucent paper. The original designs on the surfaces that had earlier been strengthened and plastered with a lime based mortar were transferred back by means of opening holes with a needle and closing them up with coal powder. These designs were then colored with metal oxide paints.
