## The column of Marcian/Kıztaşı in Istanbul and an evaluation of its restorations

**ABSTRACT:** The Column of Marcian, or Kıztaşı, is one of the magnificent monuments that were constructed in the name of Roman Emperor Marcian in Istanbul. It was built in his honor around 450–452. The monument consists of a square marble plinth block seated on a three-stepped platform and marble blocks on a single granite column topped with a marble column capital. Through the intervening years, the Marcian Column has been damaged by earthquakes, fires and repairs. With the 1999 earthquake, the column became slanted on its axis; the iron rings on the bases and those on the body itself were dislocated; the capital was deformed and hairline cracks were found in the column's body. In 2005, the Marcian Column was restored by the Istanbul Metropolitan Municipality. This article will examine the old and new restorations and will utilize contemporary restoration criteria to evaluate the last intervention.

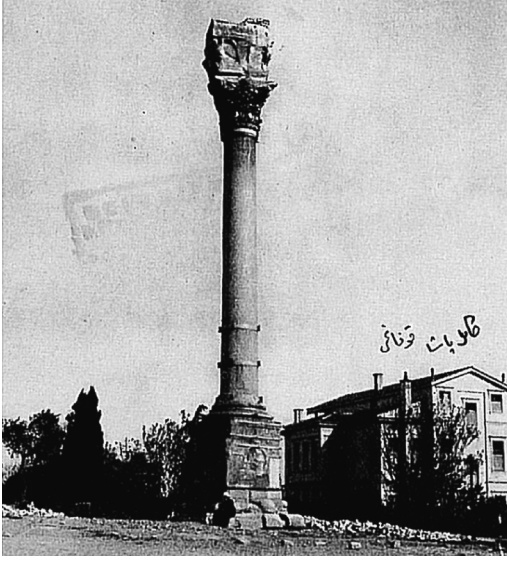
Figure 1. The Column of Marcianus/Kıztaşı, at the beginning of the 20th century (Eken, 1992).

In the photographs of the Marcian Monument taken at the beginning of the 20th century, it is seen that the monument had had hoops put on it at various levels. This repair must have been carried out on the parts of the monument that were damaged in the 1894 earthquake and the 1908 Fatih fire. In this photograph, the marble stepped platform is still at street level. On the lower plinth of the column, there are steel hoops at the column bracelet and on the body. The lower plinth has been encircled with four hoops, the bracelet with two and the column body with three. One cannot understand, however, if the metal cramp and chains that are on the column today—but are not seen in the photograph—were put on during this repair or in repairs carried out later. The photograph also does not show the statue that is said to have been on the uppermost of the monument, so it could not have been still extant at this date.

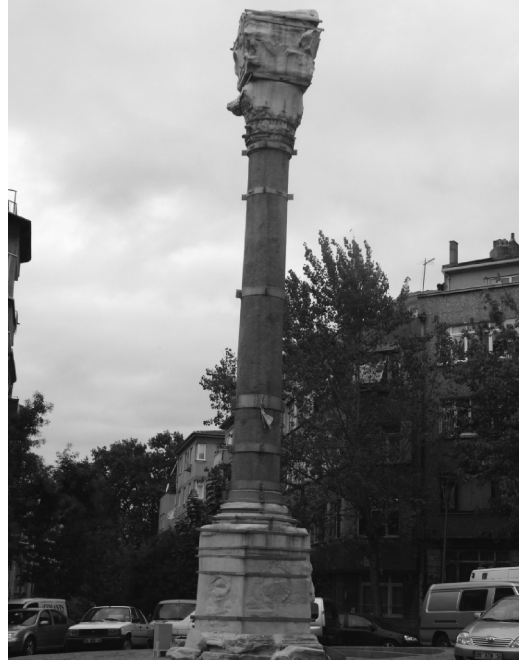
Figure 2. Kıztaşı, east façade after the restoration, 2007.

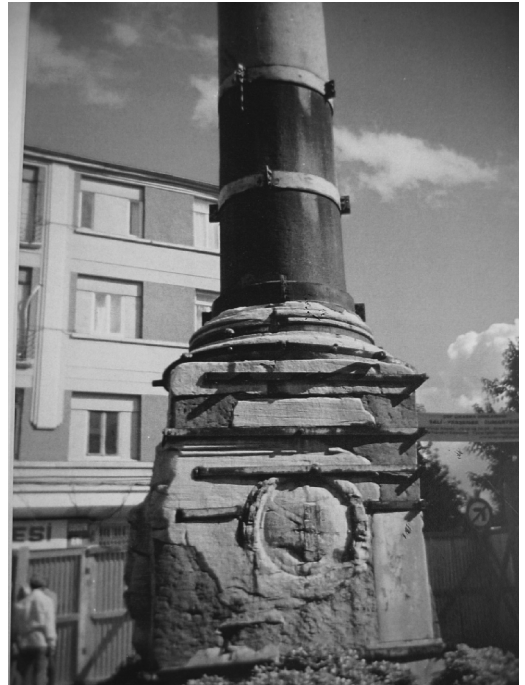
Figure 3. Kıztaşı, west façade of the column plinth before the restoration, 2005 (photograph by Üveysuna, D. & Demirel, A.).

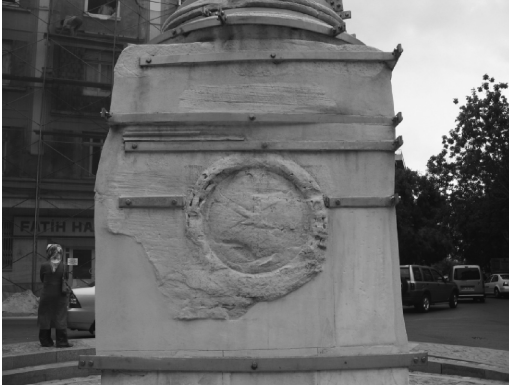
Figure 4. Kızıtaşı, west façade of the column plinth after the restoration, 2007.

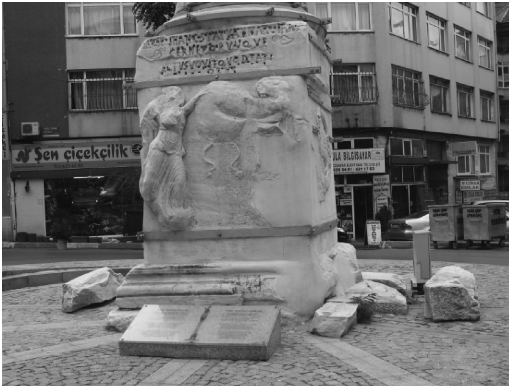
Figure 5. Kızıtaşı, north façade of the column plinth after the restoration, 2007.

the right are almost complete, the angel on the left side is missing her head. In the inscription above this decoration on the north façade is the statement: “This column was erected for the Emperor Marcianus by the Prefect Tatianus”. While it has been said that in the past the inscription was comprised of bronze letters (Yücel, 1969), only remaining today are the holes through which the letters were held.

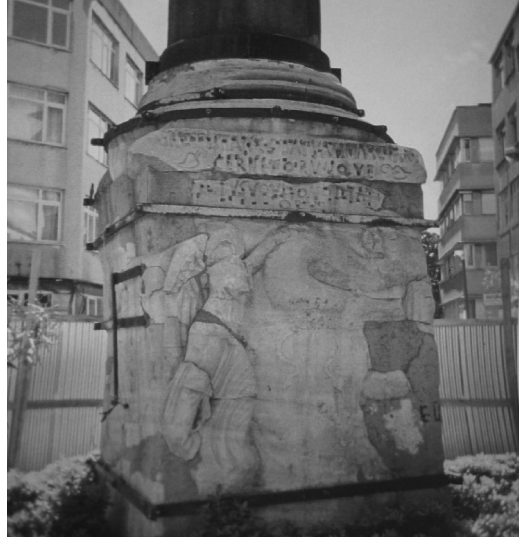
Figure 6. Kızıtaşı, north façade of the column plinth after the restoration, 2007.

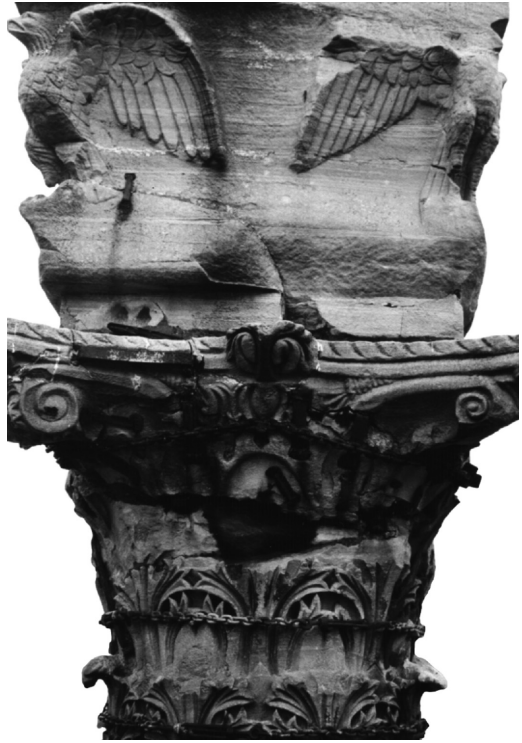
A single granite column that is nearly 110 cm in diameter and 870 cm in height rises on the lower plinth of the column. Between this column and the lower plinth is a marble bracelet 50 cm in height and on the top of the column there is a marble capital of Corinthian design (Figures 7–8). The capital, decorated with sharp-pointed acanthus leaves and its corners voluted, has been destroyed in fires. A block

Figure 7. Kızıtaşı, west façade of the column capital, marble block and upper plinth, before the restoration (Akşit & Akşit, 2001a).

At the start of the 1970s the Kıztaşı was repaired because its cracks and the pieces falling off the marble column capital had been posing a danger. Corrosion of the cramps and mortises found on the capital and their decomposition were the reason for the damage on the monument. In this repair the rusty and corroded metals were removed and then the marble pieces that had separated from the capital were cleaned and reattached with Akemi brand adhesives and the cracked parts of the capital and the body were filled in. In addition, because the corroded hoop bolts had fallen out, they were replaced and the loosened hoops were screwed back together. The other metal parts and chains, for which no objections were raised for their remaining, were painted as a barrier to corrosion. Additional hooping was carried out on the lower plinth part and the cracks were filled with cement mortar. Because adequate funding could not be located for this repair at that time, permanent measures could not be carried out with the result that the aim of that repair was to use basic interventions to keep the monument standing (Bilge, 1972).

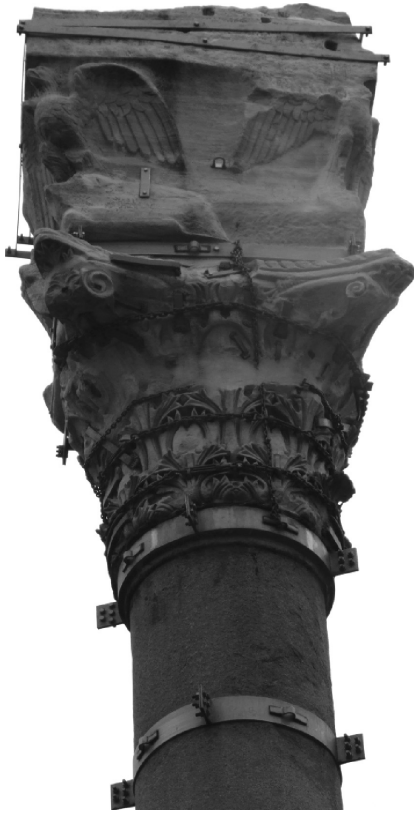
Figure 8. Kıztaşı, west façade of the column capital, marble block and upper plinth, after the restoration.
