Experimental assessment of historic building safety: The case of the Isso Tower in Castelleone, Italy

L. Binda, P. Condoleo, A. Saisi, C. Tiraboschi & L. Zanzi

DIS-Department of Structural Engineering, Politecnico of Milan, Milan, Italy

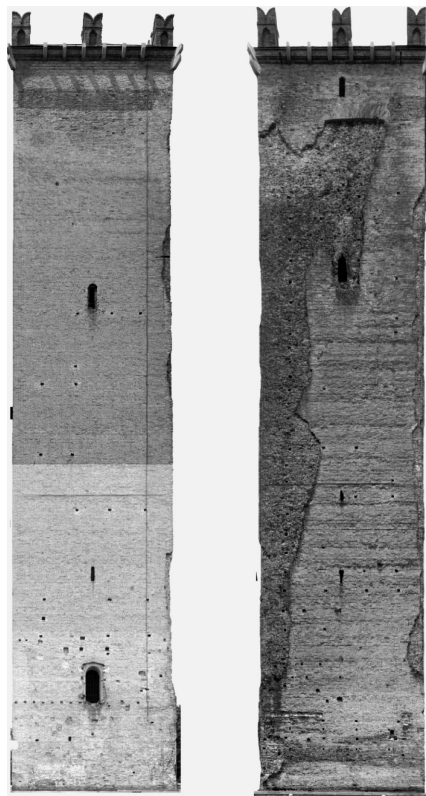
An extensive diagnostic investigation is being carried out on the Isso Tower in Castelleone. Beside other damages the Tower is showing a wide lack of the external masonry leaf (Fig. 1). A similar problem was already studied by the Authors on other case histories. In fact, the Authors applied non destructive and minor destructive techniques (radar, sonic tests, boroscopy and flat-jack) in order to investigate the situation of the Tower of the Cremona Cathedral, called the Torrazzo (Binda et al. 2000c). Interesting results concerned the

Figure 1. Isso Tower: view of the South-East and North-East prospects.

In fact, a lightning during a storm on 1845 produced serious damages along a corner; other parts of the cladding were lost for unknown reasons (Fig. 1). Therefore, instability phenomena could cause in long-term, the failure of the detached leaf. Together with the

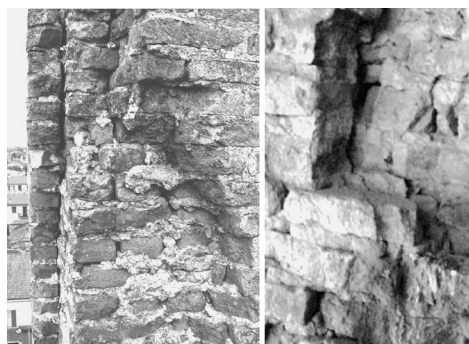
The walls made with solid bricks appear to have been covered on both sides with a sort of cladding (Fig. 3), one brick thick or more, which was built with regular bricks and thin mortar joints. The cladding hid the underneath rough surface. This was a technique frequently applied in the medieval times and also later to tall towers.

Figure 3. Isso Tower: details of the detached cladding in the external and internal sides of the bearing walls.

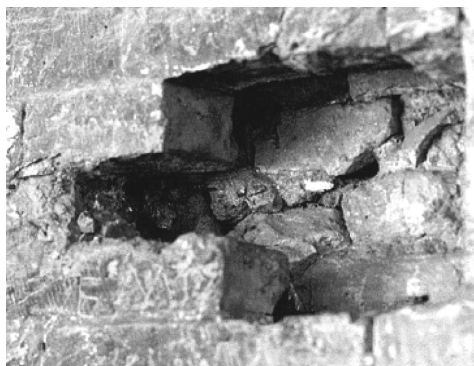
The presence of the detachment of a sort of external leaf was noticed in several parts of the Tower. Coring and boroscopy were also showing this phenomenon (Fig. 4) (Binda et al. 2001b).

Figure 4. Local inspection of the external leaf detachment in the Cremona Torrazzo.

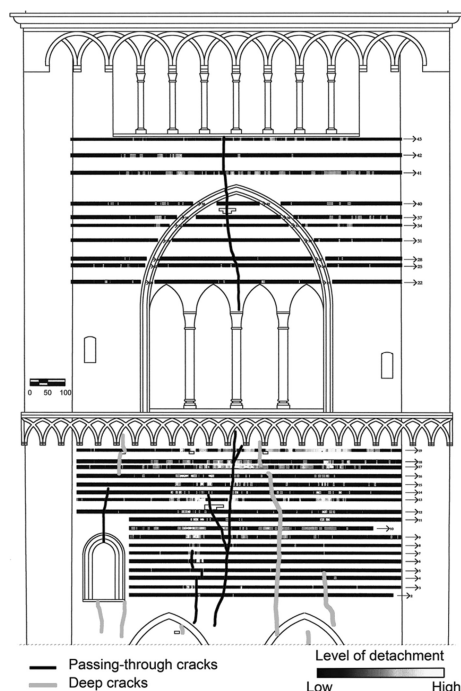
An example of the radar result is shown in Figure 5 (Binda et al. 2005). The detachment is revealed on the radar data by a strong reflection that appears at a constant depth of approximately 12 cm. The radar profiles were pre-processed in 2D mode and then assembled in two 3D volumes, which were then submitted, to a 3D processing procedure. The resulting data volume was explored according to planes parallel to the external surface.

At a depth from the external surface of the wall corresponding to the thickness of one brick (about 12 cm) appears an image, as the one reported in Figure 5. The map is associated with the intensity of the radar energy back scattered by the void space behind the external leaf. Thus, white indicates areas with serious detachment problems while black areas are expected to be safe. The images were overlapped to the crack pattern survey to facilitate the correlation of the detachment with the stress state apparently affecting this side of the Tower. The lower part in Figure 5, in fact, was more affected than the upper one by cracks and deformations of the external surface induced by the stress state. This deformation trend is very likely the main

Figure 5. Detection of the areas affected by the detachment problem. The grey-scale map is associated with the intensity of the detachment phenomenon.

reason of the detachment problem affecting this area. A coincidence can be observed between the most critical detached areas and the crack pattern: most of the white areas are located in the centre of the tower, below the mullioned window (with four lights), where the most important cracks were observed (Fig. 5).

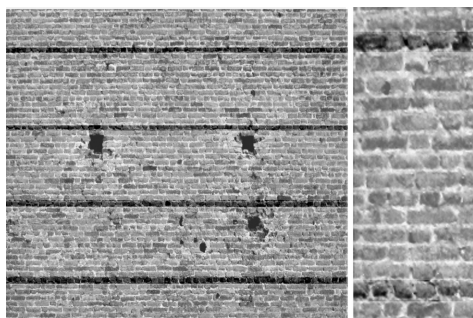
It is evident that this leaf grew up with the wall having averaging every 12 to 13 courses a course of header bricks to connect it to the rest of the wall (Fig. 6). The other courses are only partially connected with header and hence in many parts only the mortar is a contact between the leaf and the internal walls.

Figure 6. Isso Tower: regular presence of header bricks.

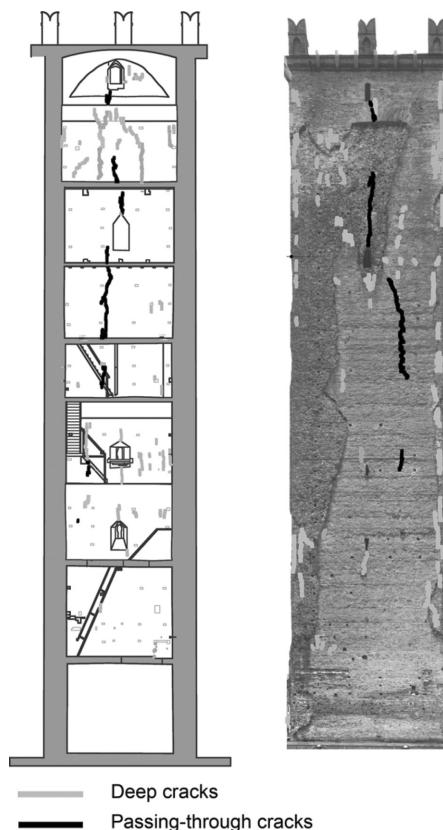
Figure 8. Crack pattern survey of the internal and external prospect of the North-East side.

Especially important is the survey and drawing of the crack patterns and the surface damage (Fig. 8). The interpretation of the crack pattern can be of great help in understanding the state of damage of the structure, its possible causes and the type of survey to be performed.

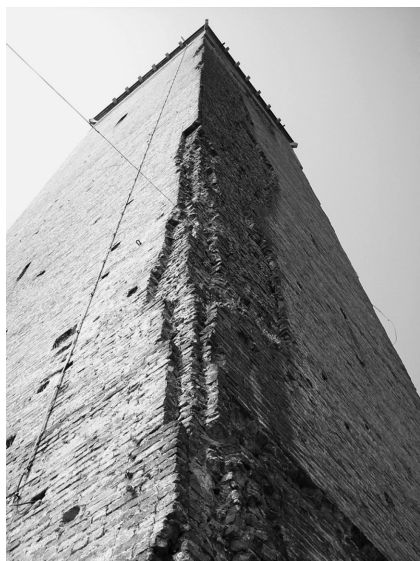
Evident damages are correlated to the lightning which struck the Tower during a storm in 1845 causing

Figure 9. Detachment of the cladding in the North corner.

a large part of the external cladding to collapse (Figs 1, 3, 9).

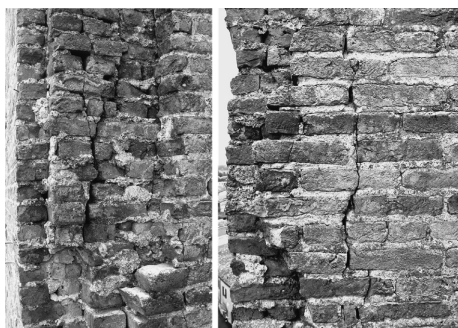
Figure 10. Examples of cracks concentration around the corner and cladding detachment.

The prospects show several repairs and replacements but also several cracks, with a dangerous concentration around the corners are correlated to the cladding detachments (Figs 10, 11).

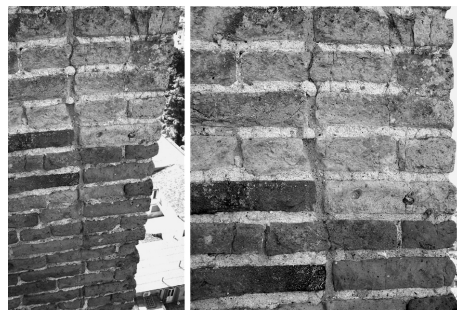
Figure 11. General view and detail of a repaired crack.

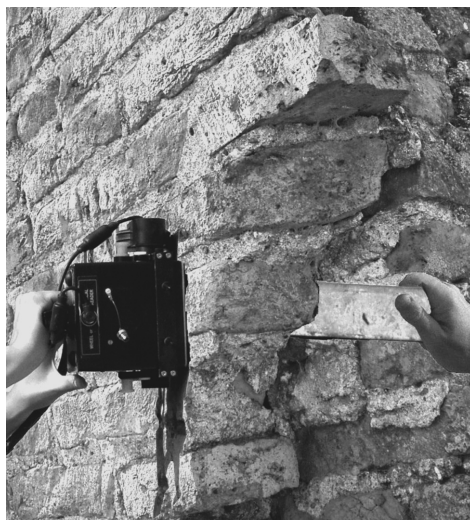
It was possible to introduce underneath the detached leaf a rigid metal ruler up to more than 80 cm (Fig. 12).

Figure 12. Introducing underneath the detached cladding a rigid metal ruler to calibrate radar tests.

This demonstrates the danger of the potential instability of the masonry.

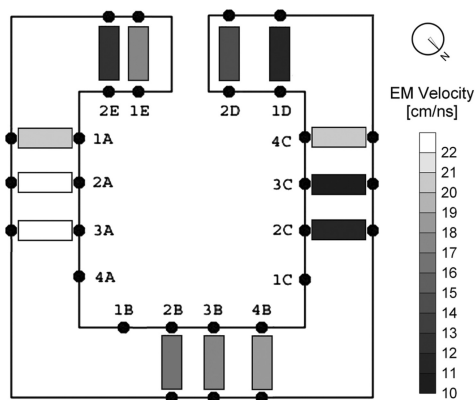
Figure 13. Distribution of the EM velocity measured by transmission at the Tower base.

The distribution of EM and pulse sonic velocity at the base of the (Figs 13 and 16) gives similar results. Usually, materials present complementary behaviours with respect to sonic and EM velocity (i.e., slow sonic materials are generally fast materials for EM waves and vice-versa). In both cases, lower compact area was found in the South-East wall.

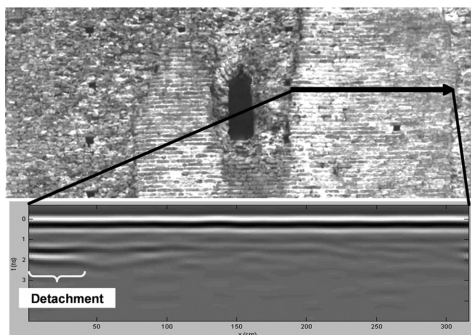
Figure 14. Radargram which indicates the detached area.

An example of the radar result is shown in Figure 14. The detachment is revealed on the radar data by a strong reflection that appears at a constant time of approximately 1.5–2.0 ns. The elaboration of the data is still going on.

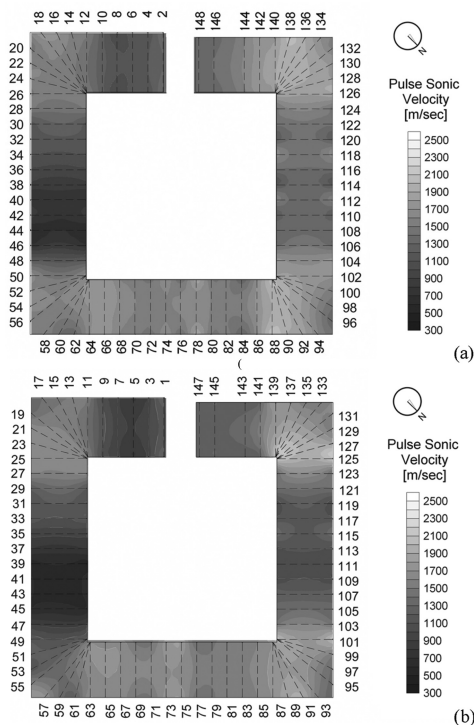
At the base level, the masonry shows several discontinuities caused by the numerous past interventions. Sonic tests were carried out before the flat-jack tests, to control the masonry characteristics along the whole perimeter of the basement. The tests were very precious to evaluate the compactness of the masonry section and the effects of the past repair. E.g. in the South-East and North-West side a low velocity area would reveal several filled openings (Figs 15, 16).

Figure 16. Distribution of the pulse sonic velocity at the Tower base respectively at 1.5 (a) and 1.8 m (b).

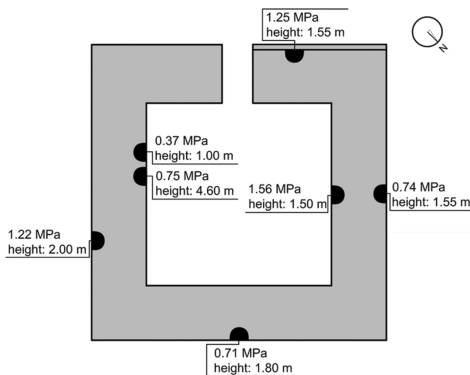
Figure 17. Local state of stress found by single flat-jack tests at the Tower base.

of the stresses measured by single flat-jack test at the base level of the Tower (Fig. 17).

As an example in the N-W side, a consistent difference between the measurements in the internal and external side was found (Fig. 17).

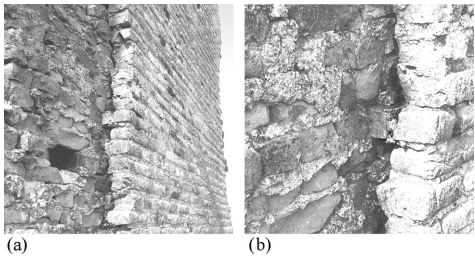
Figure 18. View of the cladding connection (a) and detail of a cracked brick in the header bond (b).

courses (about 1.0 m), of a header bond could guarantee the connection of the external cladding. However, in many situations the bricks crack during the time, failing their function of preventing the detachment and overturning of the cladding (Fig. 18).
