## Relation between sub-soil and masonry structure of Angkor monument

S. Yamada, M. Araya & T. Nagai

**ABSTRACT:** This paper is composed of two parts. One is a survey at Bayon, Angkor Thom. The other is an application of a discontinuum structural analysis to dry masonry. Preceding a structural analysis of Bayon, we apply the discontinuum structural analysis to Prasat Suor Prat and verify the structural stability of the monument in order to verify the influence of the masonry construction as well as the character of sub-soil layer in wet condition. We purpose to evaluate a risk level of the structure and suggest the policy and procedure for the restoration of Bayon, using the information obtained through JSA restoration.

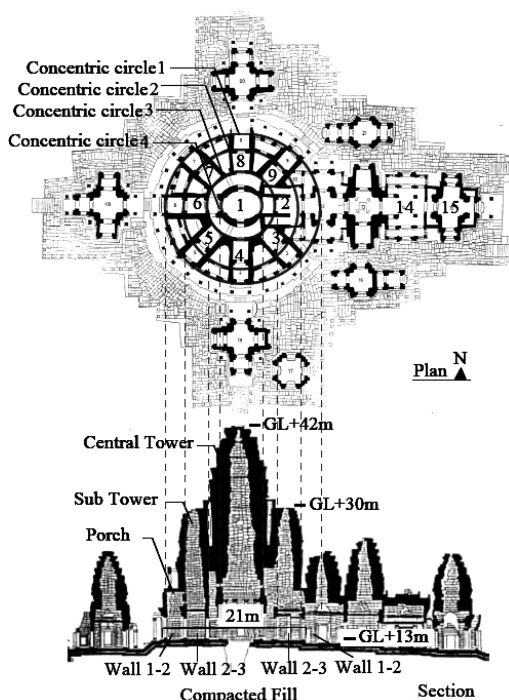
Figure 2. Plan and section of Bayon © JSA.

We surveyed the severe level of the damage to Bayon. By observing the state of the towers, many stones have cracks, lacks, gaps and outwards. Bayon is constructed of dry masonry, the drop of one critical stone will cause the collapse of upper structure. And the critical damaged area which should be reinforced urgently was founded at Tower 14 and 15, shown in Figure 2. Now, we are planning the urgent reinforcement at Tower 14 and 15.

In our survey of Bayon central tower, we measured the inclination of the entrance pillars based on the 4 concentric circles shown in Figure 2, using the plumb bob method. The characteristics of the inclinations are as follows. (1) There is a general inclination toward the outer direction. (2) There is a similarity in inclination tendency between concentric circles "1" and "2." (3) The inclination of pillars between towers is comparatively sharp. (4) The maximum inclination to the outer direction is 3.3 degrees at Tower 6 on concentric circle "4." The sharp inclination at the core of the tower cannot be neglected.

immediately cause the collapse of the tower, but they should be observed continuously. The characteristics of the open gaps are as follows. (1) Generally, the gaps toward the top are wider than the gaps toward the bottom of the wall. (2) On "Wall 2-3," the gap between towers is comparatively wide. (3) There is no similarity in the tendency of the locations of the wide gaps between "Wall 1-2" and "Wall 2-3."

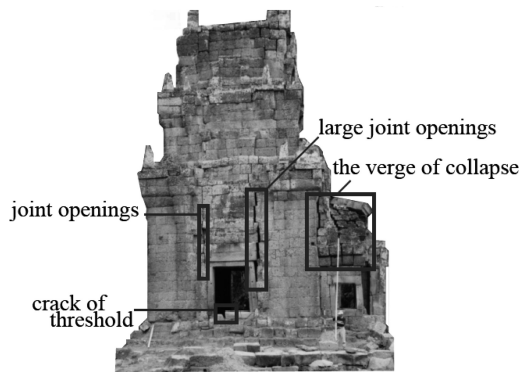
Figure 5. Damage situation of Prasat Suor Prat Tower N1 (before restoration).

From the restoration of Tower N1 by JSA, a spot of joint openings tends to be appeared as follows. (1) Large joint openings are appeared in only 1st story. (2) Joint openings are appeared between a jumb and adjoining wall. (3) Joint openings are appeared from the head corner of windows and doors to upper direction.

The above result generally agrees with the observed state of Prasat Suor Prat, shown in Figure 5.

JSA selected Tower N1 as the most dangerous tower. Then, JSA began the repair and dismantling of Prasat Suor Prat Tower N1 from 2002 and have finished the restoration in 2005. The restoration work was conducted by complete dismantling the structural elements, restoring the damaged elements, platform and foundation, and reassembling them to be the original appearance of the tower.

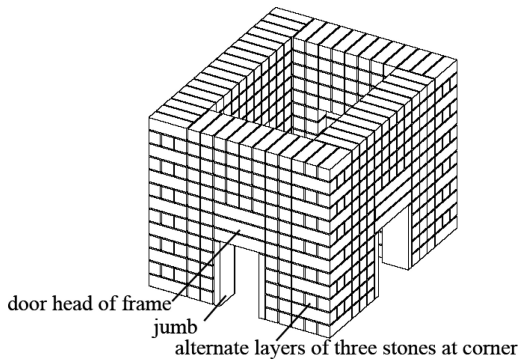
Figure 6. Masonry characteristics of 1st story, Prasat Suor Prat Tower N1.

This section describes about characteristics of a masonry construction of Tower N1. A structural characteristics derived of the masonry construction at Tower N1 is as follows. (1) The four corners of the upper structure are alternately layered three stones and behave independently. (2) The masonry over the head of windows and doors has the structural weakness. (3) Vertical arrangement of laterite blocks occurs the vertical joint openings. (4) Vertical and horizontal arrangement of laterite blocks effect on the behavior of upper structure.

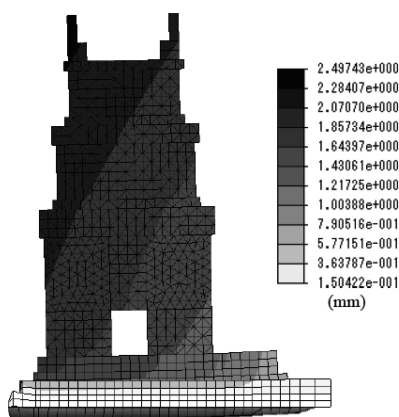
Figure 13. Deformation image.

The result is shown Figure 13 and Table 2. From this result, maximum displacement to X direction which means a direction of Northern Pond increased by 85% in wet condition.

Dry condition	Wet condition	Increment percentage
Linearity	Linear	Non-linear	
Maximum displacement of X direction	0.686 mm	1.27 mm	85%
Maximum displacement of Y direction	0.0351 mm	0.0338 mm	-3.37%
Maximum displacement of Z direction	1.43 mm	2.03 mm	42%

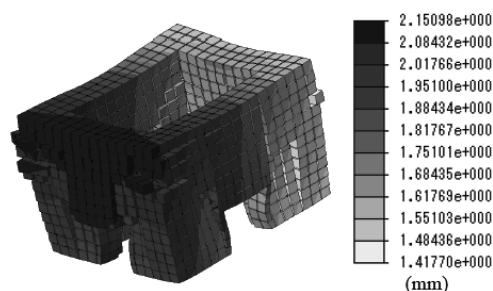
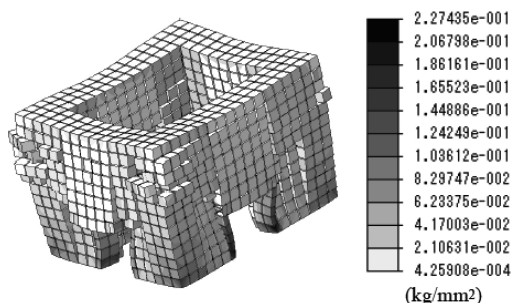
Figure 15. Deformation image of 1st story.

The result is as follows. (1) On the inclination of the upper structure, there is no so difference between the discontinuum model and continuum model. (2) The parts of corners, walls and stones over the window behave independently while mutually affecting the others.

As Figures 15 and 16 show, the behavior of 4 corners is inspected by the discontinuum structural analysis that we propose. From the result, we confirmed that the masonry construction of 4 corners was effective to the structural stability of the upper structure.
