Maria Birnbaum – Construction history, conservation history

R. Barthel, H. Maus & C. Kayser

Barthel & Maus – Beratende Ingenieure, Munich, Germany

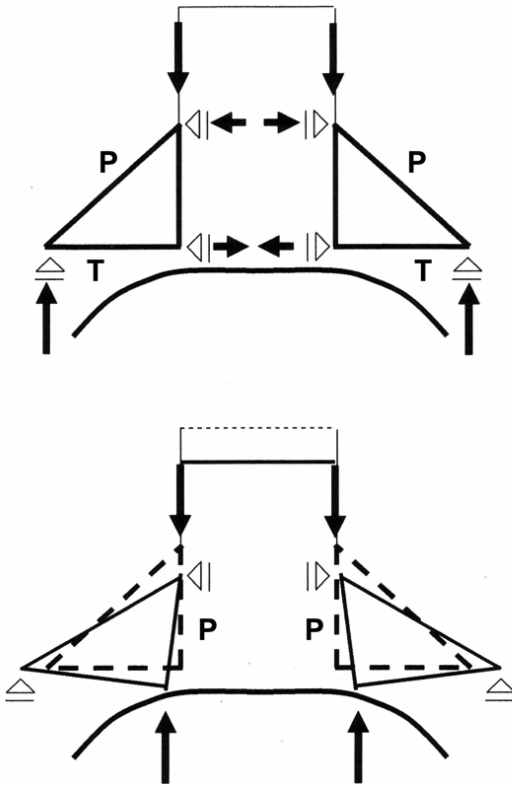
Figure 4. Top: intended structural system of the roof with pressure and tension rings, the rafters serve as strutting; bottom: structural system after deformation, the tower has lowered on the dome (P: Pressure, T: Tension).

The drawings show that the ground beams as well as the tension ring and the tie beams had lowered on the apex of the dome around the Opaion. (fig. 4)

The original, intended locations of the beams as well as the deformation figure are drawn. The mortice and tenon joint between the posts and the tie beams is open, between both members is a gap: this indicates that the tower cylinder itself did not lower; the rafter-strutting was obviously still intact. Due to the lack of a vertical suspension between the tower posts and the pressure ring, these parts of the structure could lower independently.

For the master-builders, it was evident that the apex of the brick-dome could not support any additional loads. In the accompanying text, they explain that in the case of heavy wind, the tower becomes unstable and moves. As result of the open joints at the tower's basis, the shank has no horizontal fixation at its foot ring. Under wind-load, the tower can contort around its support at the upper pressure ring. The percussions caused by the movements induce cracks and local deformations on the dome shell.

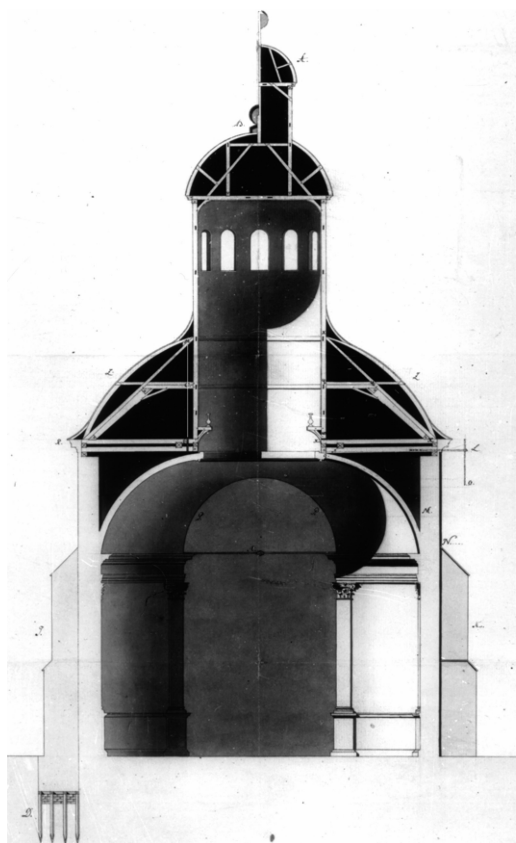
Figure 5. Diagram from the master-builders' expertise, 1793: the diagram shows possible conservation measures with additional buttresses, height reduction of the tower, tie rods in the triumphal arches und suspension rods in the roof.

As possible repairs (fig. 5), the builders proposed to reverse the deformations in the roof structure. The lower parts of the roof – the ground beams, tie beams and the tension ring – should be suspended with iron ties to the rafters and the pressure ring. A new wooden support for the iron ties should be constructed in the angle between rafters and tower. The suspension would have been tightened with screw joints.

To reduce the wind load on the tower, it was proposed to remove the high wooden lanterns on the top – “if the building is not to much defaced”.

For the stabilisation of the masonry, the expertise suggests to add additional buttresses to the outer walls. The buttresses should be set up in the bays between the windows “that take up all the loads”; due to the wet and unstable subsoil, they should be executed with a pile foundation.

Both triumphal arches between the rotunda and the western and eastern part of the church were to be stabilized with wrought iron tie rods. The tie rods would have been freely visible in the church. To put tension on the rods without exerting any percussion, a screw coupling should have connected its parts.

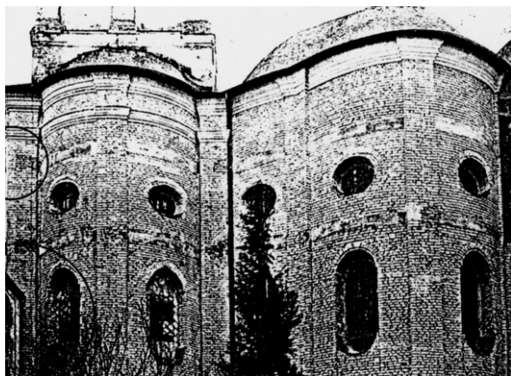
Figure 6. In the 1970s campaign, two concrete ring beams were implemented. The historic rendering was stripped off.

To prevent any further inclination of the walls, two massive ring beams of reinforced concrete of about 0,4 m height were inserted in the masonry structure. Both ring beams encircle the complex outline of the building. The lower ring beam runs at the height of the vault springers underneath the bull's eyes. This level is very well fit for counteracting the dome's horizontal forces but for a grave handicap: Due to the geometry of the two triumphal arches, both halves of the ring beams can not be connected at the intersections of the rotunda with the eastern and the western part of the building. The ring beam follows the richly moulded outline of the building.

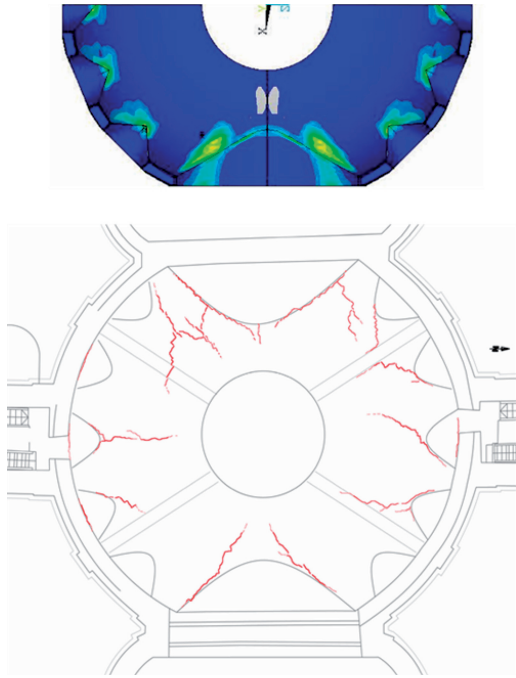
For further analysis of the dome's complex geometry and its structure, a FE-model was developed (fig. 7). Parallel, a detailed survey of the cracks on the dome's upper side was made. The results of the model confirm the observations.

Calculations and observations indicate that the dome does basically act as a large barrel vault. This is due to the two large "incisions" of the triumphal arches' lunettes. The apex of the lunettes is ascending in direction of the main Opaion, the resulting geometry "bisects" the dome into two halves. Only around the Opaion, the dome does actually "work". Thus, the construction of Maria Birnbaum's main rotunda differs fundamentally from its roman model, the Pantheon.

During the surveys, the cracks in the vault were monitored by means of plaster labels. One of the first inspection of the tell-tale labels showed that movements in the brick shell had occurred.

Due to the earlier deformation of the outer walls and the lowering of the dome's apex, the brick area around the Opaion is, in geometric terms, without inclination. The bricks have a thickness of about 15 cm. With the large wooden tower resting on this fragile, deformed shell, a spontaneous yielding of the brick shell around the Opaion could occur.

Figure 7. Below: survey of cracks in the dome's brick shell; above: FE-model of the dome under dead load.

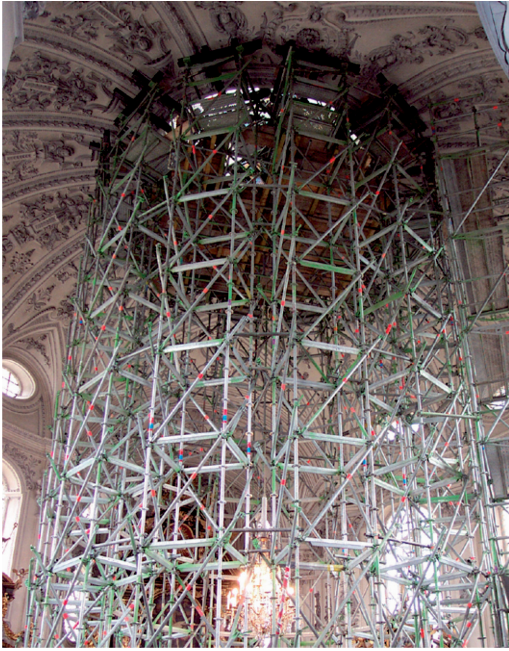
Figure 8. Supporting scaffolding tower under the dome's apex.

The discovery of the structural deficiencies made inevitable a closure of the church for visitors. During this time, in winter 2005, a cylindrical scaffolding tower was erected under the Opaion (fig. 8). The tower supports the dome around the Opaion. The supreme level of the scaffolding was raised up under the brick shell. To preserve the precious baroque stucco, carved pieces of wood and a special kind of hardened plaster were inserted between scaffolding and dome with the help of an expert conservator.
