## The structural strengthening of early and mid 20th century reinforced concrete diaphragms

L. Sorrentino & C. Tocchi

**ABSTRACT:** During the 20th century it was very common in Italy to substitute masonry buildings' timber floors and roofs, which were considered inadequate, by reinforced concrete or reinforced clay diaphragms. Such interventions, especially if belonging to the early stage of reinforced concrete spreading, emphasize new conservation problems. Whereas on the one hand such structural elements are testimony of the construction practice of one era, a practice frequently not in use anymore, on the other they are also commonly inadequate to carry the loads currently specified by the building codes. Two such examples are to be found at Villa Borghese's Casino dell'Orologio, in Rome (Italy). One consists of reinforced clay unit beams, and the other of a thin ribbed reinforced concrete slab. The two have been strengthened in different ways as follows: 1) the first by replacing a few of the clay beams with reinforced concrete beams, 2) the second by adding an elastic support at the ribs' midspans. However, the intervention attitude is the same: preserving historical examp

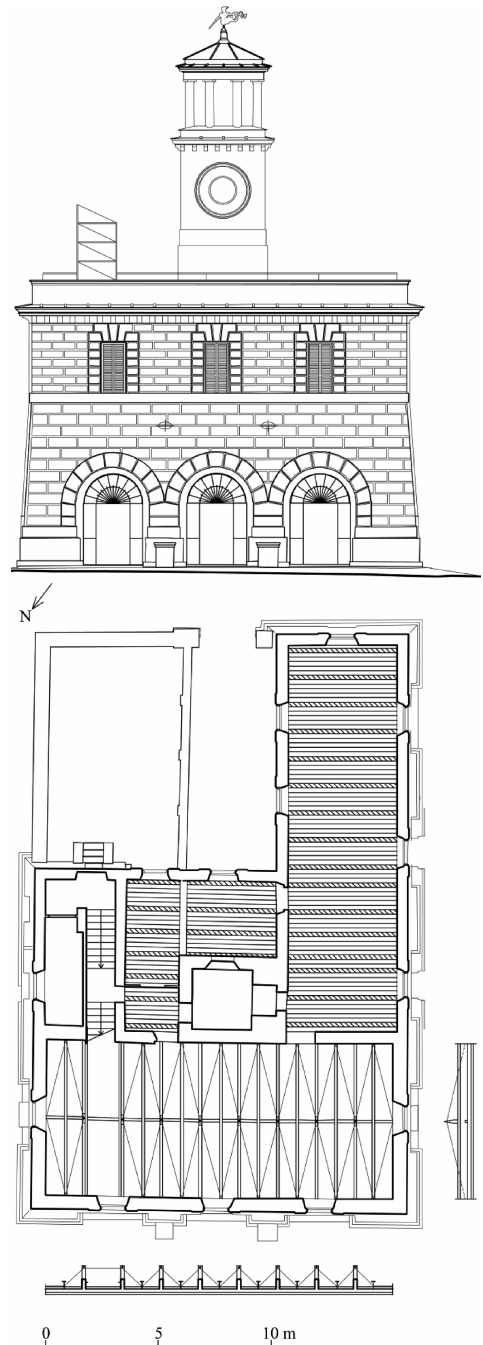
Figure 1. Plan of the first floor with projection of the roof structure (both existing and added) and north-west façade. Strengthened reinforced clay beams are dashed; in the bottom and right-lateral small sections is presented the three-dimensional bow-string retrofitting of the ribbed reinforced concrete roof.

Therefore, it has been computed that it is sufficient to replace one out of six clay beams (Figure 4), with some occasional thickening in order to avoid supports over the openings (Figure 1, dashed beams). Furthermore, a 5 cm concrete slab reinforced by welded wire mesh is cast on top of the existing structure. This grants a load distribution capacity to the terrace and connects the new reinforced concrete beams.

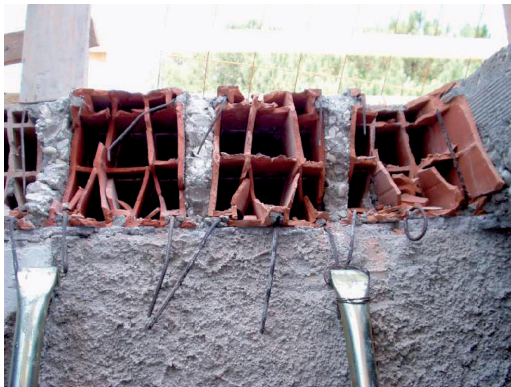
Figure 3. Reinforced clay floor in the Casino.

In the Casino the clay beams are 20 cm high, the bottom longitudinal reinforcement consists in three 5 mm diameter plain bars, and the top reinforcement in two 2 mm diameter plain bars.

A 2 cm concrete finishing is present on top of the beams. The reinforcement is anchored in a lateral beam, reinforced with four plain 6 mm diameter bars. Overall state of conservation is rather good.

Based on the data available in the technical literature (Colonnetti 1953 and 1962) the extant floor is assessed capable of carrying a load per unit area of  $4.4 \text{ kN/m}^2$ . Since the dead load, without considering the floor structure self-weight, is estimated in  $3.25 \text{ kN/m}^2$ , and the live load imposed by the program is  $4.0 \text{ kN/m}^2$  the reinforced clay floor is considered inadequate.

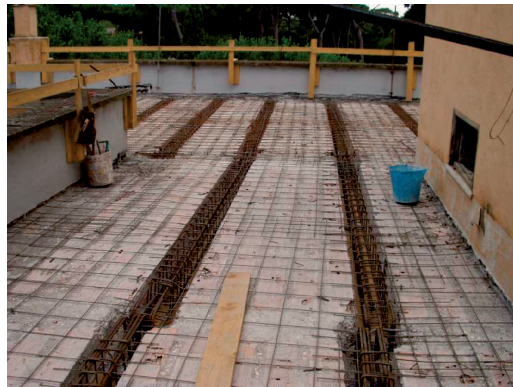
Figure 4. Reinforced clay floor: one out of six clay beams is replaced by a reinforced concrete one.

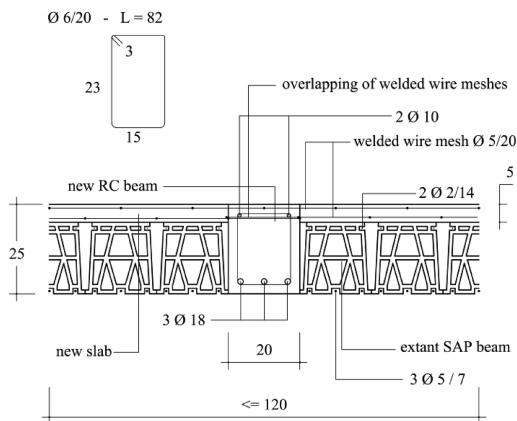
Figure 5. Reinforced clay floor: cross section of the intervention.

In addition, the slab gives to the reinforced concrete beams a very convenient  $T$  cross section (Figure 5).

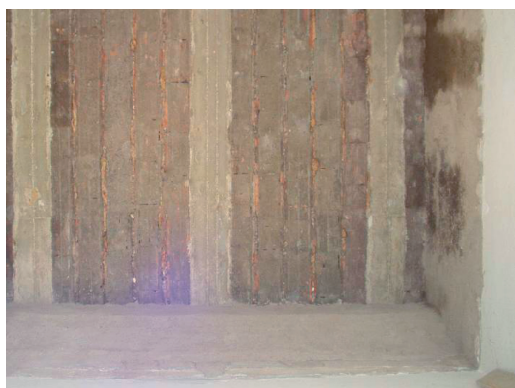
Figure 6. Intrados of the reinforced clay beams floor after the intervention.

The use of reinforced concrete for the retrofitting has the advantage of employing the lateral clay beams as part of the formwork. In addition, it guarantees a good bond between new and existing structure. The adopted solution markedly reduced the need for formwork and temporary shoring, taking advantage of the load-bearing capacity of the preserved clay elements (Figure 6).

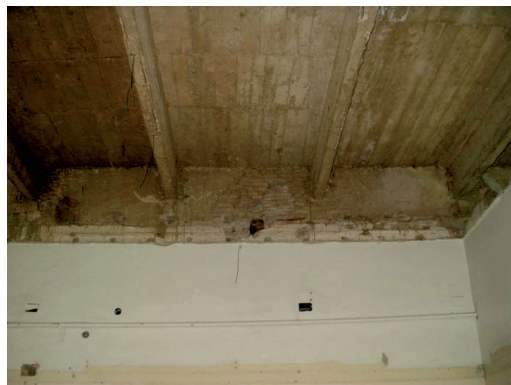
Figure 7. Ribbed reinforced concrete floor before intervention.

spacing of 1.70 m, with a  $12 \times 45 \text{ cm}^2$  cross section (Figure 7).

Before the intervention only limited investigation were possible on the geometry. Close to the support each rib has two 14 mm plain rebars as bottom reinforcement.

The slab, only 5 cm thick, has 10 mm plain rebars, placed every 38 cm. No investigation was possible at midspan or at the extrados. The dead load was estimated in  $4.25 \text{ kN/m}^2$ . Preliminary calculations, considering such dead load only, strongly suggested the presence of additional reinforcement at midspan. Probably these rebars were bended close to the supports.

Therefore, uncertainties about geometry of the reinforcement and material mechanical properties are substantial.

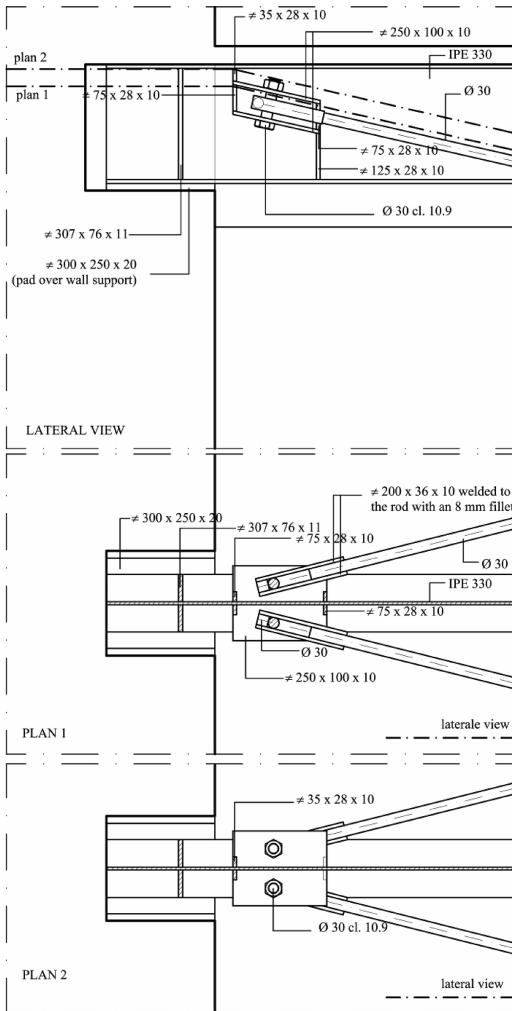
Figure 8. Detail of the intersection between the rods and the I beam.

The top chord of the bow-string is made up by a steel *I* beam placed between two adjacent reinforced concrete ribs (Figure 8). In addition to the compressive component induced by the 30 mm diameter rods, the *I* beams contribute to halve the tributary width of each rib. The *I* beam section is selected in order to make the deflections of the existing reinforced concrete rib and of the steel added element compatible. Thus, a IPE 330 profile is necessary.

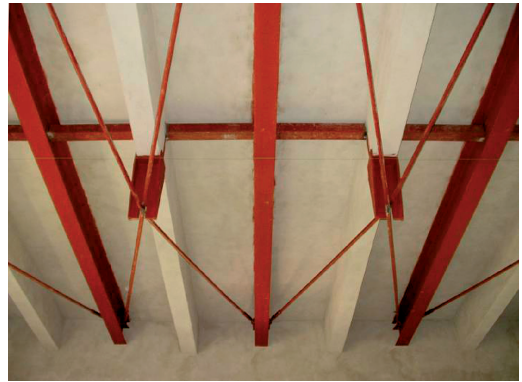
Figure 9. The ribs are supported at midspan by two adjacent bow-string beams.

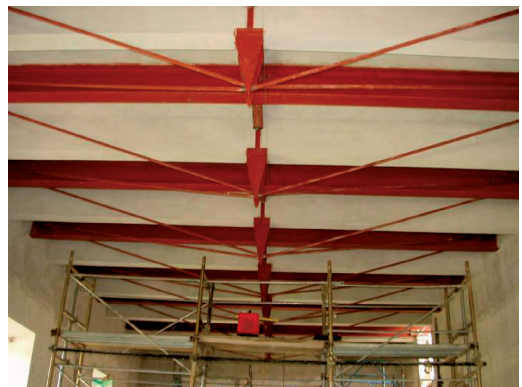
Figure 10. The system of three-dimensional bow-string beams.

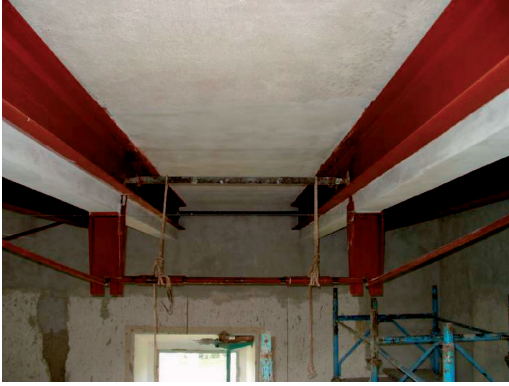
Figure 11. The exception in the system of bow-string beams where the stairs are going to be built.

The serial system of bow-string beams has an exception where the stairs are located (Figure 1 and Figure 11). At the two ends of the wing the compression induced by the rods is transferred to an alignment of square box-section beams. These beams run along the longitudinal axis of the north-west wing (Figure 1 and Figure 9).

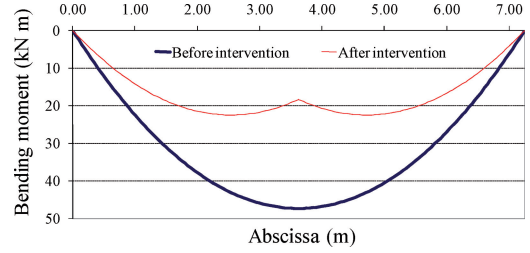
Figure 12. Bending moment diagram before and after intervention.

$R_M$  is estimated by means of an iterative analysis. The bending moment diagram, after the convergence, is presented in Figure 12. Everywhere the internal loading is lower than the one induced by the dead load acting before the intervention. Therefore, any uncertainty about geometry and mechanical properties are experimentally overcome. Moreover the elastic support avoids any bending moment reversal.
