Non conventional solutions for the consolidation of bell towers

C. Mileto & F. Vegas López-Manzanares

ABSTRACT: During 2003, the authors of this paper achieved the first phase of the consolidation of the XVIII century bell tower of the monumental parish church at Vistabella del Maestrazgo (Castellón, Spain). For this first intervention, a very precise survey study was carried out on the structural problems of the bell tower through the analysis and interpretation of the cracking and deformation maps. Nevertheless, in this occasion only a few restoration works could be done due to both financial problems and the emergency character of the intervention. In 2006, after two years of detailed monitoring of the bell tower movements, the same authors have been able to design a second phase of restoration aimed to solve the serious and still existing structural problems.

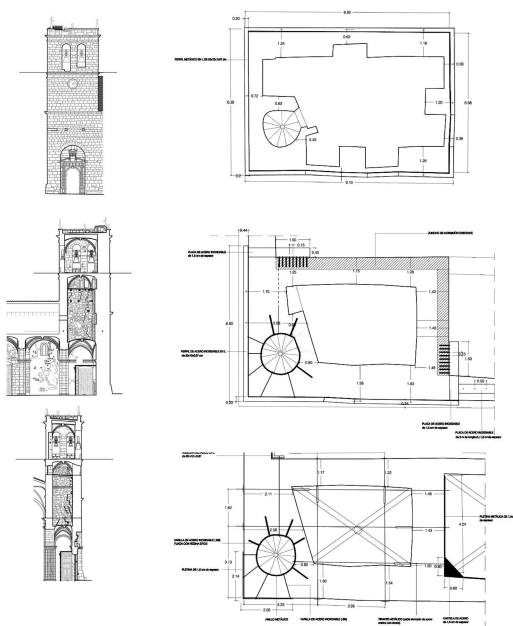
Figure 4. Projected braces for the bell tower at levels 1, 2 and 3.

During the 1st intervention phase the opening of the bell tower's crowning was tightened by means of the insertion of stainless steel cable braces at the upper cornice. During the 2nd intervention phase, other braces at three different levels are to be inserted to tighten the bell tower and stop its opening (figs. 4–5). Given the diversity of the characteristics of the bell tower, the proposed solutions are different and specific for each case.

- Level 3 (at the middle cornice). At this height, the bell tower is still free-standing from the church, so that a perimeter restraint for the bell tower to stop its opening is still possible. In this case, this exterior brace will be done with a stainless steel L-profile 20×12 cm that will seize the perimeter of the bell tower and will be placed on its middle cornice in order to avoid as much as possible its direct vision from the streets. Given the irregularity of the bell tower's exterior shape this brace will be composed of several shorter profiles to be welded in continuity so that they will be able to adapt to the polygonal bell tower's contour. If necessary, hydraulic mortar will be poured on the back of the profile to fill the little gaps in order to ensure a better contact of the bell tower's whole perimeter.

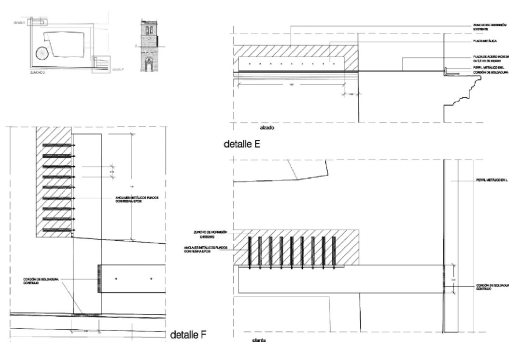
Figure 5. Constructive detail for the brace at level 2 (lower cornice).

- Level 2 (at the lower cornice). At this level, the bell tower is not longer free-standing and forms part of the church's body in two of its four facades. The installation of an exterior brace is much more difficult and less evident at this level. First, at the

exterior facades the bell tower has its lower cornice where a similar L-profile as the one installed at the middle cornice may be installed. In a previous intervention of 1992 conducted by other architects with different criteria, a reinforced concrete brace inserted in the masonry fabric was made at this level of the bell tower as part of the consolidation of the whole church that substituted the whole roof old structure. Even not sharing this intervention philosophy already done in the past because of the rigidity and invasive character of the reinforced concrete, in our project we use the unavoidable presence of this concrete brace in order to be able to tie together the bell tower exterior profiles.

Thus, we connect the exterior profiles with the existing reinforced concrete brace with two 40 cm wide plates to be welded to the exterior profiles and anchored to the interior concrete brace. The width of these two plates is due to the necessity of resisting horizontal stresses. At this level, a structural stainless steel ring plate is also inserted in the interior walls of the round stairway that will be connected both with the exterior stainless steel profiles and the rest of the masonry fabric by means of metal bars. This element will serve as contention and reinforcement of the corner as well as an anchorage to the church.

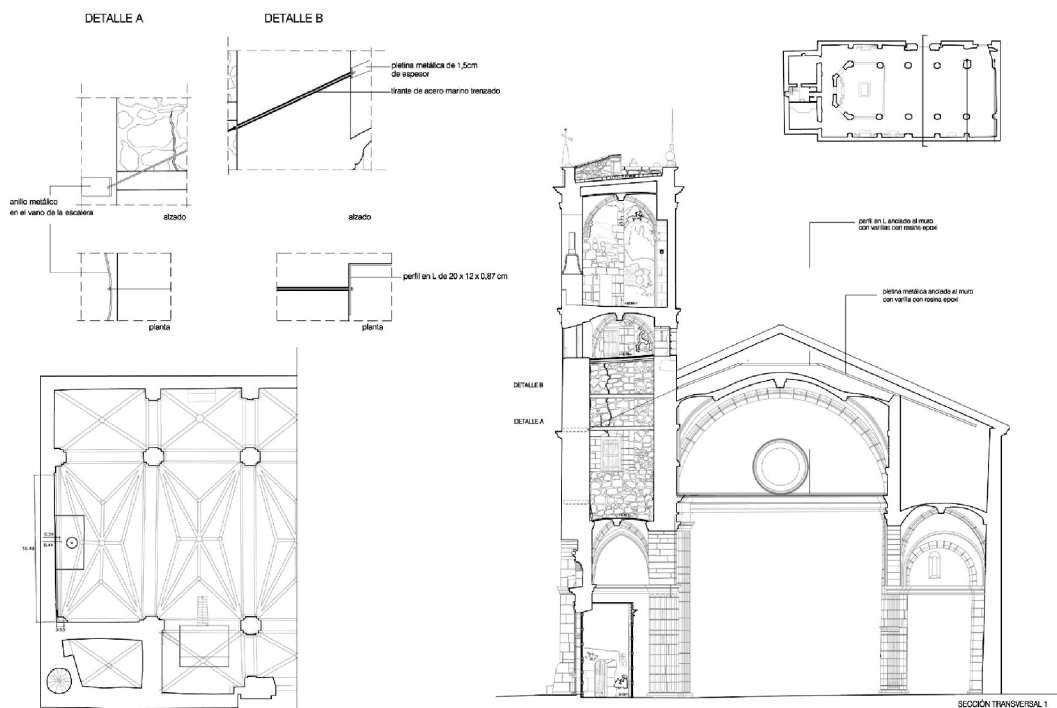
Figure 6. Example of ties between the bell tower and the church.

The increasing movement of tilting of the bell tower towards the Southwest corner suggests to tie it with the rest of the church in order to stop this living movement of detaching. Therefore, it has been necessary to tie the bell tower to the church in two directions (along the South and West facades) in order to counteract

its movement (fig. 6). In order to invade as less as possible the interior of the church, the most obvious and direct solution of installing visible cable braces in the first bay of the church nave has been rejected and alternative non visible solutions have been designed in every facade and level.

First, two ties at two different levels have been designed along the South facade. The upper tie will take place at the height of the middle bell tower's cornice where a stainless steel plate 40 cm wide will be welded to the exterior stainless steel brace and placed on top of the church's facade wall in order to be able to hide it under the roof tiles. This element will be connected with the church's wall through 2 meters long metallic bars inserted vertically in it with epoxy resin. The second lower tie between the bell tower and the church will be placed at the level of the bell tower's lower cornice, placed in the interior face of the church's wall over the lateral nave, through a 40 cm wide stainless steel plate that will be fixed with the help of metallic bars and epoxy resin along the South wall and a steel cable brace to the bell tower's round stairway.

Second, two other ties at two different levels have also been designed to connect the bell tower to the church along the West facade. A stainless steel 20×12 cm L-profile is to be placed on at the height of an interior church cornice connected with a metallic cable brace to the reinforcement stainless steel ring plate in the round stairway at the bell tower's level 1. In the upper level, placed in the hidden space between the vaults and the roof of the church, several stainless steel plates welded in continuity and connected at the level 2 to the bell tower's brace have been designed to follow the shape of the church's gable end to be completely invisible for the visitors.

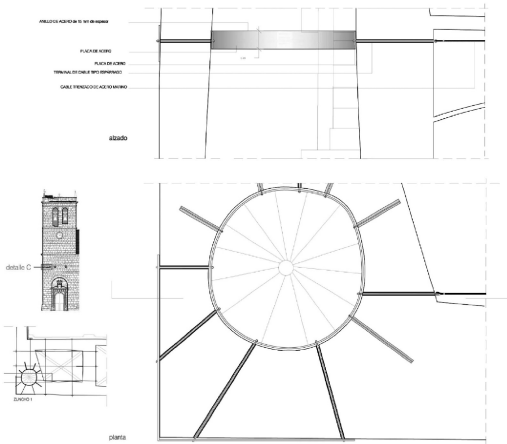
Figure 7. Detail of the round stairway reinforcement at level 1.

- Level 1 (half way the height of the church facade). Even not existing a cornice to place a brace, the need of tighten the bell tower at this level has forced us to create a different restraint system as the two upper levels. In this first level, we shall use again the same system with stainless steel cable braces that was used during the 1st intervention phase at the bell tower's upper cornice. Six cable braces will be installed, three on each side, that hold the fabric through small stainless steel plates in the exterior facade and a continuous bigger stainless steel plate in the interior side, placed in a hidden space. The two braces that arrive to the round stairway will be connected to a second stainless steel ring plate placed in the interior walls and linked to the exterior plate through metallic bars (fig. 7). This element also allows tightening the bell tower's corner.

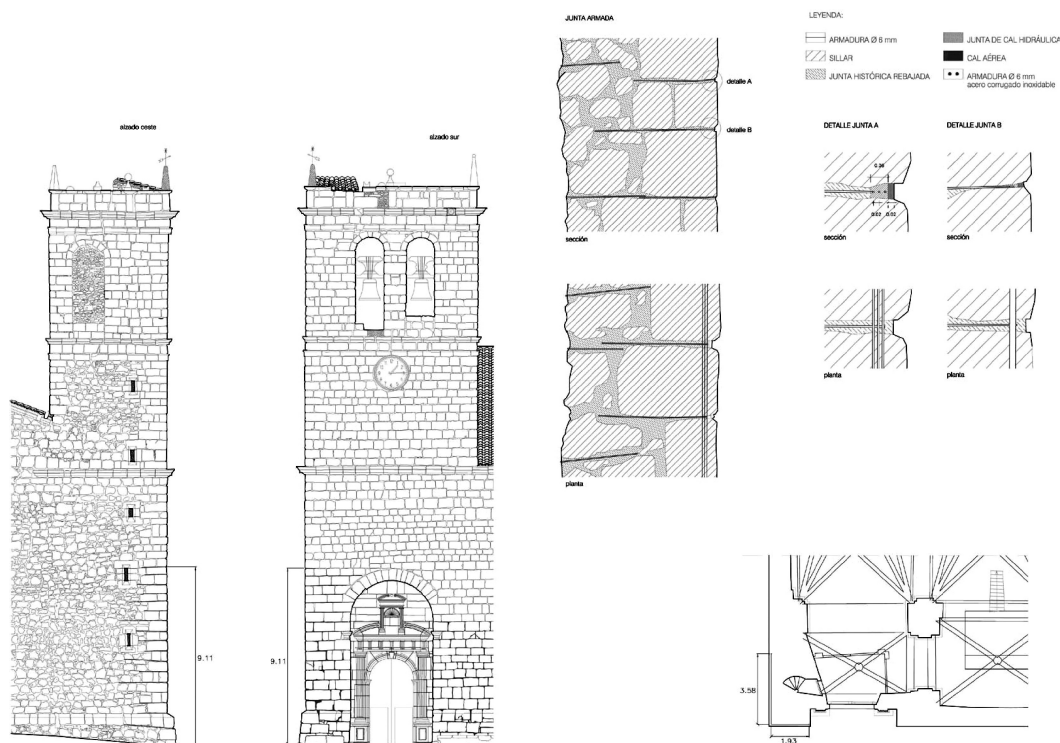
The bell tower's Southwest corner, at its foot, has a clear flattening phenomenon that should be taken care of. A solution for this corner has been designed after the example of the interventions designed by Prof. Luigia Binda (Polytechnic of Milano) and Prof. Claudio Modena (University of Padua) for some bell towers in Italy (Binda et al. 2001). The proposed consolidation consists of a disseminated reinforcement in all the lower part of the corner affected by flattening little but dangerous cracks, where the tower apparently stands on a single buttress because of the presence of the secondary entrance of the church (fig. 8). This intervention will be done through the insertion of reinforced joints and the connection between the interior and exterior of the masonry fabric with its own nucleus.

Figure 8. Reinforced joints to repair the flattening at the SW corner.

The reinforced joints will be done emptying 10 cm of the ashlar work joints in all the length of the corner, inserting three 6 mm in diameter corrugated stainless steel bars or a flexible stainless steel plate 1–1.5 mm wide in the joints, filling the interior with hydraulic lime mortar and repointing the exterior with aerial lime mortar. These elements, both bars and plates, will be welded to perpendicular bars that will connect them to the wall nucleus through holes drilled in the masonry. Being the interior of the round stairway a masonry fabric and therefore not having clear horizontal joints to be reinforced in parallel with the exterior facade, only perpendicular bars will be deeply inserted as reinforcement from the inner side. These bars will overlap the perpendicular bars inserted from the exterior in order to form a continuous reinforced ashlar and masonry fabric that should notably improve the behaviour of this wall against the flattening phenomenon. This little sacrifice and loss of historical mortar bring a great relief to the flattening stresses that affect both the stone and the mortar and is worth as long as allows the bell tower to survive this dangerous phenomenon.
