Strengthening of a wooden covering built in the 18th century

N. Augenti

Department of Structural Engineering, University of Naples Federico II, Naples, Italy

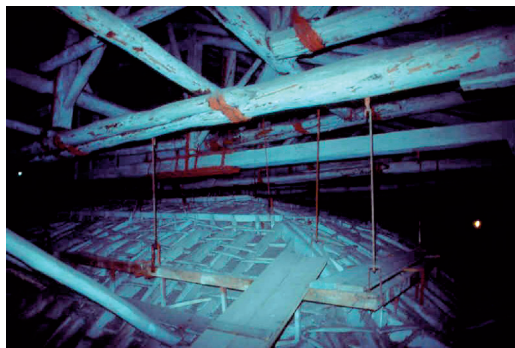
Figure 7. Flat vault suspended to the trusses.

- large deformations were observed on the vault with relevant depression of its flat part;
- the connections of the chestnut trunks that constitute the tie beams underwent slips up to 11 cm in the lower trusses and 24 cm in the upper trusses;

- almost all tie rods, which connected the vault to the tie beams of the upper trusses, were highly stretched to advantage of the ones (almost all released) that connected the vault to the tie beams of the lower trusses;
- the most part of trusses joints had inadequate connections;
- more bars were highly deflected (tie beams and struts), twisted or disjointed;
- the most part of the trusses had lack of planarity;
- local deformations were observed on the lower covering flush coat;
- compression cracking of masonry was localized near the truss supports;
- some wooden elements were locally rotten or subjected to biological attacks;
- some tie beams and struts were cracked;
- wide water infiltrations were concentrated in small zones of the covering.

A zone of the flat vault suspended to the lower trusses can be observed in Figure 7.

After these operations, the vault experienced further depressions due to elastic deformation of the new structures, so that its connection to the upper trusses was necessary. Therefore, these interventions provoked further deformations of the flat vault and damages of the upper trusses, which were not designed to support the self-weight of the vault.

After that the prostheses were assembled, a new suspending system of the vault was realized. This one was constituted by threaded Ø12 steel tie rods, whose upper end was connected to the horizontal beams of the prostheses while the lower one was joined to the wooden ribs of the vault, by means of U-shaped metallic plates obtained by 100×5 mm straps. After assembly of all vault suspensions (operating on top end

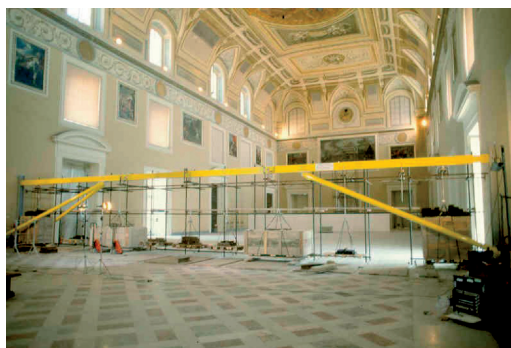
Figure 10. View of the Big Hall and prosthesis prototype.

The first phase of work, as described above, consisted of realization of the RC strip on the top of the masonries to connect the walls themselves and to give effective support to the upper trusses. Successively, the masonry was strengthened in the belt along which new steel structures would have been applied. In order to assess the analysis results, a prototype of prosthesis was assembled in the Big Hall and was loaded, according to the project documents. The Big Hall, whose coverings had to be retrofitted, and the prototype are showed in Figure 10.
