## Restoration of a historical building for Cyprus Technical Chamber

M. Pittas

*M. Pittas & Associates, Nicosia, Cyprus*

**ABSTRACT:** An abandoned building in the old town of Nicosia, built in 1828, was chosen by the Council of the Technical Chamber of Cyprus to host their offices. Our design team won the first price of the architectural competition in 1998. The task was to restore a half ruined building, restore its bearing capacity for the usual loads and strengthen it for earthquake loading, trying at the same time to minimize interventions so that historical identity and traditional character is not lost. Study and works were monitored by Nicosia Municipality, the Preservation Department, and the Antiquities Department and by the Chamber's monitoring committee. Study started 1998, works commenced in 1999 and by 2001 Cyprus Technical Chamber moved to the new offices. The building is approximately 600 sq.m, and is made of stone built walls and adobe walls, wooden floors and roofs. Small additions were built for connecting the two parts and the two levels of the building. These were made of light steel frames, wood and glass. This presentation concerns the structural design an

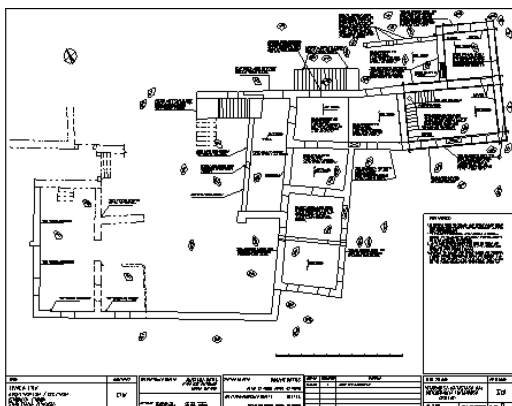
Figure 1. Existing layout of ground floor.

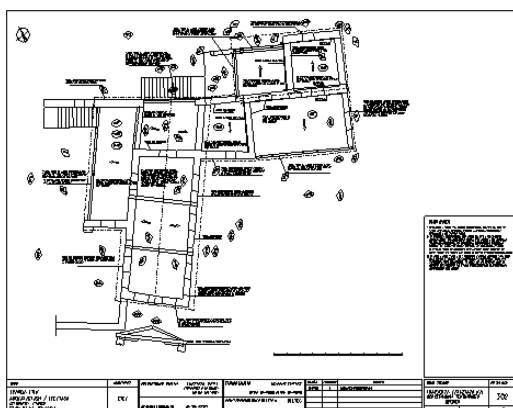
Figure 2. Existing layout of first floor.

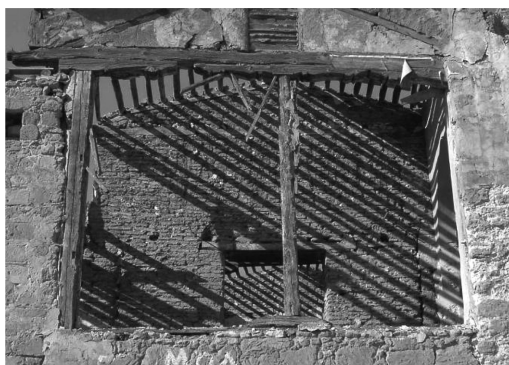
Figure 5. Stone built walls. An adobe wall is shown at the back. A deteriorated wooden frame in front.

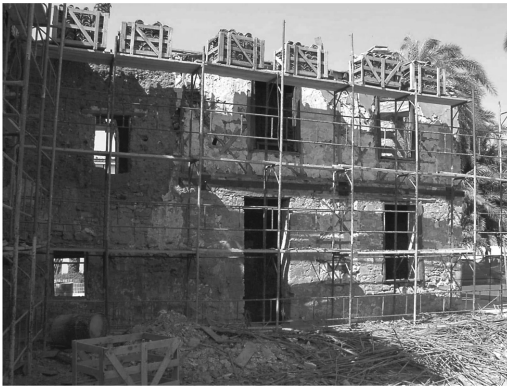
Figure 7. Loss of material and erosion of stone built and adobe walls.

Exposing the wall to the environment caused additionally erosion of stone surfaces and mortars. Exposed adobe walls are very weak to water erosion, so significant loss of material developed on these walls. Wet surfaces of adobe walls become soft and even birds are digging their nests on these walls.

Loss of material developed at the base of walls due to rising damp. A loss of 10–20 cm of thickness on a 50 cm thick wall and usually on one side, introduces significant eccentricities between external and internal forces, leading to deformations and cracking and overstresses the remaining section of the wall.

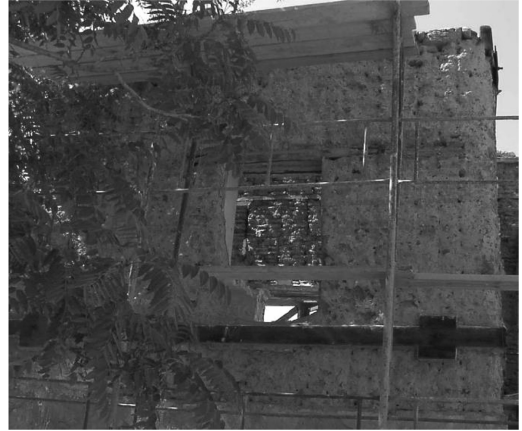
Figure 8. Erosion of surface, birds nests.

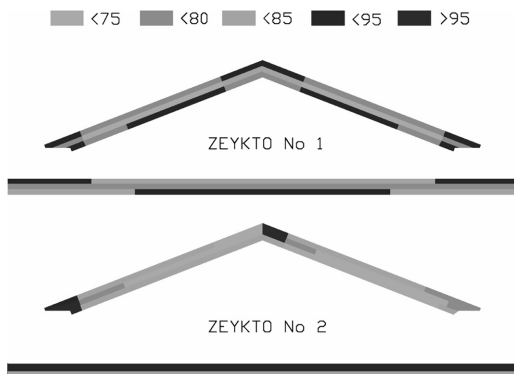
Additionally insects created a lot of holes and channels causing additional loss of material and strength. The most significant case was the condition of the three main trusses over the meeting room. The trusses were formed using beams of sections  $20 \times 20$  cm. No significant damage was detected at the beginning, but when they were lowered to the ground for inspection and maintenance, it was realized that areas embedded in wall's thickness and faces of the beams on the ridge were full of holes. Trusses were scanned using ultrasound equipment and the result was that sections around connection areas were significantly affected. It was decided to replace them with new ones and preserve the existing ones for repair in the future. (Figure 9)

Figure 9. Ultrasound test on wooden trusses.

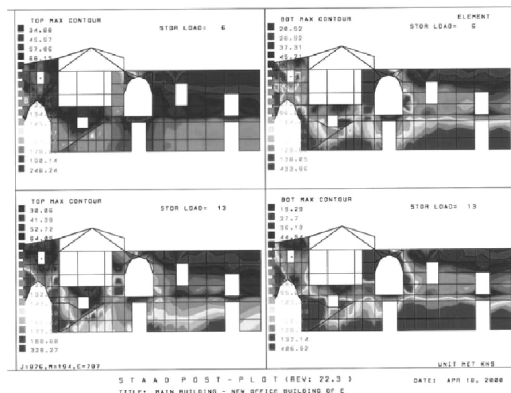
Figure 10. Stress contours on the north wall.

walls improved significantly building's behavior to seismic actions (at analysis level) and upgrading of the walls could establish the required level of safety. Figures 10 & 11 indicate stress contours produced for walls scaled down. Analytical printouts of stresses were produced and submitted to authorities to verify and justify the proposed interventions.

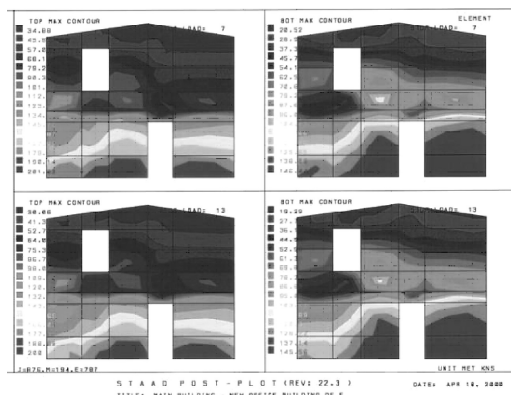
Figure 11. Stress contours on the east wall.

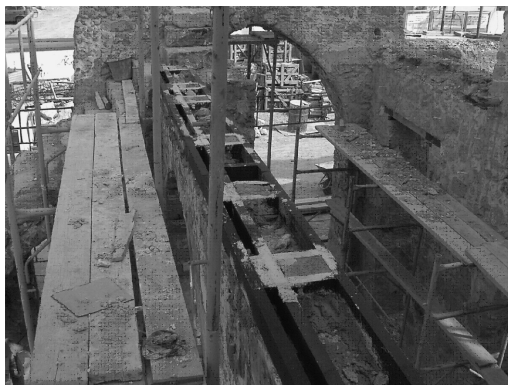
Figure 12. wooden ring beam.

- 6) Props and temporary supports of no use, since walls have been repaired, were removed. Pockets for the new beams were opened on walls and existing pockets were carefully cleaned. Additional pockets were provided on the top of the walls, to put wooden poles connecting the ring beam to the walls. The new ring beam consists of two wooden beams connected to the poles using stainless steel bolts. Hydraulic lime mortar was used for filling the vertical pockets and building the

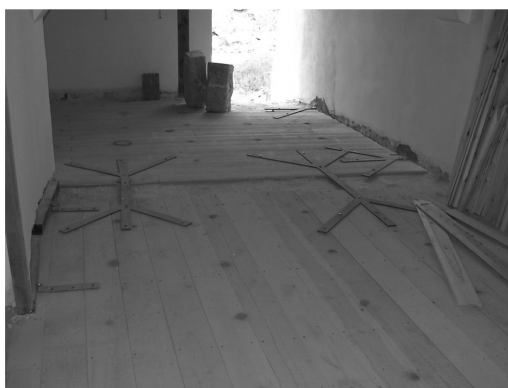
Figure 13. Steel connectors.

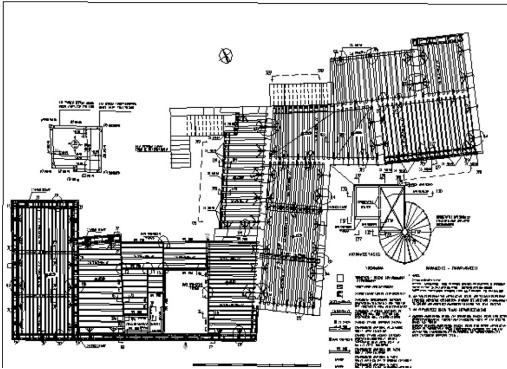
Figure 14. Final layout – ceiling over ground floor.

- 7) New roof beams were connected to the ring beam. Wooden boards 20 mm thick were used on both roof and ceiling over ground floor, so that beams together with boards provide the weak diaphragm that was considered in the design. On roof level beams were directly connected to the walls through the ring beam. On ceiling over ground floor, special steel connectors were used. (Figures 12 & 13).
- 8) All lintels and sills have been replaced using new material of same origin and shape with the existing ones. Additionally stones of arched that deformed were brought to their right place and the ones cracked were replaced. Connecting the cracked parts of a stone together using injections was not successful due to the high porosity of the material.

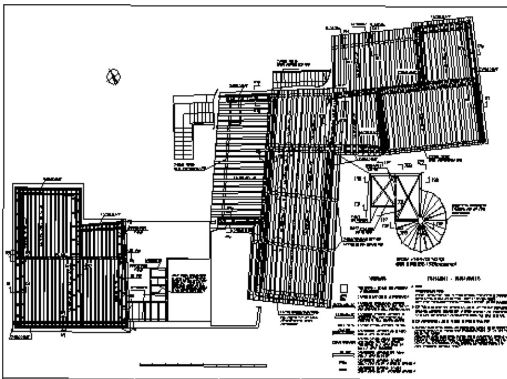
Figure 15. Final layout – roof over first floor.

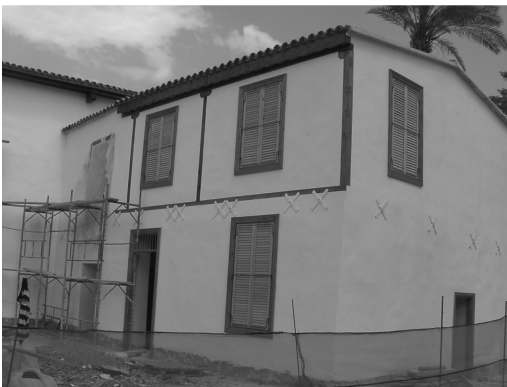
Figure 16. Steel connectors.

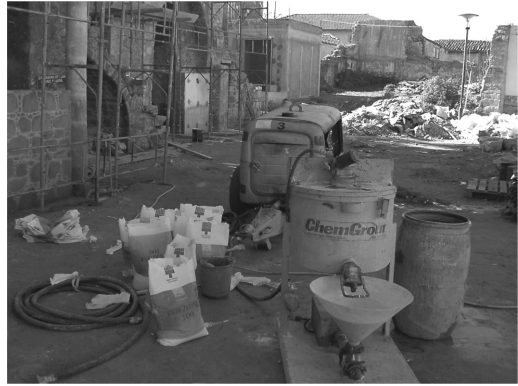
Figure 17. Grouting equipment.

- 9) A net of grouting points on both sides of every wall, staggered from face to face and at distances between them around 50 cm and not more than 70 cm. was installed. After all wall repairs

had finished and all wooden elements had been installed, grouting was carried out to enhance binding between the two leafs of the wall and fill any interior gaps or cracks. The procedure

includes injection of water in a wall the first day and the grouting the next day. Hydraulic lime mortar with fine aggregates was used. Approximately 2 litres per grouting point was used.

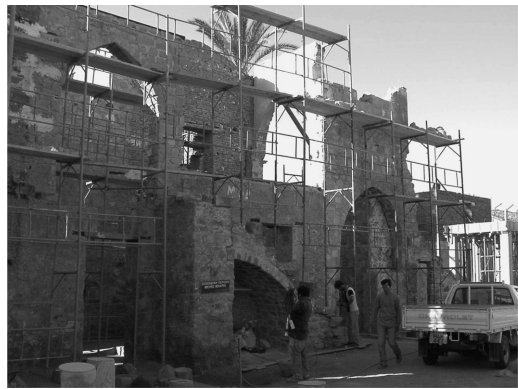
Figure 18. North wall before repair.

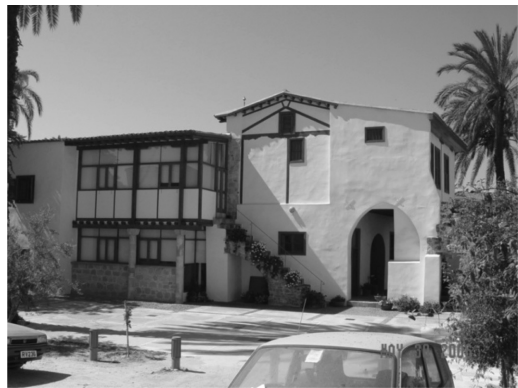
Figure 19. North wall today.

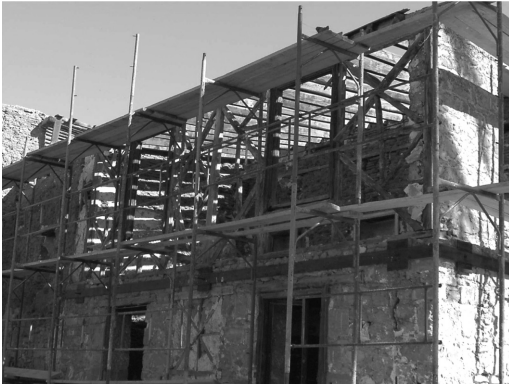
Figure 20. Repair of existing wooden wall.

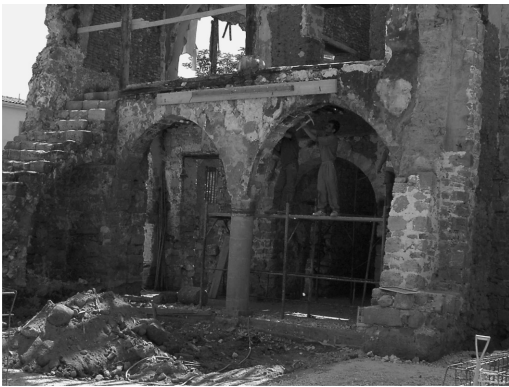
Figure 21. West wall being repaired.

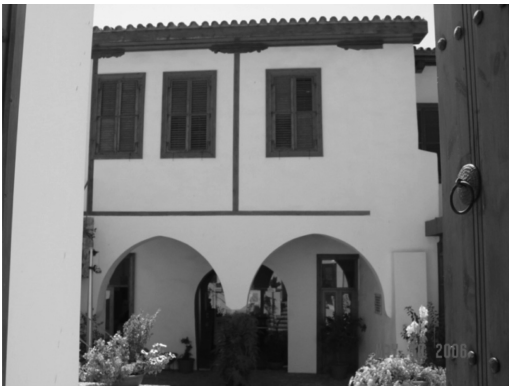
Figure 22. West wall today.

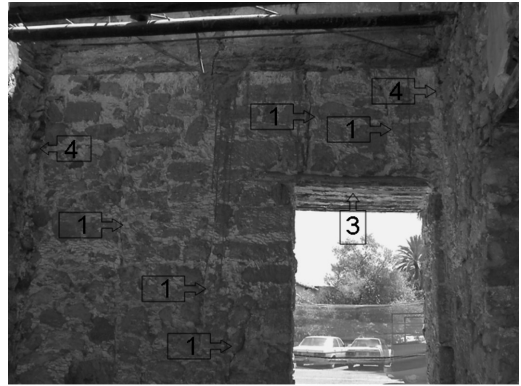
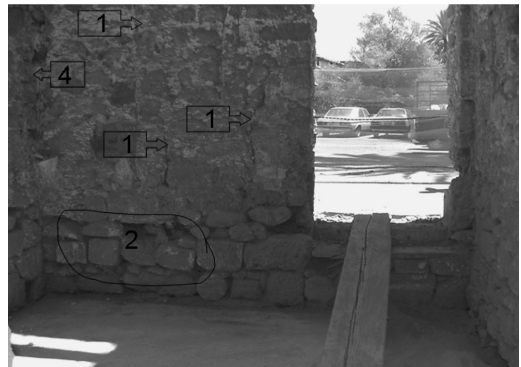
Figure 23. Instructions on photographs.

- 2) Photographing of all wall panels from both sides and in detail was then carried out. These were used to indicate instructions for repairs directly on them. Repair of joints, bridging of cracks, replacing damaged stones and mud bricks, changing the location of stones to break continuity of vertical joints providing key stones etc. were marked one by one on the photographs using code numbers and marking of areas. This way a sort of wall repairing shop drawings were provided to the contractor. These were supplemented with analytical descriptions and specifications for each and every code number, for the work to be carried out and the material to be used.

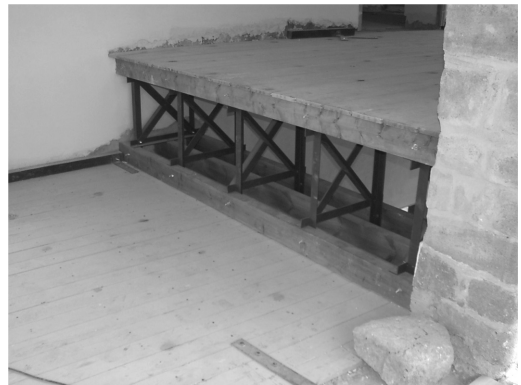
Figure 24. Installation of a steel truss to connect diaphragms on different levels.
