## The XIX century opera theatre of Catania: Conservation and seismic strengthening interventions

**ABSTRACT:** This paper presents a study carried out on the dome which covers the horseshoe shaped hall of the Massimo Bellini Theatre in Catania. The dome's painted surface shows a set of cracks whose pattern, probably come out as a consequence of a seismic action, seems to be depending on some features of its structural behavior which are related to its geometrical configuration. The structural behavior of the trussed dome is at present the subject of a numerical (via f.e.) analysis with the purpose to clarify the importance of the different mechanical parameters and, in case, to recognize potential weak points of the assembly. But a preliminary attempt has been made to understand, by means of simply logical reasoning and on the basis of the observation of the structure and of its damages, the mechanisms of the structural behaviour. The results of such an effort have been used as a guide in defining consistent intervention criteria.

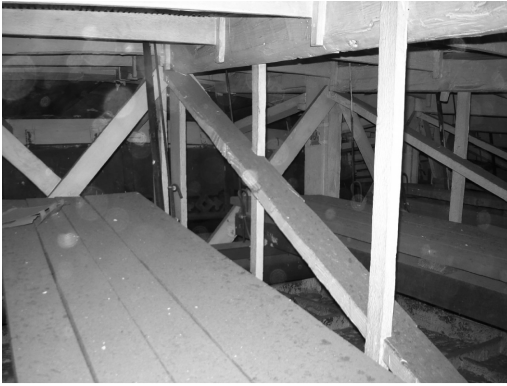
Figure 11. Internal view of dome's structure: it can be noticed next to the truss, one of the circumferential cross braces and the recently added footbridge.

These footbridges are hanged up by steel cables to the metallic structure of the new roof, so they do not weigh on the dome. Anyway the steel cables pass through the extrados plaster layer so that every movement of the footbridges, even during maintenance inspections, could affect the dome.

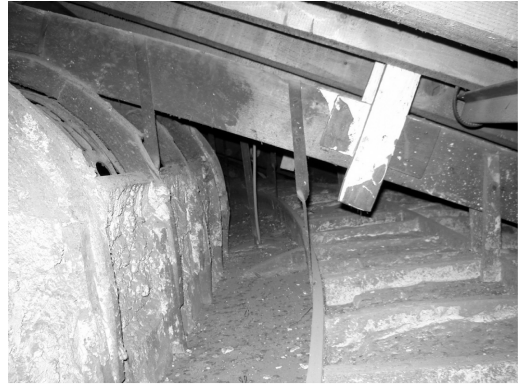
Figure 12. View of dome's the suspension system in the area close to the perimeter masonry wall.

Concerning this last point it can be noticed that in the dome's portion close to the impost, precisely between the cornice and the perimeter curved wall, the trusses are not connected by transversal wooden elements. Therefore both transversal wooden elements and the intrados plaster layer are hanged up to the trusses by metallic and wooden ties.

This different arrangement introduces a lack of connections in the direction of dome hoops which has been controlled with attention above all because of the contemporary lack in the same zone of cross braces.

In this sense, some constructive features of the dome achieve a stringently structural meaning. First of all, the radial asymmetry of the wooden trusses, but also the different suspension system of the dome nearby the border walls (because of which the lower cords of the trusses cannot count on the bracing effect of the centering) and the simultaneous lack, in the same zone, of the cross braces (figure 12).

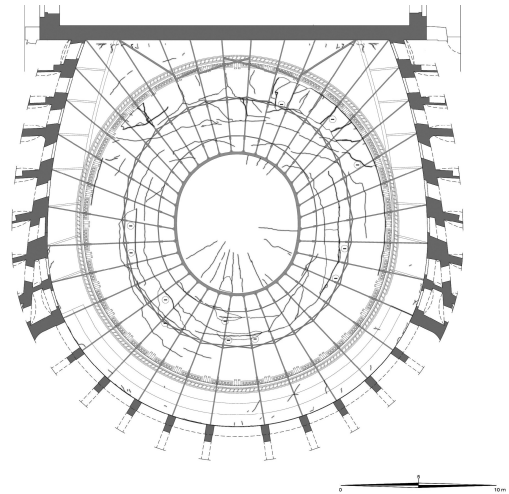
Figure 13. Relationship among wooden trusses, masonry walls and crack pattern of the plaster.

These geometrical and constructive features affect, and locally modify, the shell behavior of the trusses' assembly – a typical biaxial stress state, with internal action both in the meridian direction (in this case, the trusses) and in the hoop one (braces and centering) – and can produce, as a consequence, a crack pattern similar to the surveyed one (figures 13, 14).

The circumferential layout of some of the fractures – which are almost perfectly disposed along the dome's hoops – seems indeed classical.

Domes struck by seismic action frequently crack horizontally, and it's undoubtedly not by chance that such cracks came out, in the painted dome of the Bellini theatre, after the 1990 earthquake (the so called "Santa Lucia" earthquake).

Furthermore these cracks are localized in the zone of the dome where the suspension system passes from wooden centering to metallic ties.

The meridian cracks that are mainly located in the zone of the dome nearby the stage walls seem instead consistent with the radial asymmetry of the wooden trusses.

This circumstance causes a different deformability in the different zones of the dome's structure, in such a way that the zones where trusses are acted upon by smaller hoop forces exhibit, for the same load condition, greater vertical displacements. Relative displacements between contiguous trusses can produce cracks directed along the dome's meridians.

- (B) Although the crack pattern of the dome does not imply serious structural lacks, it is nevertheless to worry about (i) both for the possibility of detachment of plaster portions delimited by cracks' intersection (ii) and for the weakening that it could introduce in the bracing system.

Therefore, one of the purposes of the intervention should be to assure the adhesion of the precarious portions of plaster layer to its reed upper support; while it is not evident at present if it would be convenient to restore the continuity of the plaster layer.

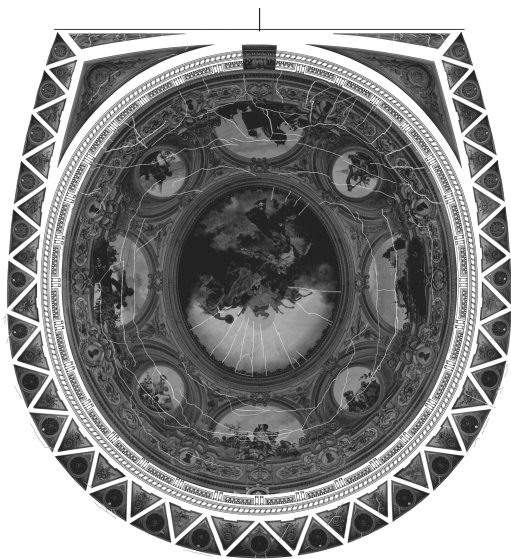
Figure 14. View of the crack pattern from the bottom.

As for the circumferential cracks, it is possible that the meridian cracks too came out after the "Santa Lucia" earthquake. In fact, most of the relative vertical displacements between the trusses could have produced gradually during the building of the dome, and further settlements, caused by the completion of the intrados, could have been absorbed by the elasticity of the plaster.

In such an hypothesis, however, the thin plaster layer of the dome would have been subjected to a self stress state that the occurrence of an even weak seismic action could have relaxed generating the meridian surveyed cracks.
