Structural inspection and analysis of former British Consulate in Shanghai

ABSTRACT: The building of former British Consulate in Shanghai is a protective historical building. The 2-story building is a composite structure of masonry and timber. The aged building has been used for more than one hundred years. Several retrofits have been performed and the structure has been partially changed. To ensure the safety of the current building and protect the building efficiently, structural inspection and analysis were performed based on the inspection techniques and the theoretical method developed by the authors. It was indicated by the inspection and the analysis results that most of the load bearing members are safe, however, some indispensable structural measures demanded by the current code to ensure the seismic capacities are missed, and proper retrofit is needed to realize these measures on the structure without affecting the original profile of the building.

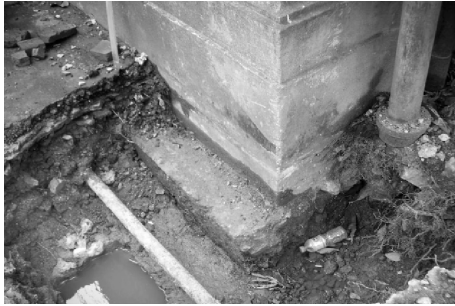
Figure 5. Inspection of the foundation.

according to the status of the building. The foundation of the building was inspected by digging (Figure 5).

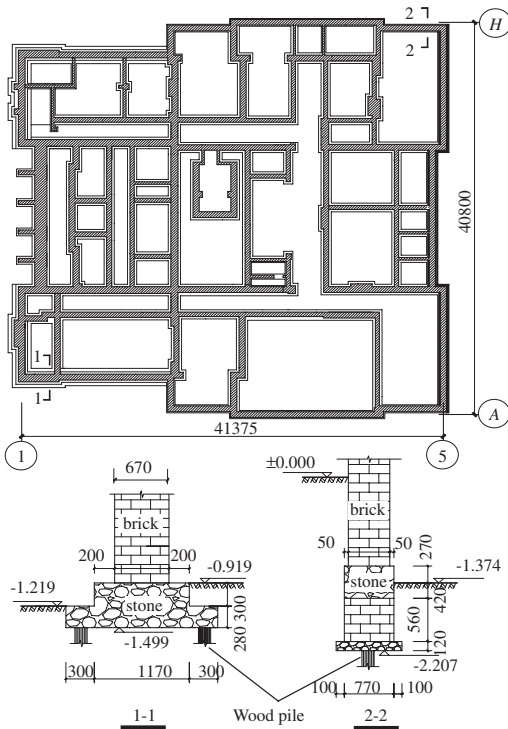
Typical architectural drawings, the details of the foundation and the structural plane of the second floor are shown in Figures 6–9 respectively. In the original structure, the foundation of the building was built by stone standing on the top of wood piles with the diameter of 150 mm and the space of 500 mm in the longitudinal direction (Figure 8), the second floor was constructed using 10-millimeter-thick wood plank supported by orthogonal timber grille (Figure 10). Section sizes of the bars used in the grille are 84×200 mm, 62×300 mm, 76×300 mm and 76×200 mm. Spacing between the bars are 360 mm and 395 mm. Wood sheathings covered by waterproof layer and fired clay shingles were used to construct the roof, which is supported by timber purlin on timber trusses (Figure 11). Size of the purlin section is 75×140 mm and the spacing is 625 mm. Section sizes of the bars used in the supporting trusses are 157×304 mm and 170×300 mm for

Figure 8. Details of the foundation.

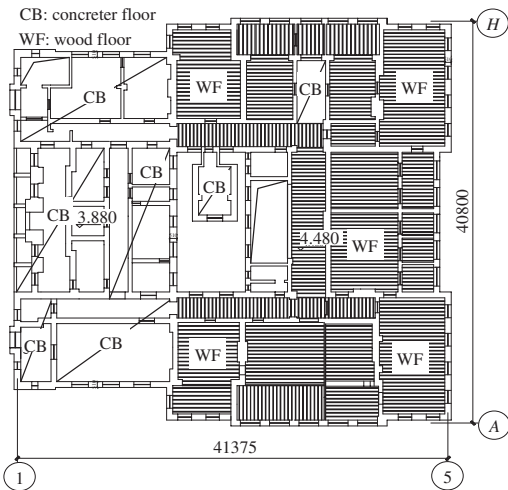
Figure 9. Structural plane of the 2nd floor.

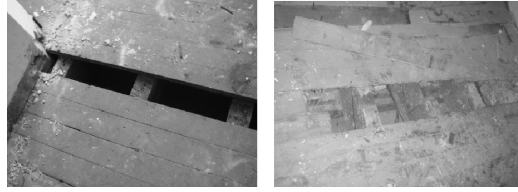
Figure 10. Timber grille on the 2nd floor.

It is indicated by the static calculation results for the timber grille that the safety margin of the grille is acceptable and no measure is needed to strengthen the grille under the current condition (Table 7).

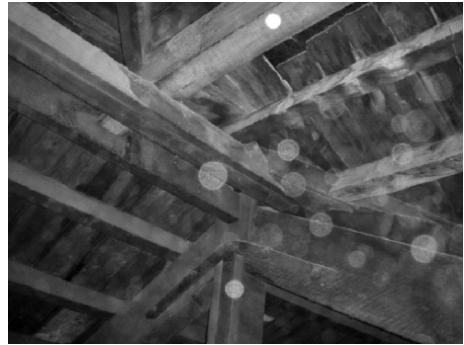
Figure 11. Connection of the roof structure.

There are some faults in the load-bearing systems of the building. There are no roof braces. Connection between the purlins and the trusses are missed. Some linking bolts on the lower end of roof truss braces are also missed. Besides, many bars are connected in the inner joints of the trusses and fastening measurements on the joints are missed. Large deformation of the joint under normal loading might affect safety of the trusses (Doherty et al. 2002). Further more, there are no ring beams and structural concrete columns inside the bearing masonry walls, and spacing between

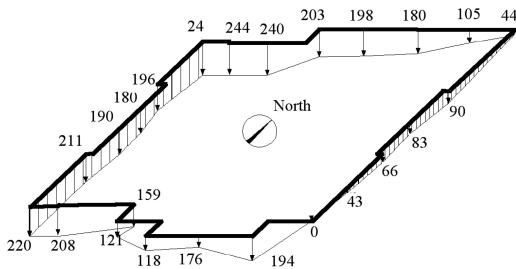
Figure 14. Relative settlements along the outer walls.

Considering the difference of density of materials used in the structure, the weak connections between load-bearing members and the soft characteristic of the ground soil, relative settlements and the leaning of the building structure were measured and the results are listed in Figure 14 and Table 4 respectively. The results indicate that the uneven settlements result in obvious leaning of the building.
