Revitalization of Historical Building in Wrocław's City Centre, Poland

Abstract Some aspects of the revitalization of the 14th century historical building are presented in the paper. The building was originally used as a poorhouse and a hospital for children. The original Gothic masonry building on the site was a two-storey building with a cellar, situated in a corner of two streets. In the middle of the 19th century the building was converted into a school and then the first large-scale demolition of the hospital's Gothic walls took place. After the 2nd World War a school was also situated in the building, where it existed until the late nineties. The aim of the renovation process was to convert it into an exclusive office block. The design works were preceded by historical research and on-site investigations. Complex conversion of the object consisted in the reconstruction of the old building structure, creating the inner courtyard and covering it with a glass roof. In the existing part of the basement one of the longest single-nave vaults in Poland and the exquisite roof truss system with a lying bidding-rafter post deserved special attention during the renovation.

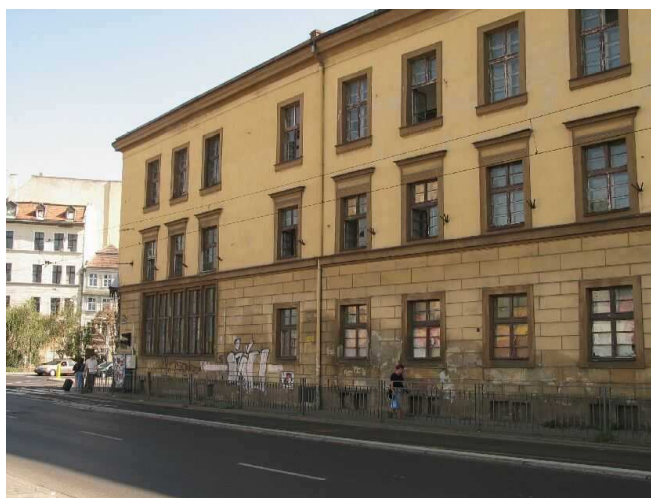
Figure 1: General view of buildings front façade before reconstruction

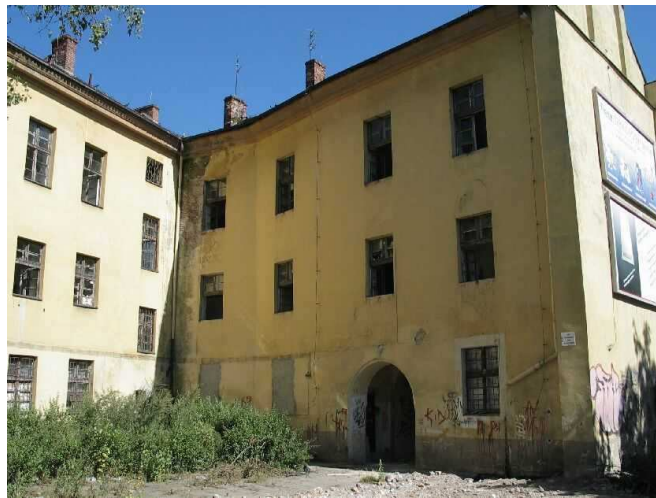
Figure 2: Part of building back façade before reconstruction

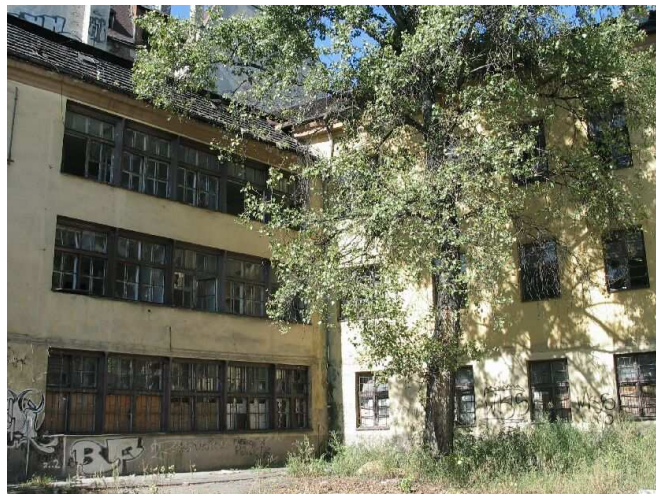
Figure 3: View of part of building's back façade from inner yard before reconstruction

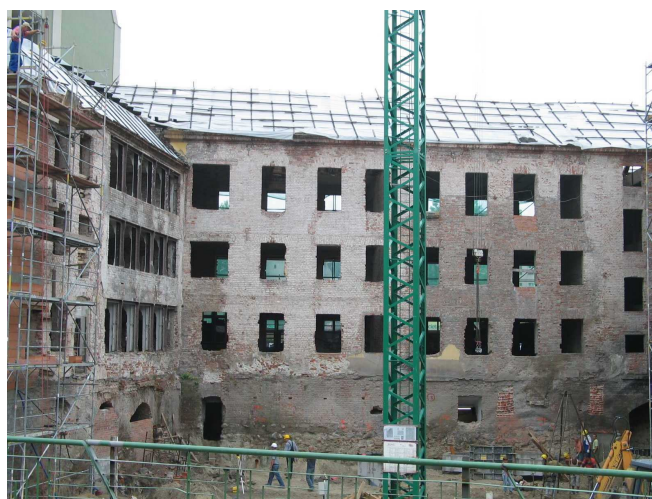
Figure 4: Building back façades during reconstruction works

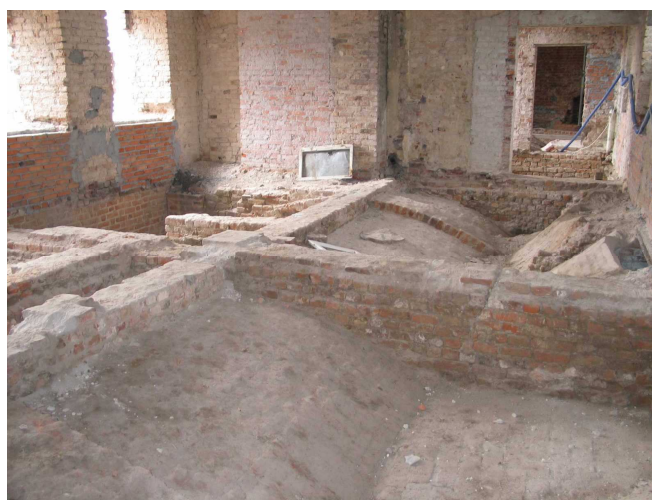
Figure 5: View of masonry vault over basement after removing floor layers

The vaults were filled with slag and wooden or cement floors were laid on them. Moisture and surface corrosion of the mortar in the joints between bricks were found. There were no cracks or other significant damage detected in these elements. The higher floors were rebuilt of massive Klein type on steel beams, with slag filling and wooden floors.

In the case of the historic part of the building the cellars masonry vaults were assumed to be left as well as Klein slabs over higher floors. Finishing layers and slag filling were removed from the existing floors. Vaults were cleaned and mortar loss in joints were filled using new lime mortar.

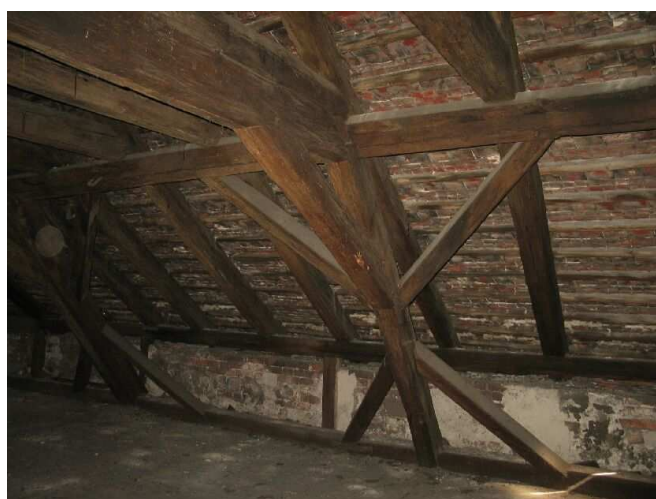
The roof rafter-framing is wooden, generally two-slanted and covered with ceramic tiles. It has different rafter layouts (Fig. 6). On one part of the roof a truss system of unique solution was made with lying bidding-rafter posts (Fig. 7). Some of the main roof trusses were not fixed to the steel ceiling beams and then large horizontal forces were directly transmitted onto wooden foundation beams and then on the brick attic wall. This resulted in visible deformation of the walls in these places. Some of the wooden elements of the roof structure suffered superficial destruction by biological corrosion despite them being made of larch, and having longitudinal cracks. The truss structural elements, however, showed no excessive deflections or displacements.

Figure 6: View of wooden rafter framing before repair

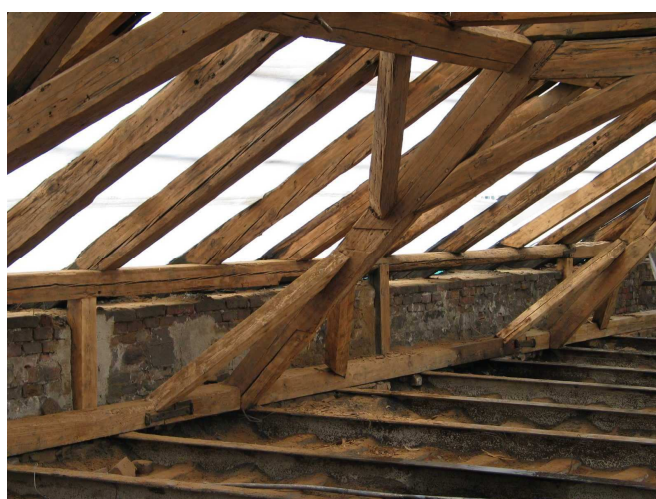
Figure 7: Laying wooden rafter framing during renovation

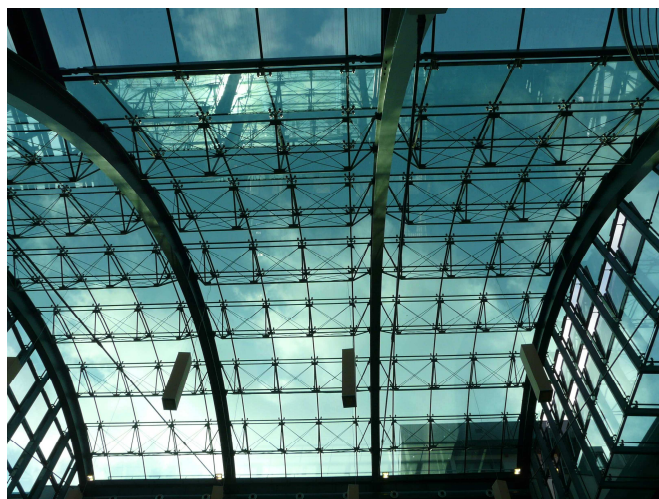
Figure 9: New steel roof over building's courtyard

The main load-bearing element of the courtyard glass roof was designed as a system of arched steel girders and flat beams (Fig. 9). At one end these arcs are based on curved reinforced concrete columns, referring to the line of arcs coming out from the basement. However, a significant part of the roof had to be based on the walls and pillars of the old building. It was an important problem because of the large horizontal and vertical forces generated by the roof. In this case it was decided to strengthen the masonry pillars of the old building by using steel casing and support roof girders on masonry walls using special sliding posts that do not transfer horizontal forces. The horizontal parts of the roof were based on spatial trusses and beams made of rectangular tubes (Fig. 10).

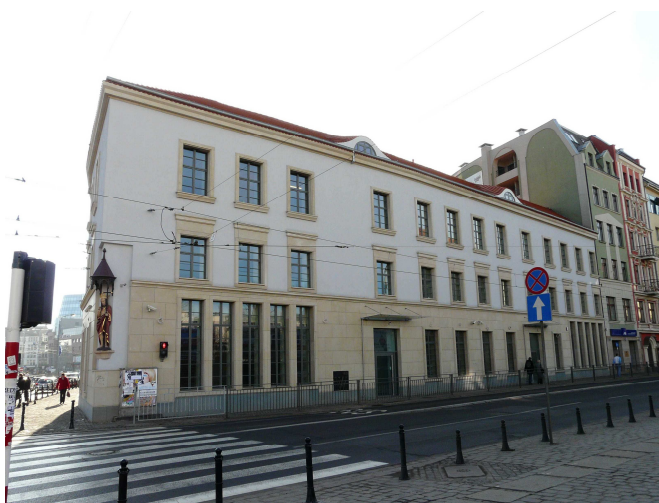
Figure 10: Old building after renovation
