Conservation and Preservation of Historical Earthen Structures

Abstract: This paper discusses the different techniques that can be adopted for conservation and preservation of historical earthen structures constructed using adobe mud bricks in non-seismic regions. Initially, it reports the different damage patterns and modes of failure that are usually exhibited by these structures due to aging process and poor environmental conditions as recorded from field visits. Then, it explains using structural fundamentals and soil mechanics principles the causes for these defects. Finally, it suggests various measures that can be taken to restore and preserve these endangered structures.

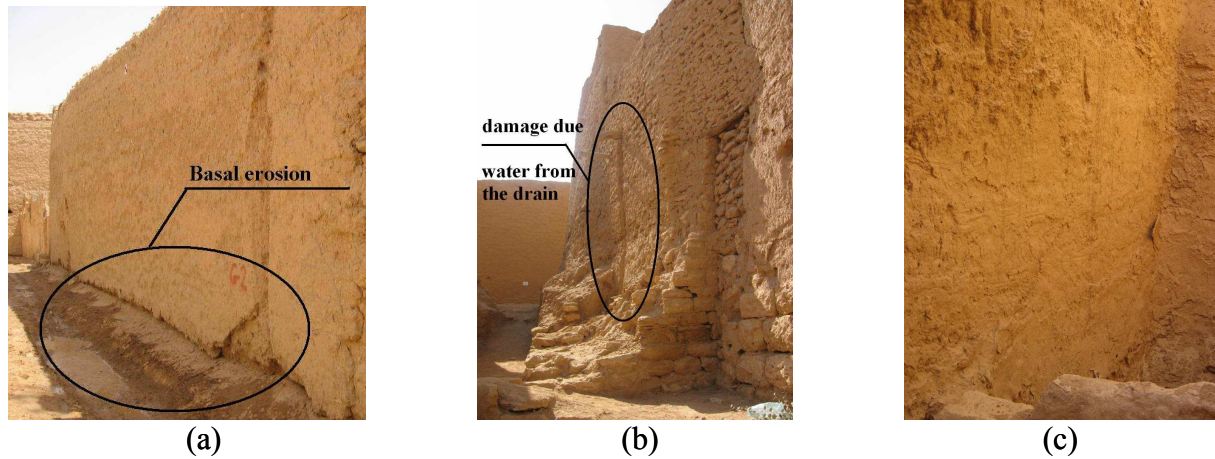
Figure 5: Damage patterns due to water action

Water is considered the main threat to these historical mud structures. As can be observed from examining Fig. 5(a), basal erosion, which is defined as the disintegration and loss of portion of wall at its base, can be caused by surface water runoff during flooding, by water falling from the roof and splashing up against the wall bases, or by accumulation of water beside these walls for relatively long time. Also, damage can be caused by water being drawn up into the walls by capillary action and then diffusing to the wall surface to evaporate. The water in this case may contain soluble salts that crystallize near the surface as the water evaporates. In crystallizing, the salts expand and can fracture the muddy walls. Continuing this process can slowly erode the surface plaster layers and lead to total disintegration of the external plaster leaving the internal wall layer exposed directly to external environment. Furthermore, this erosion can be increased by the abrasive action of the wind, sand and plant growth. In addition, water leaking from around the gargoyles and falling on walls external facade, can cause erosion to external surface of these walls as shown on Fig. 5 (b) and with time, the clay material within this zone can be totally disintegrated. Rain water falls over external walls surfaces can also be a source of damage. With the combination of environmental conditions, continuous drying and wetting of external clayey plaster due to rain fall can cause plaster cracking, disintegration and subsequent fall down exposing the internal walls composition to external atmosphere as shown on Fig. 5(c).

To avoid the occurrence of damage associated with water, it is recommended to cover the base of all walls with stone skirts up to a height of about 50 cm in order to prevent wall erosion resulting from running water or splashing effect. Also, the land outside the premises of the building should be sloped away from the walls to divert the rainwater away from the walls as shown on Fig. 14. Furthermore, accumulation of water adjacent to walls should be prevented.

For damaged walls, loose parts should be removed. Then, the remaining walls treated with suitable chemical (with Silbond-40 or equivalent) to soak into porous adobe, where it sets up and hardens so that the adobe is no longer turned into mud when in contact with water. At the same time replace the lost parts of the wall thickness by the erosion process. Then, new plaster layers are provided to walls surface. This layer should be associated with water repellent suitable for adobe protection. All roof drainage gargoyles should be replaced with sufficiently long ones to drain water far away from wall surfaces and their connections with the buildings should be treated adequately to prevent leakage.

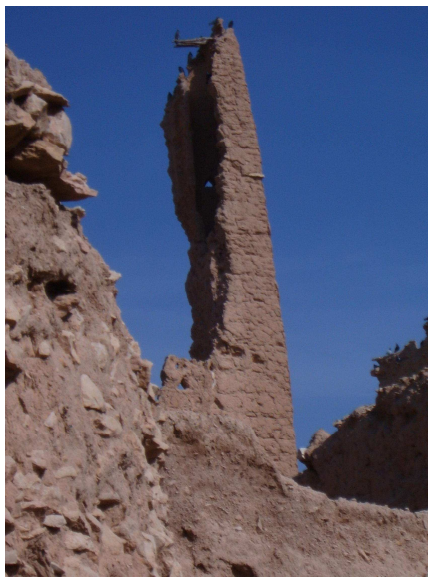
Figure 6: Tilted wall at site

Another observed damage pattern, was the walls out-of-plumb that results from faults in vertical alignment during construction of walls, settlement to the soil supporting the wall, distortion to wall after getting wet (wall slumping), and unbalanced erosion on walls both sides. This issue can be further aggravated by the loss of any strong connection between this wall and the rest of the buildings.

Fig. 6 shows an example of tilted walls at site. In addition, some walls were noted to be unstable due to absence of any firm tying connection with surrounding walls or due to high slenderness of these walls ($h/t > 8$), where h is the wall height and t is the wall thickness. Fig. 7 shows one of these slender walls were, the height to thickness ratio for the wall exceeded 8. In response to such instability, the authority had to safe guard these walls against collapse by safeguarding and propping them.

For slender walls having height to width ratio more than 6, buttresses should be provided to avoid any possible overturning. Buttressing can be done by firmly tying this wall to other perpendicular walls or by installing a tapered buttress. Fig. 15 illustrates the rules followed for laterally restraining the walls using cross-walls or buttresses. Tie-rods made from non-corroded material and environmentally friendly such as stainless steel or titanium can be used to connect wall to buttress.

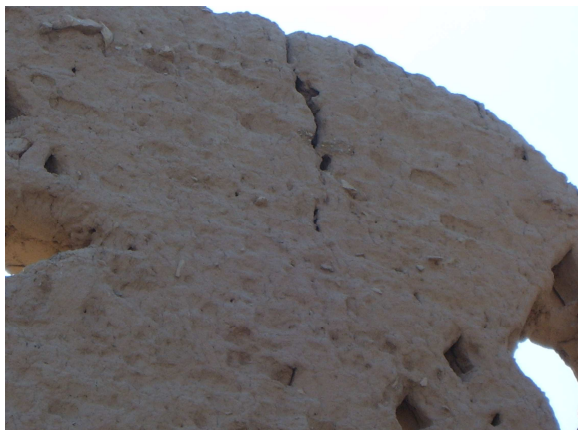
Figure 8: Cracks within walls bodies

Deep through cracks within the walls and between perpendicular and adjacent walls at their intersection were noted to be another major defect. The initiation of cracks within the walls bodies was attributed mainly to; 1) cycles of wetting and drying accompanied by small movements resulting from possible settlement; 2) weakness at certain planes within the walls due to disintegration of bonding materials; or 3) high local stresses due to the existence of openings. Fig. 8 shows an example of such failure pattern. With regard to cracks at walls intersections, it was attributed to loss of physical connection between these walls and presence of high flexural and tensile stresses at wall connections. Fig. 9 shows an example to these deep cracks. In general these existing cracks are affecting the stability of these walls, since they tend to make the behavior of them independent from each other, rather than making them to behave as one unit.

For cracks within walls, wood/stainless wedges/bars can be used to connect both sides of the walls along the cracks. Also, perpendicular walls can be connected using wooden ties to provide the required stiffness to building and stitch any existing cracks along the corner.

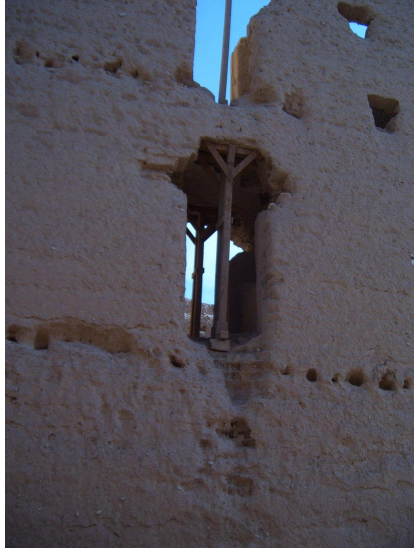
Figure 10: Collapse at door opening due to loss of the wooden lintels

At many locations around openings, damage was recorded in the form of cracking or collapse to the blocks above the opening lintel. Such failures were attributed either to disintegration and/or deflection of the doors wooden lintels, or to the inadequate embedment length of the wooden lintels inside walls along the two sides of the opening. Fig. 10 and Fig. 11 show examples for such failures for the two indicated patterns, respectively.

To rectify the damage due to decay of wooden lintels, new lintels with sufficient embedment length into the adjacent walls should replace the old ones. Also, props should be done through the walls to identify the existence of cavities. Normally, four holes drilled per square meter. In case any tunnels are discovered, the thin external clay layers should be carefully removed and the tunnel filled again. These holes can be also, used for injecting anti termites materials. Fig. 16 shows views to different suggested remedial measures, as reconstruction of parts of damaged walls to enhance walls stability, rejoining perpendicular walls and stitching cracked walls. On the other hands, Fig.17 shows the mathematical model utilized to examine the stress within the body of parts of the building to assess the need for remedial measures.

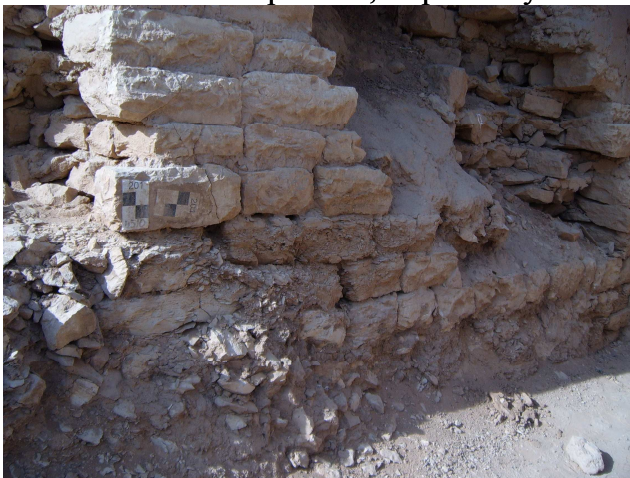
Figure 12: Decay to foundation rocks

Another damage pattern was disintegration and decay of the rocks forming the foundation layer for the walls as shown on Fig. 12. Such damage can lead to wall total collapse. Burrowing tunnels within walls bodies by reptiles as shown on Fig. 13 is another damage pattern that was recorded during these site visits. These tunnels can reduce tremendously the walls thickness leading to their collapse.
