The Protection Problems and Reparations of Ahi Çelebi Mosque in Istanbul

ÖZAKIN Rabia^{1, a} and ERDEM Ayten^{2, b}

Abstract The Ahi Çelebi Mosque, which is among Istanbul's oldest mosques, is located on the shores of the Golden Horn in the Eminönü. This mosque, which was very probably built by Ahi Çelebi towards the end of the 15th century, was restored during the 16th century by Architect Sinan. It is a stone building with a rectangular plan, single dome, with a rear congregational area/*son cemaat yeri* in front of its main space, and a cut stone minaret at its right corner. Damaged by fires and earthquakes during its long history, this building, set on reclaimed land, was restored and strengthened at various times through the years.

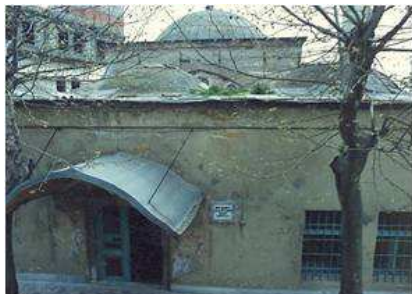
Figure 16: Northern façade, before the last restoration

20th Century The building was impacted by the construction of new Galata Bridge and excavation conducted within the scope of landscaping works in Haliç in 1980s; shakes occurring while driving in a stake during construction works caused cracks to emerge on walls of the mosque. Since the ground on which the mosque was located was made-up ground, differential settlements were formed on the footings carrying the arches on which domes were located, and bending and buckling emerged in ties binding arches to one another in the course of time (Sesigür et al. 2007). When damaged mosque started to slip towards Haliç by sinking into the ground, it was closed to worship.

Cracks emerging due to settlement and deformations were seen on dome, walls and carrying elements when plasters were removed and dome leads were disassembled in order to see the problems of the building with regard to restoration works in 1990. Ground strengthening works were started in 1991, but they were stopped due to monetary problems (Topkaç 1992). At the end of geophysical measurements and exploration drillings performed in 1993, it was realized that differential settlements occurring on bases of the mosque led to bending as well as cracks and openings in main walls in the eastern and western part and in dome and arches (Gözübol and Kipman 1993). In addition, it was seen that ground water was 7-10 cm beneath the slab level of the mosque and the mihrap wall drew capillary water from a water source located to the east of the building. Projects and technical reports of the building were prepared in 1995, and ground strengthening works were restarted. Strengthening works performed by means of micro pile method were stopped again due to monetary problems following the first phase at the end of 1997. Since structural problems increased due to Marmara earthquake in 1999, urgent reparation of the mosque came to the fore. Ground strengthening works were continued in 2000; sea water in the base level was evacuated; and it was seen via the conducted measurements that bending and settlement in the ground was stopped (KTVKK Archives 2001). Restoration project suggestion mosque to be protected in accordance with periodical features belonging to 19th century (current situation at the present time) was approved in 2004 and put into practice, and the restoration was completed in 2006 (KTVKK Archives 2004).

In the restoration, in the first place, made-up ground of the mosque was strengthened via micro piles, and sea level was evacuated through the pipes put in the base level. Operations of curetting, cleaning, partly reconstruction and integration were conducted in all of the façades (Fig. 16-Fig. 21). Structural cracks widespread in walls, main dome and rear congregational area domes were strengthened, and sutures losing their features were renewed (Fig. 22, Fig. 23). Capillary cracks on walls and domes were filled with mortar having physical features similar to the quality of original mortar through pressure injection. Wide cracks were filled via injection method after being planted, or they were disassembled regionally and bonded again (Sesigür and Çılı 2004). Non-utilizable fire/od stones in all of the walls were renewed, and stones and bricks not losing their features were used in their original places. Western façade of the narthex was disassembled, and its reconstruction was conducted with available materials and Pınarhisar stone (Ersen et al. 2008). The mosque and its
