The Restoration of a Wood-Frame House in Anatolia, The Yakup Ağa Mansion

ERDEM Ayten^{1, a} and ÖZAKIN Rabia^{2, b}

In this paper, the consolidation, completion and reconstruction interventions carried out to preserve the wooden mansion will be analysed, with the aim of determining the degree of conservation of the aesthetic, historical evidence and authenticity values of the building.

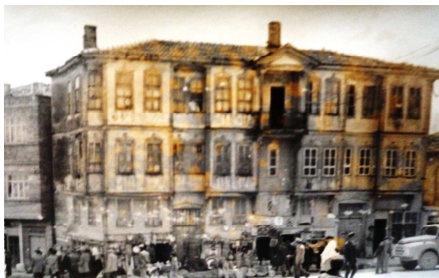
Situation of the Mansion before Reparation Periodic maintenance and simple reparations of the building left by losing its social and cultural status in 1980s could not be made since it had many owners and these owners could not come to an agreement (Fig. 11). Destruction of the building increased more in the period when it was not used; and partly collapses occurred. The balcony and its roof existing until 1988 and some parts of the rooms behind the balcony were destroyed in 2000s (Fig. 12, Fig. 13) South front of the mansion fell into ruin from basement floor level to roof level; wooden roof material decayed; and it was fortified from various places to prevent it from being demolished. Before the reparation, a great part of the plasters in the west front taking prevailing wind and rain peeled off; a great part of bearer studs and plaster laths holding the plaster decayed; and cracks and collapses emerged from place to place due to the decay of wooden material in internal parts. For that reason, local government applied to the related preservation board, mentioned that it created danger against the public health and so it must be destroyed. In this way, local government was taken a decision that Yakup Ağa Mansion must pull down because of insecure building.

Figure 11: Mansion, 1940

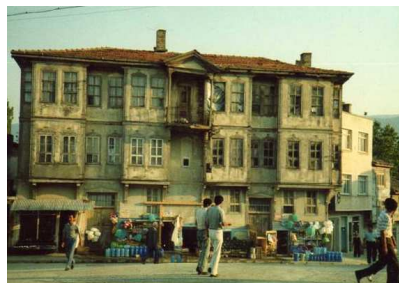
Figure 12: Mansion, 1988

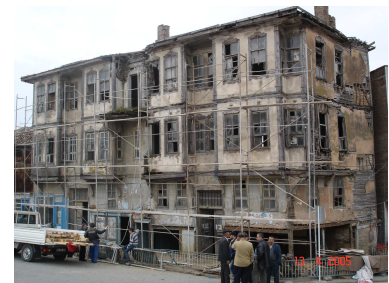
Figure 13: Mansion, 2005

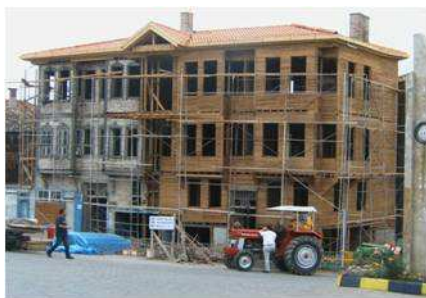
Figure 14: During the restoration

Restoration Phase Restoration of the building was started in 2006. West exterior wall, a great part of south exterior wall and northwest part of north exterior wall including also the balcony which were all in a structurally bad situation were rebuilt in a timber framing way by suspending original ceiling and floor coverings. As a way of intervention, consolidation action was preferred in the west part and interior walls of the building; healthy sections were preserved (Fig. 14, Fig. 15); and part replacement was made in decaying elements (Fig. 16). Floor beams were strengthened with new beams put to them; window woodworks were renewed in compliance with original window type; doors were preserved (Fig. 17) and wooden roof was rebuilt completely. During the reparation process, decorated walls and ceilings were covered and taken under protection, and partly destroyed and rebuilt sections due to reparation were plastered in a way forming base to the decoration (Fig. 18). Architect taking responsibility of reparation mentioned that reparation and completion of the decoration referred to a different area of expertise, and preferred not to make reparation in engraving /hand-carved decorations (Fig. 18, Fig. 19).

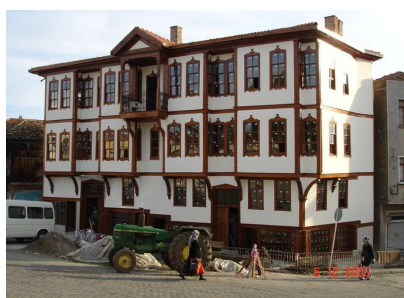
Figure 15: After restoration

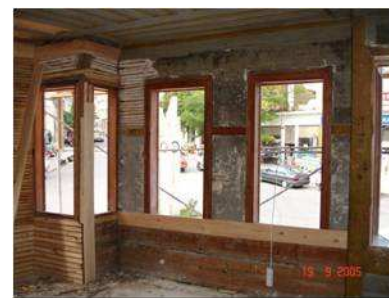
Figure 16: During the restoration

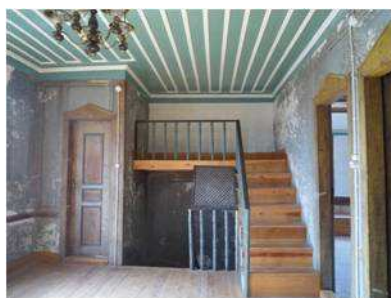
Figure 17: After restoration

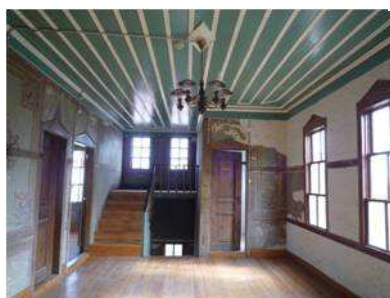
Figure 18: After restoration

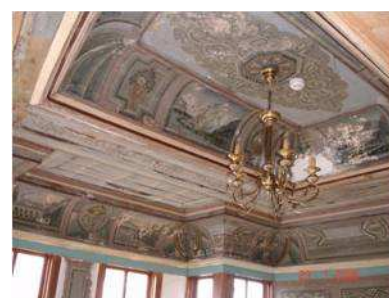
Figure 19: After restoration

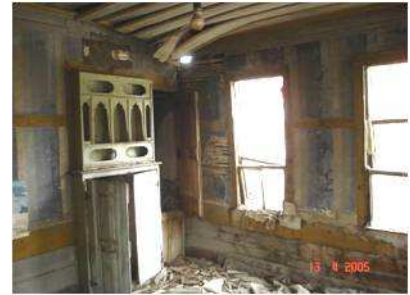
Restoration Evaluation In restoration of Yakup Ağa Mansion, primary target was preserving the building without destructing it wholly, and this target was achieved, though partly. However, preservation of more original materials did not become possible due to the deficiencies starting in the phase of project designing. It is seen that before the reparation, analytical building survey involving period, structure, material and deterioration analyses of the building was not made, decorations were not documented via photograph and stamping method, and parts to be rebuilt, parts to be preserved and ways of intervention were not mentioned in the restoration project. Due to these deficiencies, the parts experiencing greatest destruction in the reparation made at the discretion of the masters came to be decorated walls. Even though it was possible to separate parts which had to be structurally renewed but which had their decorated plasters on them from timber frame and to preserve them in a different place and then to put them on renewed wall, decorations were considered as unimportant elements which could be formed again (Fig. 20, Fig. 21, Fig. 23, Fig. 24). Original color tone was not paid attention in painting the ceilings (Fig. 22, Fig. 25), and also original covering dimensions were not paid attention in floor covering.

Figure 22: Before restoration

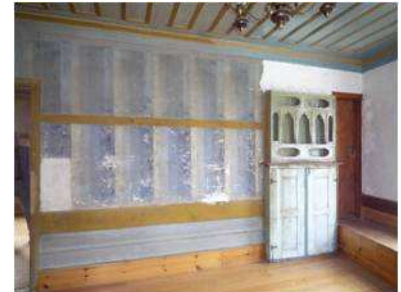
Figure 25: After restoration
