Interventions on the Gothic Roof Structure of the Nave at the Lutheran Church in Bistrița (Romania)

Keywords: Lutheran Church in Bistrița, Gothic roof structure, restoration works

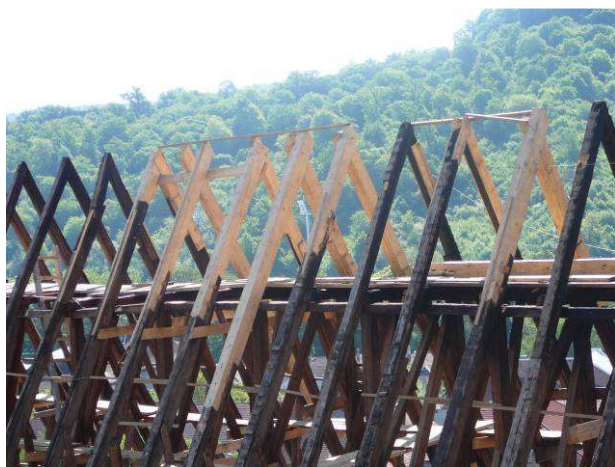
Figure 10: Local interventions –rafters' end repair *Figure 11: Local interventions – collar end repair*

Degraded missing parts and shorter parts (in particular angle braces) were totally replaced, even if only locally degraded. Longer parts (i.e. common rafters, tie-beams, collar beams, compound rafters, King/Queen posts in tension, longitudinal plates, etc.) were restored by replacing the degraded parts of the respective elements, achieving connecting joints able to carry tension, as well as eccentric compression loads.

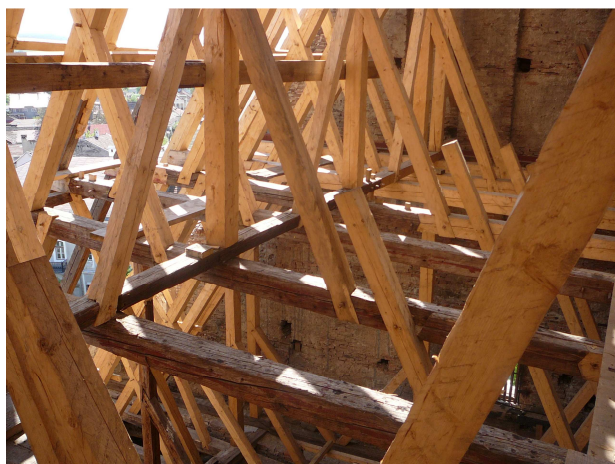
Figure 12: Reconstruction intervention at the first section, level II *Figure 13: Replacement of damaged rafter and upper collar, second section*

The first section, made of the first 9 trusses, destroyed to an extent of around 70% by the fire, was restored respecting its initial shape, that of 1559-1563. Parts of elements preserved from the fire were lengthened with new material, identical to the existing one, i.e. hand hewn fir timber. The curtailed trusses in the area of the tower were anchored to the tower masonry with metal. The longitudinal frames were also fixed to the western gable through metal elements.

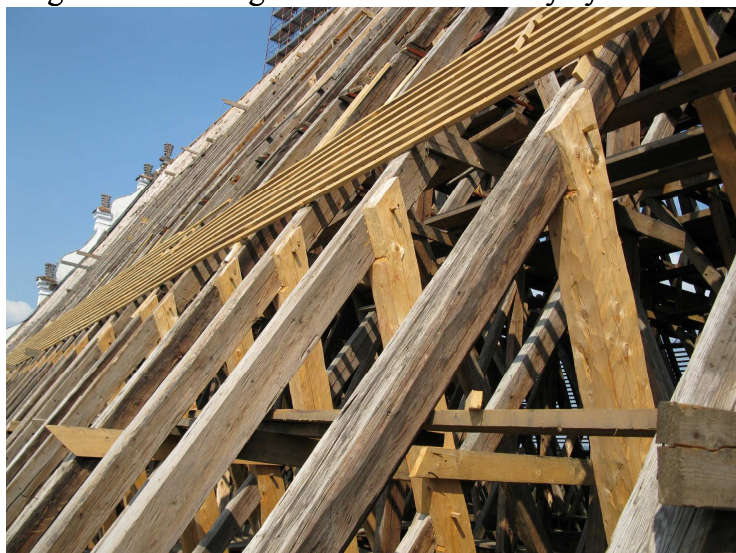
Figure 14: New angle brace – rafter dovetail joints

Many of the angle braces and compound rafters were replaced locally or completely rebuilt, because when the tie-beams had been previously replaced, the angle braces-tie beam joints and the compound rafter-tie beam joints were destroyed, cutting off the ends of the angled elements, without dovetail halved joint in the newly introduced tie beam. On this occasion, the restoration consisted in replacing the properly cut-out slanted elements and in carving slots for the tie-beams halved joint.

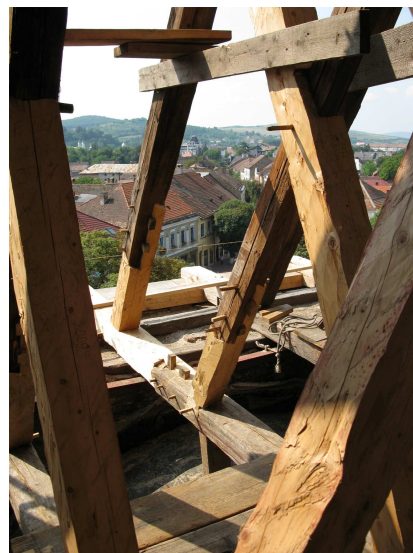
Figure 15: Rafter, compound rafter extension joints
