Assessment of the Compatibility of Repair Mortars in Restoration Projects

CIZER Özlem^{1, a}, SCHUEREMANS Luc^{2, b}, SERRE Gerty³, JANSSENS Eike⁴
and VAN BALEM Koen^{5, c}

^{1,2,3,4,5}K.U.Leuven, Department of Civil Engineering, Reyntjens Laboratory, Heverlee, Belgium

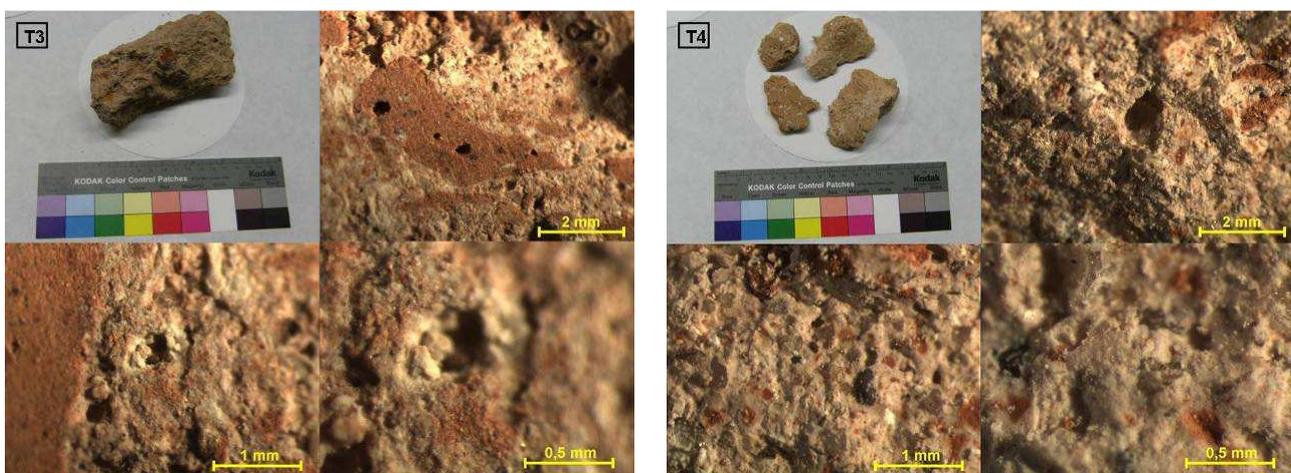
Figure 2: Original brick laying mortar (T3) (left) and repair brick laying mortar (T4) (right)

From visual layout of the existing original mortar T3 and executed repair mortar T4 nearly a perfect match is realized (Fig. 2). Both mortars include brick particles and white inclusions related to the binder part. On the other hand, a large difference is recognized in their chemical compositions with the insoluble part referring to the aggregate fraction, the amount of soluble SiO_2 originating from hydration products and the amount of CO_2 related to the calcium carbonate phases (Table 1). The insoluble part in T4 is considerably low because of presence of chalk and limestone powder which dissolve in HCl during wet chemical analysis. This gives higher fractions of CaO and CO_2 . Higher content of soluble SiO_2 in T4 repair mortar indicates higher degree of hydration reactions indicating pozzolanic reaction between brick particles and lime. This large compositional difference between T3 and T4 mortars is also observed in their XRD patterns with varying intensities of calcite and quartz minerals (Fig. 3). TGA results support these findings with large differences in CaCO_3 and CO_2

Intentional use of pozzolanic brick powder in T4 repair mortar for visual concerns has improved the mortar quality with a high structural integrity. However, together with the addition of limestone powder and chalk, this complex composition leads to vast different conclusions, as can be seen from the binder to sand ratio (Table 1). The low amount of soluble part together with the high amount of soluble CaO warns for partial soluble aggregates in the mixture that are wrongly interpreted as part of the binder fraction based on a wet chemical analysis solely. This has been verified by the particle size distribution before and after HCl attack on the aggregate fraction (Janssens and Serré 2010). Besides wet chemical analysis, XRD and TGA cannot retrieve actual composition of this type of T4 mortar without having information on the exact fractions of the components within the mix.

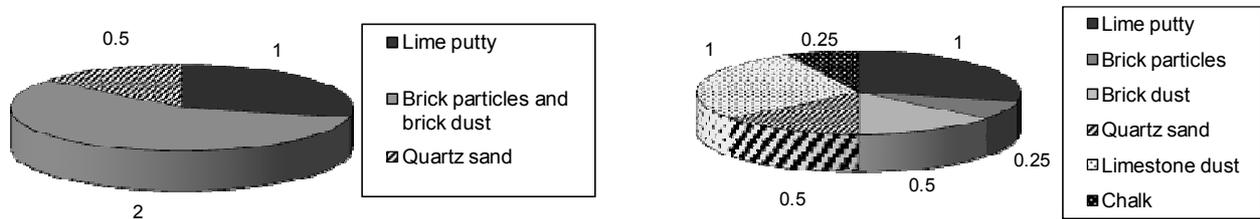
Figure 4: Compositions of the prescribed repair mortar (left) and executed repair mortar (right) of T4 (in volume fractions).

T4 is the prescribed repair mortar composed of lime putty, brick particles/dust and quartz sand (Fig. 4). However, the executed mortar composition was altered in fractions and in components by the restoration architect. The fractions of lime putty and sand were kept the same but that of brick particles/dust was replaced by chalk and limestone powder to duplicate white lime inclusions present in the original mortar T3, giving crucial information on how the binder was prepared such as the way lime was slaked (Fig. 4). These materials are not compatible with the original materials used and cannot be treated as the part of binder. These results clearly indicate that mortar composition of T4 was optimized by the restoration architect for aesthetical reasons to reach compatibility with the original mortar in terms of colour, texture and structure.

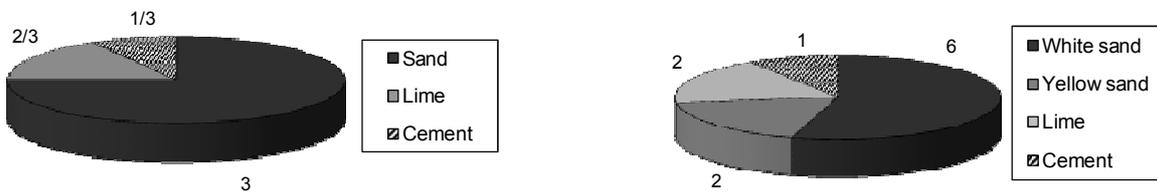
Figure 5: Compositions of the prescribed repair mortar (left) and executed repair mortar (right) of H2 (in mass fractions)

Similar conclusions are also drawn from the second case study. Chemical composition of H2 repair mortar differs from H0 original mortar composition with insoluble part, CaO content and CO₂ content. Although the original mortar is pure lime mortar, the repair mortar contains a small fraction (1/3rd of binder fraction) of cement together with lime to get a faster hardening and initial strength. Also in this case study the visual aspect was one of the major concerns for the restoration architect.

Sand fraction in the prescribed mortar composition was replaced with white and yellow sand to duplicate the visual aspects of the original mortar (Fig. 5).
