Structural Rehabilitation of Siad Hashim Historical Mosque in Gaza

Abstract Historical structures in Palestine are subjected to various types of damages due to natural or manmade causes that result in sudden destruction or progressive deterioration. “*Siad Hashim*” mosque has been subjected to progressive deterioration due to long neglect, abuse, environmental factors, inadequate design and construction, soil settlement, damping, growth of vegetation and other factors that led this structure to a critical condition. This paper describes the nature, cause, assessment and rehabilitation measures corresponding to existing damages. Recent rehabilitation carried out in the structure is also described, emphasizing the criteria and techniques adopted and the underlying studies and analyses. The repair and strengthening carried out to the mosque have not only succeeded in restoring its original conditions but also upgraded its ability to carry applied loads and actions satisfying current code requirements.

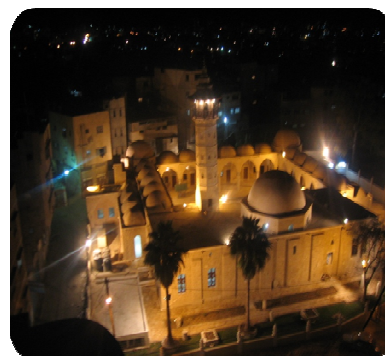
Figure 3: Photo of the mosque after rehabilitation

The structural rehabilitation needs for the mosque were determined based on the results of the structural analysis and the assessment of existing damages. The structural damages in the mosque included wrong interventions, stone deterioration and crushing, cracking of wide thickness in all types of the structural elements, minaret tilting and vertical misalignment, separation between different construction members, e.g. between walls, walls and slabs, etc., vegetation growth in the stones, splitting of column capitals, damp infiltration to the stones and corrosion of steel plates used to connect the minaret stones. A summary of damages, wrong interventions and carried out repair works in the mosque are presented in table 1 to table 3. Each table is concerned with one element type of the mosque; i.e. external walls including foundation, internal walls and roofs and minaret, respectively. The photo in Fig. 3 shows the mosque after rehabilitation.
