## "Respecting the Diversity"

### The Timber Roof of the "Cannons Loggia" in the Thun Castle (Italy)

MASSARI Giovanna A.<sup>1, a</sup>, RIGGIO Mariapaola<sup>2, b</sup> and GADOTTI Francesco<sup>3, c</sup>

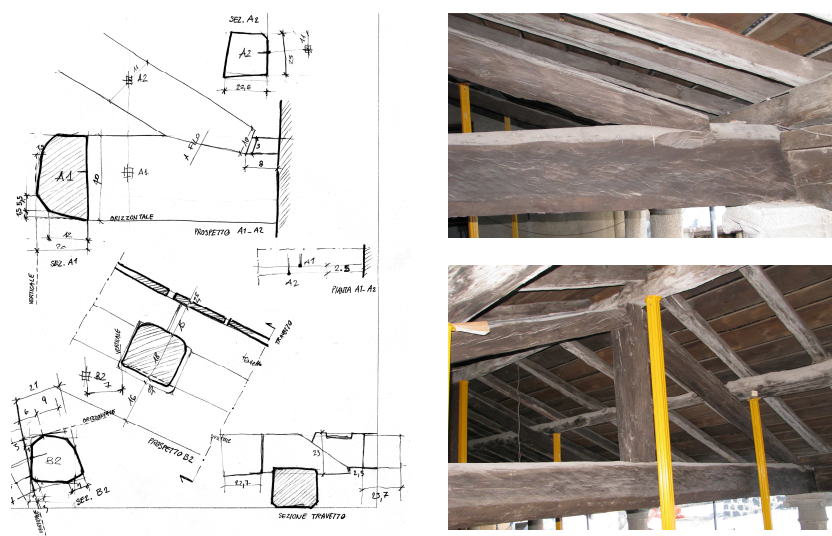
*Figure 4: Truss T03 - Sketches on site and photographs*

The architecture of the "Loggia" corresponds to the military and defensive character of the fabric: there is no room for ornamentation. The colonnade is composed by ten unfluted stone columns and two engaged columns at the end, which rest on a rustic stone basement and bear a wooden architrave. The wood roofing system consists of ten timber trusses spaced at the mean distance of 4.10 m and spanning 8.50 m. The principal rafters support one purlin at each slope. The trusses rest on the one side on the wooden architrave, on the other side, directly on the masonry wall, without the interposition of wall plates. Tie beams are tenoned to the architrave plates. The rafters are connected to the tie beam and to the post with plain butt joints assembled with nails; some rudimental birdsmouth joints are also present, but in most cases the abutment is insufficient to let the joint properly work (Fig. 4). The lower end of the post is tenoned to the tie beam; iron straps are occasionally present.

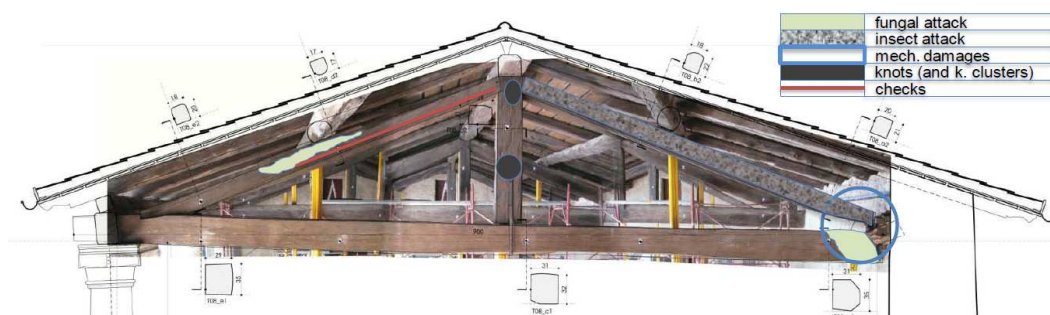
Figure 5: Thematic map –Truss T08-front east

Local mechanical damages were found, where decay already reduced the resistance of the material. In winter 2009, the high and protracted snow load on the northern pitch caused the rupture of the tie beam in a truss, at the interface with masonry, where rot already reduced the resistance of the connection (Fig. 5). Failure propagated with the displacement of the truss members and the degradation of the connections. The connection of the trusses to the bearing wall is one of the most crucial points of the whole roof system, as evidenced by past repairs.

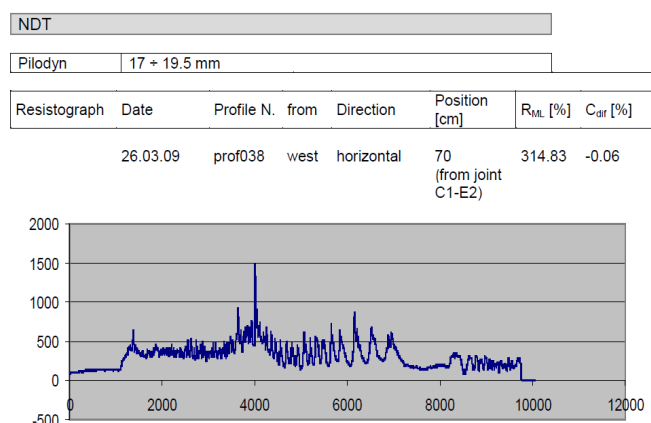
Figure 6: Thematic fiches T01

Biotic attack	fungi	local
	insects	present (House longhorn beetle) on intradox and west face locally, depth > 4 cm
Defects	Knots	Group of knots at the joint with rafter E2 and at the extradox
	splits	Present, max depth 7 cm on the west face
Damage other	Slope of grain 1:14	
MC	average: 17 [%]

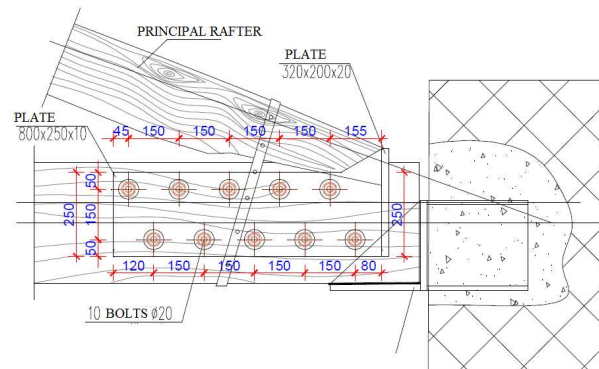
The basic form of the truss used in the Loggia is the king-post truss without struts, which is more appropriate for small spans. The structural form and the presence of poorly proportioned members resulted in large deflection. Deformations, breaks and kinematic movements are also consequent to the incorrect execution of the joints, which produced a not homogeneous distribution of the stresses. Discoloration on timbers and local wet areas are evidence of localized hollow of the pitches with stagnation of rainwater. The lack of templates and wall plates and the eccentricity of the joint connecting the rafter and the tie beam caused the presence of shear stress at the tie beam tail, between the joint and the wall and bending stresses on the masonry wall. This stress state is particular dangerous, especially if coupled with the decay of the eaves, due to moisture stagnation in the built-in portions of the tie beams. The truss failure was caused by a combination of these factors. The outward thrust produced by the roof, after the tie beam failure, caused the southern support to spread. Kinematic movements have been developed also in the adjacent structural systems.

Figure 7: Strengthening of the birdsmouth joint and of the connection with the masonry wall

In this case the most satisfactory approach to repair was to change the structural behaviour to the more normal sequence of load transfer, by introducing punctual and reversible elements, which could be at the same time compatible with and distinguishable from the original structure. Steel templates with neoprene pads have been designed to center the load from the northern joint and transfer it to masonry. Teflon plates at the interface between tie beam and column provide a roller at the southern support. The reinforcement of the two heel joints have been designed so that axial forces are transmitted from the rafter to the head of a steel plate inserted into the tie beam end and then from the plate to the tie beam by means of bolts (Fig. 7). The addition of timber struts propping the rafters, directly under the purlins, avoid bending into the principals. Substitution of members has been proposed only for those elements that were severely and extensively degraded.
