## Geotechnical Aspects of the N1 Tower, Prasat Sour Prat, Angkor Thom, Cambodia

**Abstract** This paper presents a case study of foundation of an inclined independent masonry tower in Angkor. One of the Prasat Sour Prat towers had been dismantled before reconstruction for conservation. The foundation was inclined as the same as the upper structure of the tower and spreading outwards. The inclination was considered caused by foundation failure with some differential settlements of the ground. During dismantling, the soil layers exposed on the trenched section were found rather horizontal than the inclined state that had been expected. Laterite blocks of step slope stones was found to have slid down along the soil mound of the foundation. The mechanism might have been caused by weakening of soil strength by wetting ground. Without dismantling, the real mechanism of the inclination was never known as well as the corresponding counter measures.

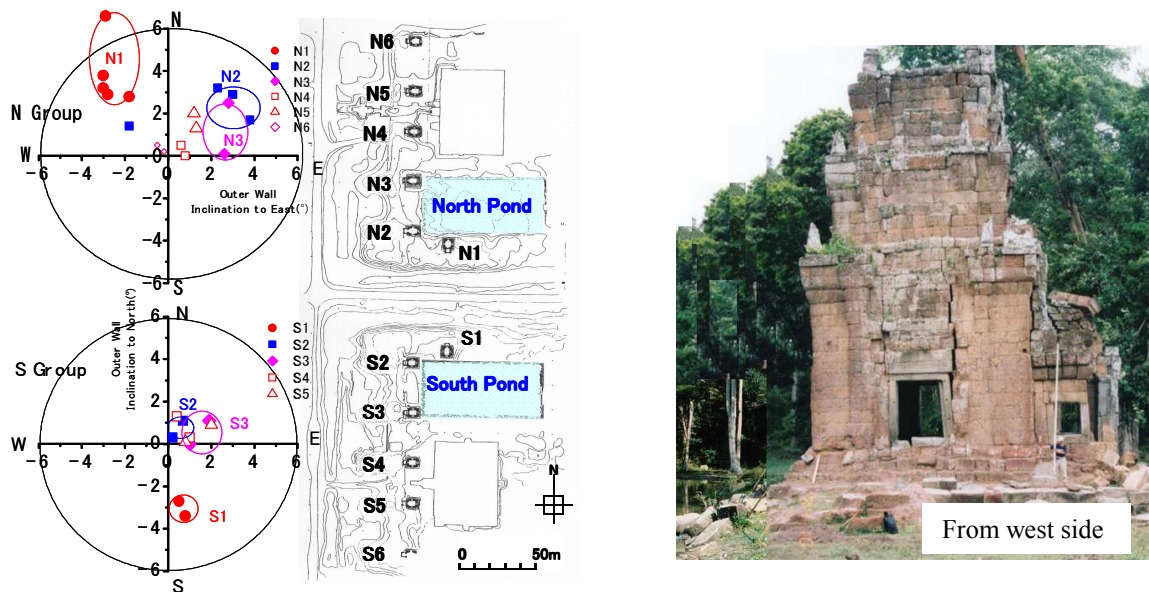
Figure1: Prasat Sour Prat, inclination of wall of the towers and N1 Tower of Prasat Sour Prat

shown in Fig.2 except S6 that was failed down and impossible to measure. In general, the directions of inclinations are within a few degrees towards eastwards except two towers of N1 and S1. N1 has inclined towards northwards and S1 towards or both for pond nearby (JSA 1997). The Tower N1 showed the largest inclination of 4-6degrees and JSA began conservation work for the N1 Tower.

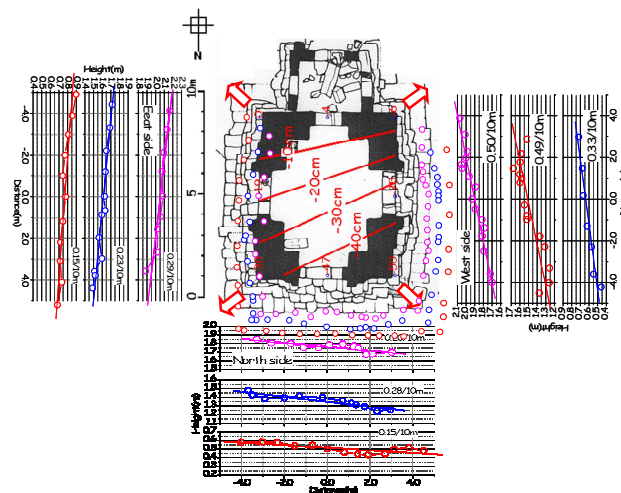
Figure 2: Inclination of blocks of step of the foundation of N1 Tower

**Inclination of the Steps of the Foundation** The height of the surface of steps blocks was measured (JSA 1995) and plotted in Fig.2. The average angles of the inclinations for east, north and west faces are calculated ranges from 15-50cm/10m. The maximum inclination was top step of the west face of 50cm/10m, which is about 5.7 degrees northwards with the same order of that of the outer walls of the N1 tower.

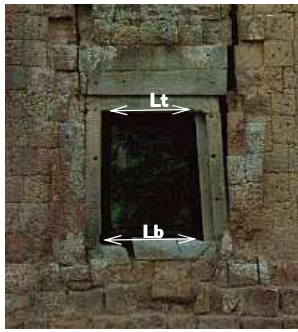
Photo: 3 Window frame (west side)

**Widening of the Bottom Space Distance of the Window** There is a window for each wall of the tower. The horizontal space distance at the bottom between the frames was found wider than those at the top as shown in Photo 3. The measured distances are listed in Table 1 and the widened ratio was 6-8%.

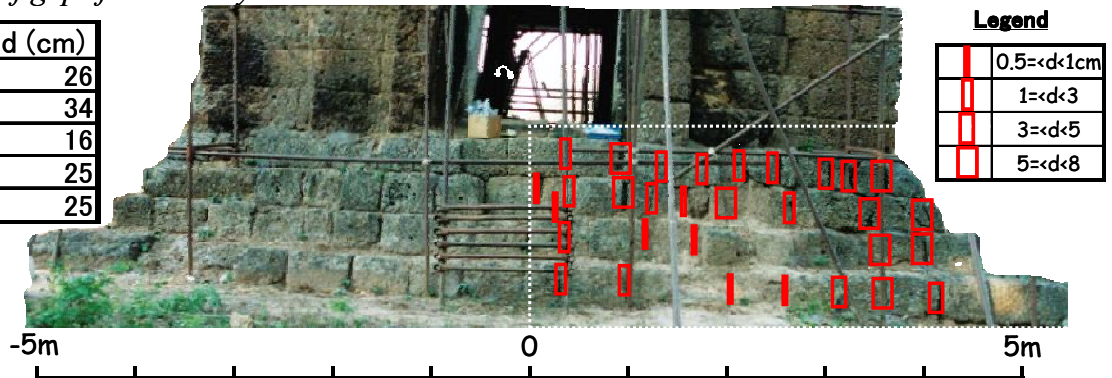
Figure 3: Gap distribution of step blocks at north of east face of N1 Tower of Prasat Sour Prat

**Lateral Spreading of the Block of Stepped Wall Foundation** Gaps were noticed between the blocks of step slope of the foundation. Typical example of step blocks of east face is shown in Fig.3. The gaps of northern side are marked with four different widths as legend in Fig.3. The widths of the most gaps are less than 3-5cm. The gaps are distributed more or less in random manner.

Table 1 shows the summation of the widths for each step level. The averaged summation for four steps was 25cm. Since the half width of the foundation is about 4-5m, the horizontal expansion ratio was about 5-6% in average. Gaps in other sides were also recognized.

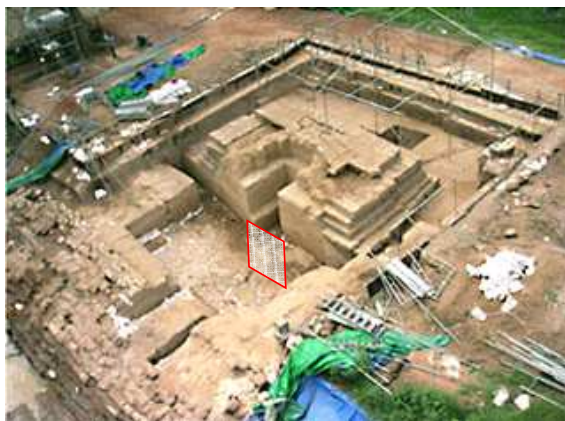
Photo 4: Excavated foundation soil mound

**Streak Lines** The vertical section of the soil mound beneath the foundation was exposed during the dismantling of the N1 Tower as shown in Photo 4. Many streak lines were recognized as in Photo 5.

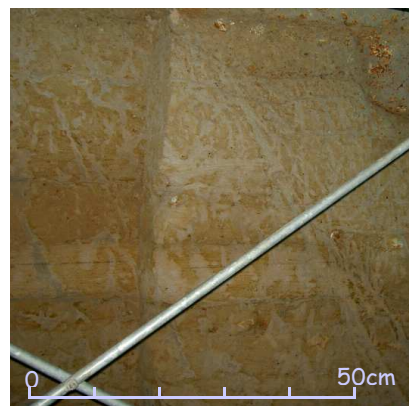
Photo 5: Streak lines on the trench section

The streak lines are whitish in color and softer than the surrounding soil with width of about 5mm. These streak lines were analyzed to obtain the distributions of the direction angles from the vertical.

Fig.7 shows the copies of the streaks on a trenched section and the distribution of the angle. The predominant angles was  $\theta = \pm 30$  degrees. It is very likely that these streak lines were shear failure lines that were caused by vertical compression stress from the tower structure. The internal friction angle of the sandy soils with the natural water contents was obtained as  $\phi = 30$  degrees that satisfies the relationship between the angle of failure line from the major principle direction and the angle of the internal friction of the ground.

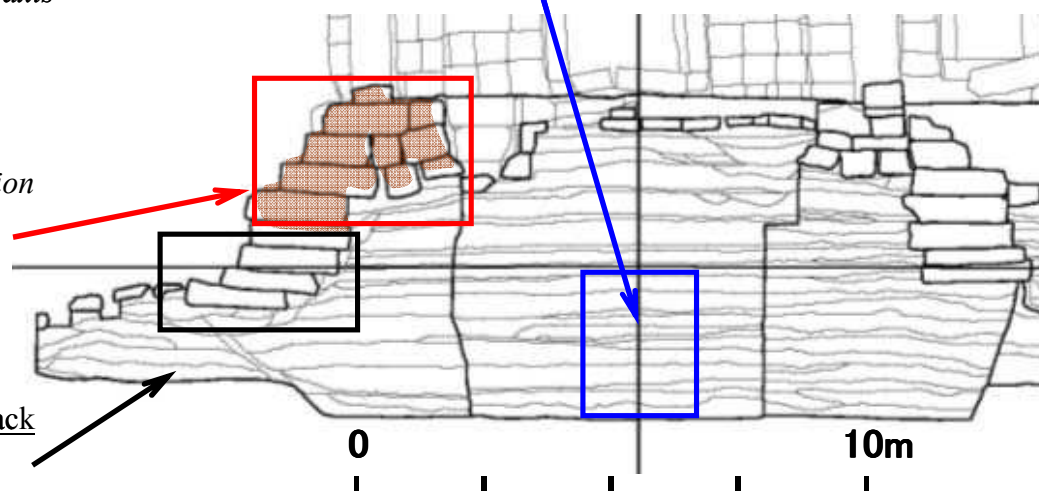
Figure 10: Laterite blocks of step slope

**Deformation of Step Slope** Fig.10 shows the vertical section of the soil mound beneath the foundation(Fukuda 2005). The compacted soil layer was found rather horizontal than inclined state that was expected by the deformations of the tower structure and the foundations. We realized that we had fallen in a pitfall of the difference between the speculation before dismantling and the exposed real section after trench. The speculation was based upon the experiences and the theory of geotechnical engineering. The pit fall was rather deep and not easy to be filled up. At the northend of the foundation mound, a step slope was found under a peculiar deformation as shown in Fig.10.

In Fig.10, it is clearly understood that the upper three laterite blocks at the outermost position were situated at lower height than the corresponding inner blocks. The compacted fill behind the laterite blocks was inclined outwards direction as shown in Fig.9 as well as Fig.10. Another deformation should be noted at the lowest part (rectangle in black, Fig.9) of the laterite block where the large downwards deformation of the ground was caused by probable bearing failure.

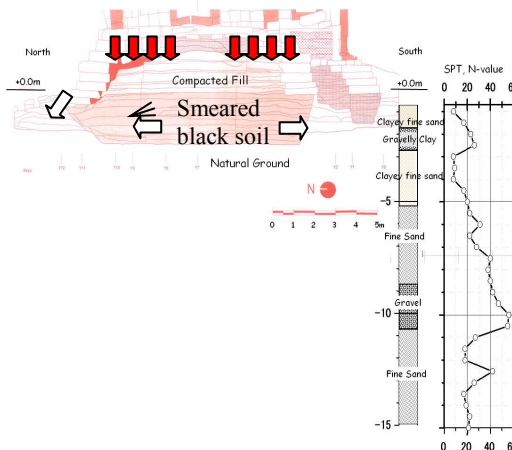
Figure 12: Foundation of N1 Tower and geotechnical condition

The streak lines indicate that the soil mound had yielded and vertical compression strain might have been larger than the horizontal expansion of 5%. Smeared soil in black color was found in the sheared zone beneath the sliding blocks of step stones as shown in Fig.12. The geotechnical conditions at 50m apart from N1 tower is also shown in Fig.12.

The soil underneath the compacted soil is clayey fine sand of SPT  $N=10$ . The soil was capable to support the load from the tower and may be classified as stiff clay or medium dense sandy soil.

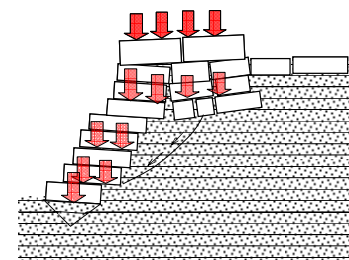
Figure 15: Stress redistribution

4. When the shear resistance was fully mobilized and the soil became weaken, the acceptable load by the soil decreased. The extra load that could not be supported by the ground was to redistribute to the adjacent step blocks. Load to the adjacent block was increased and transferred downwards.

5. The gradual redistribution of the load from the upper to the lower blocks caused to increase the load upon the bottom block finally resulted in bearing failure of the ground.

6. Thus, the process of wetting soil mound might have resulted in the plastic deformation of the soil mound and caused horizontal spreading as well as slip down of the step blocks along the mound slope to the northwards with no confinement of displacement. These stress redistribution and associated deformation is shown in Fig. 15.
