Restoration of the Tsar-Bell Pedestal in the Moscow Kremlin

Abstract The report contains brief historic and technical information about the Tsar-Bell as well as the structure of its pedestal and gives a detailed description of the instrumental inspection performed to assess structural state of the monument which included examination of the pedestal broad stone/brick masonry and metal fixing elements, check drilling and probing. The inspection results set up the basis for the restoration works.

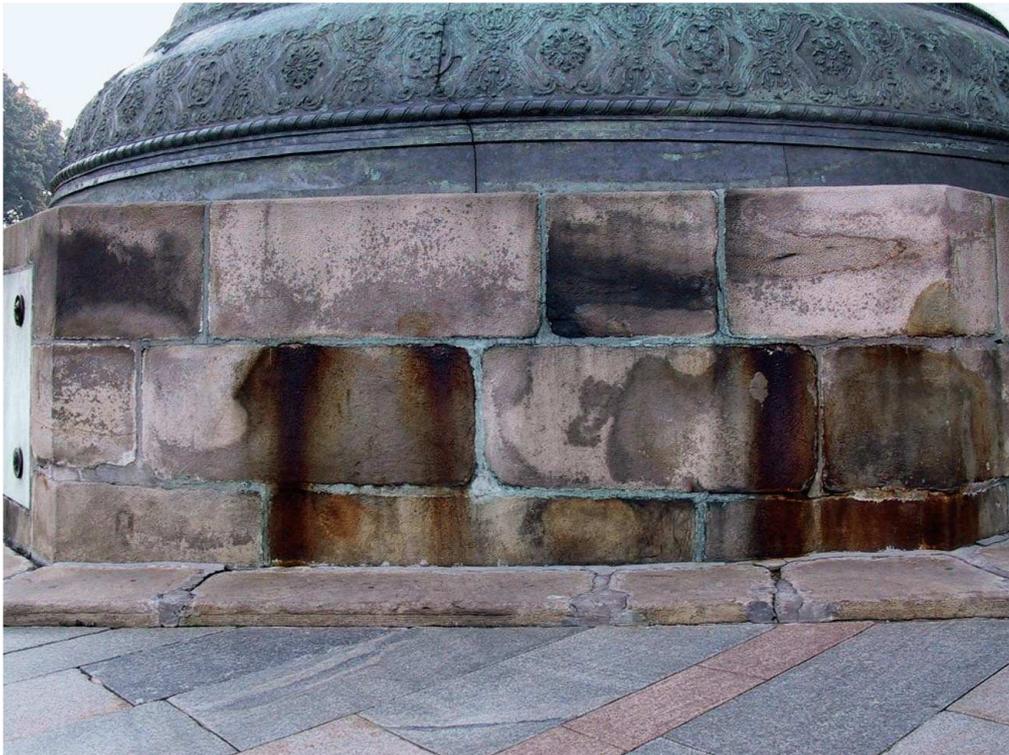
The necessity to accomplish thorough inspection of the pedestal with subsequent rehabilitation works was dictated by the actively propagating corrosion of both external and internal metal ties, surface deterioration of the brickwork and the material filling the joints between the stone blocks of the load-bearing belt. Traces of corrosion could be seen on the surface of the internal brickwork. Their repair could lead to cracking and deterioration of the external stonework. Besides, previous inspections showed that wooden piles under the foundation went rotten and in some parts became void and filled with soil (Fig. 2).

Figure 2: Pedestal prior to reconstruction

The results of our visual and instrumental inspections as well as the results of the previous inspections made it clear that actually the complex of rehabilitation works should include two stages: consolidation of soils under the pedestal foundation and strengthening of the foundation and the pedestal body (stonework and brickwork). Taking into consideration non-uniformity of the soil it was decided to make micro-piles under the foundation.

When choosing a particular technological scheme, we decided in favour of injections of hydro-active polyurethane foams which we used successfully for rehabilitation of other historical buildings and architectural monuments.

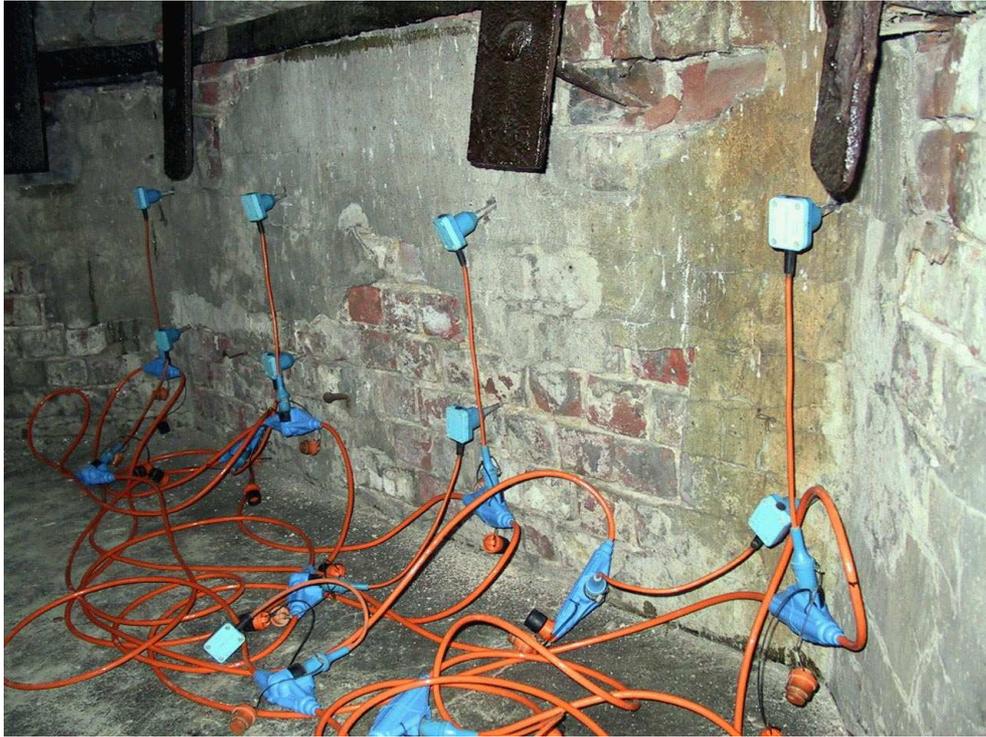
- non-homogeneity of the brickwork could be explained mainly by cyclic wetting-drying of the lime mortar in the joints till its complete softening at the contact with the load-bearing belt stones. The wetting action was aggravated by the absence of any kind of sealing between the bell edge and the pedestal surface which could eliminate water seepage through the masonry joints and accumulation of precipitation inside the pedestal as well as by the absence of a peripheral drainage system (Fig. 3).

Figure 3: Instrumental inspection (acoustic probing)

As mentioned above, accumulation of precipitation inside the pedestal as well as absence of external water drainage system leads to excessive wetting of the structure. To eliminate negative consequences we proposed a horizontal drainage system with a filtering pit located under the sandstone floor plates. Outside the pedestal drainage pipes were laid under the external stone pavement with the outflow into the existing storm water sewer.
