The Structural Analysis of The Historical Constructions of West China Campus-Sichuan University

LUO L L^{1,a}, XIE Z T¹, WU T¹, WANG Y W¹, XIAO C B¹ and LING C J¹

¹Sichuan Institute of Building Research, Chengdu, China

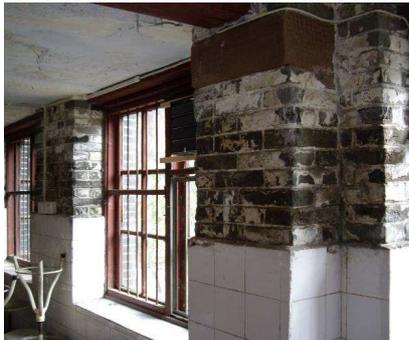
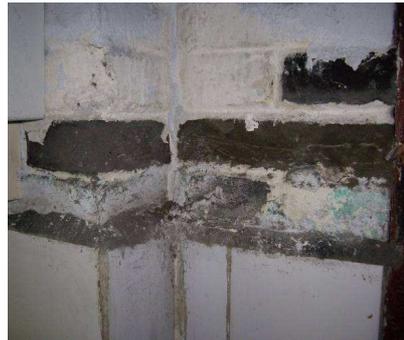
Parts of this building's wall are damp: plaster gets hollowing, efflorescence and shedding, surface of the flashed bricks are moist and efflorescence. Vertical and oblique cracks appear in the corner of some windows and under window sills. After taking off plasterer coat, we observed that brick wall cracks. U-crack appears in the top of brick arches of many doors and windows. Top brick lintels of few arches are broken and caving. Oblique cracks are observed in the joints of few pillars. Photos are showed as follows:

Figure 1: Damp and saltpetering on the surface of wall

- (1) Reinforce unqualified walls;
- (2) Reinforce cracked walls and brick arches;
- (3) For effloresce and decay walls, clean off superficial rotten parts first, then coat proper protective materials according to exterior decoration.
- (4) For the rotten, wormed or damaged timber members, replace with new ones.

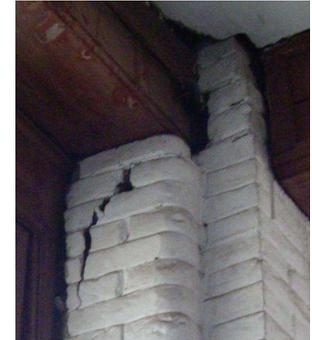
Oblique crack in the top of pillar

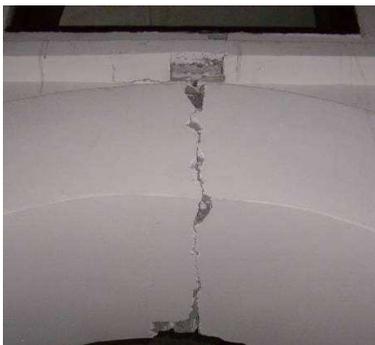
Figure 2: Crack on top of brick arch Broken top of brick lintel arch Vertical crack in the joint of walls

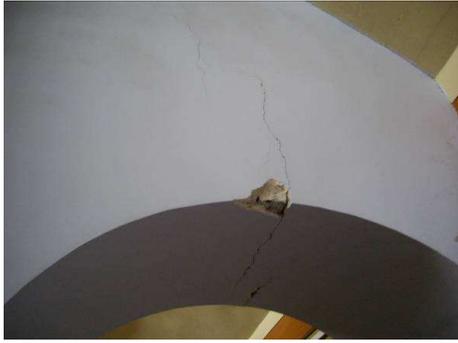
Parts of the building's wall are damp, plaster gets hollowing, efflorescence and shedding, surface of the flashed bricks are moist and efflorescence. Vertical and oblique crack appears in the corners of some windows and under window sills, maximum width of the crack is about 1.5mm. U-crack appears in the top of arch of doors and windows on the 1st and 2nd floor. After taking off plasterer coat, we find some arch crack extend along the vertical mortar gap, a few brick crack width reach 2.5mm. Photos are showed as follows:

Figure 3: Arch vertical crack

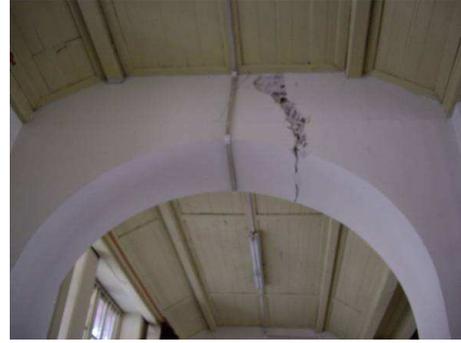
Arch vertical crack

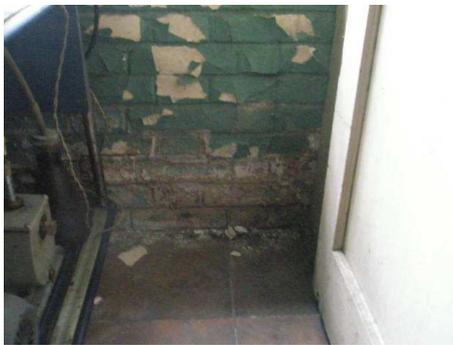
Part of this building's walls are damp, plaster gets hollowing, efflorescence and shedding, surface of the flashed bricks are efflorescence. Crack appears in parts of wall, maximum width of the crack is about 0.35mm. Crack appears in part of top arch of doors and windows. After taking off plasterer coat, we find some arch crack extend along the vertical mortar gap, a few brick crack width reach 0.3mm.

Figure 4: Wall damp and effloresce

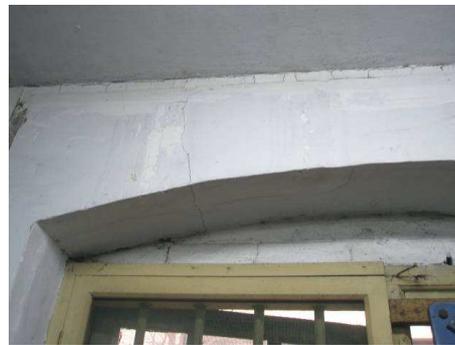
Arch vertical crack

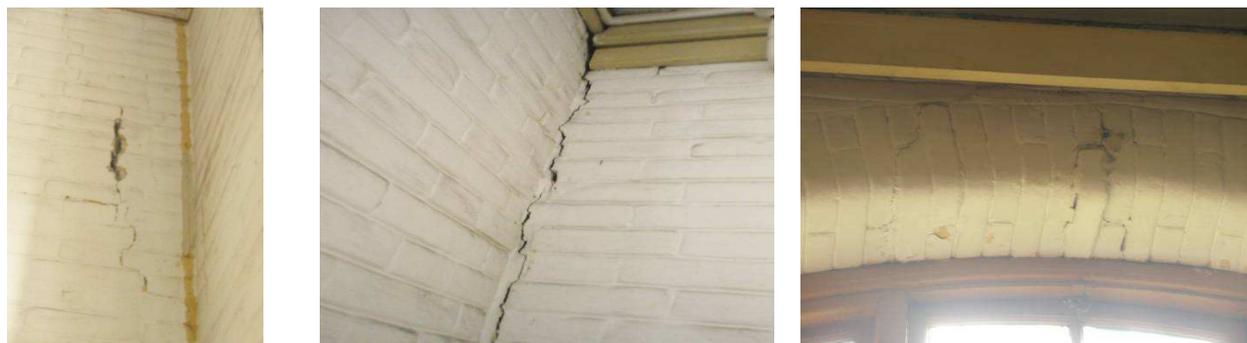
Parts of this building's wall are damp: plaster gets shedding, surface of flashed bricks is efflorescence. Vertical crack appears in some joint parts of wall. Crack appears in part of top arch of doors and windows, and maximum width of the crack is about 0.30mm.

Figure 5: Wall crack Vertical crack along juncture of walls Arch vertical crack
