The Case Study of Santa Maria Paganica Church Damaged by 2009 L'Aquila Earthquake

Abstract Santa Maria Paganica Church, built in the second half of XIII century, represents one of the most important church for L'Aquila history (being the second so-called "capoquarto" church). During the centuries, due also to the damages suffered by various earthquakes, important structural modifications, which are decisive for the interpretation of the seismic response, followed. In particular, as a consequence of L'Aquila earthquake (April 6, 2009), severe collapses interested the church, which in particular occurred in: the dome and dome cladding, the whole roof (with exception of apse), the upper part of the lateral wall on left side, the gable of façade. Several vulnerability factors facilitated the collapse of these portions, in particular: the constructive precariousness of nave's masonry walls; the asymmetric transversal stiffness on the two opposite sides of nave; the replacement of the original roof. In the paper, starting from the analysis of the constructive details and the subsequent transformations which interested this church, the interpretation of its seismic response will be discu

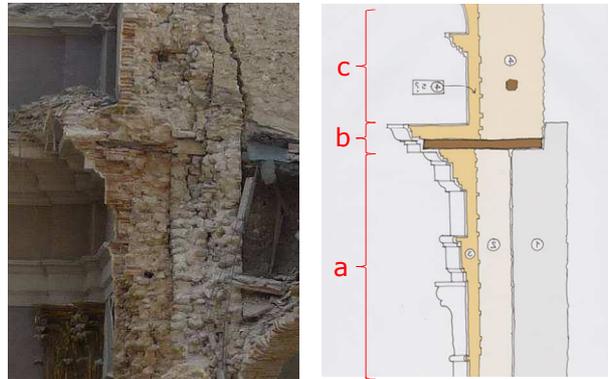
In particular, the longitudinal sections of lateral walls highlight a set of subsequent transformations which are distinctly ascribable to the different - above mentioned - historic phases. As shown in Fig. 2, it is possible remarking three portions which are characterized by different features. The lower portion of section (quoted as *a*) is composed by two panels not coupled (made on hewn stone masonry): presumably, the external panel corresponds to an enlargement of transversal section due to the baroque raising up of church. At level of the cornice (quoted as *b*), passing from lower to higher portion, a wooden element represents both overhang for this artistic asset and base for the upper panel, stressing the discontinuity between these two structural portions. Finally the upper part (quoted as *c*), ascribable to the baroque raising up of church, is composed by a hewn stone masonry panel: moreover a wooden element, lined up in the masonry wall (as testified also by bolts visible in façade), was introduced (see also Fig. 3). In case of both *a* and *c* portions, a further cover, made by brick (ascribable to the baroque transformation), is placed against the internal panel by slight toothing. Of course, it is evident as all these subsequent transformations, coupled to a poor quality of connections, stress the constructive precariousness of nave's masonry walls.

Figure 2: Masonry nave walls: constructive details of longitudinal section

Finally, further issues concern both the strengthening of masonry wall on right side and the reconstruction of that on left side. As stressed in constructive details analysis, particular attention should be paid to the precauriouness due to a poor connection between panels.

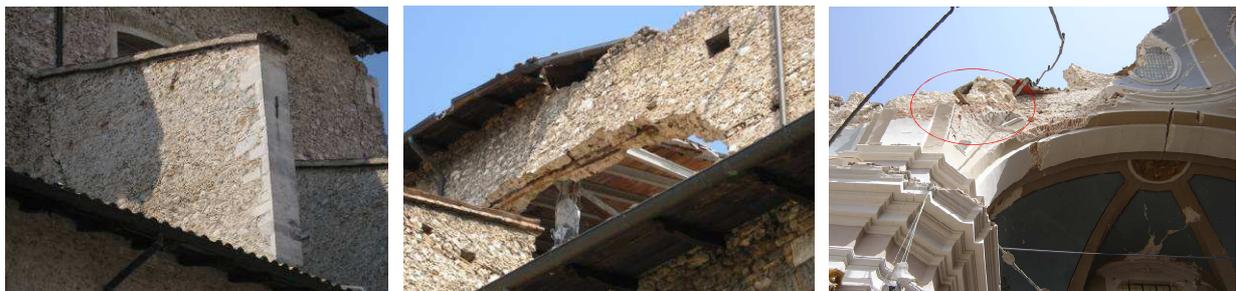
With reference to other structural elements, the dome, apse and transept vaults, built in the baroque phase, were made by brick masonry, whereas that of central nave was a wattle vault. In case of triumphal arch which support the dome, it is important noting a poor scarf in correspondence of tower side due presumably to the different masonry types. In particular in case of dome, it is worth noting the presence of wooden elements arranged at 45 degrees at the base of arches (see Fig. 3). Actually, the insertion of these elements, noticed also in case of transversal masonry walls and in buttresses, is typical of the constructive rule-of-art of L'Aquila (post-1703).

Figure 3: Insertion of wooden elements in: buttresses, transversal walls and at the base of dome arches (from left to right)

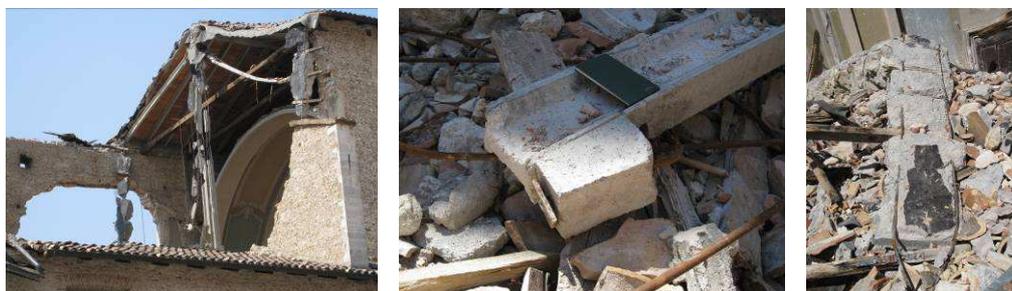
The roof, as previously mentioned, was made by a mixed masonry-reinforced concrete structure: in particular it was composed by prefabricated trusses (like as the “Varese” type) and steel tie-rods with brick flats and heavy concrete slab. Some details are shown in Fig. 4.

Figure 4: View of reinforced concrete roof after the mainshock on 6th April 2009 and of some constructive detail

Finally, with reference to issue c), in addition to the increasing of seismic loads due to the weight of the masonry-reinforced concrete roof, it is justifiable that the significant vertical component recorded in L'Aquila earthquake induced a relevant increasing of the force acting on tie-rods promoting their sudden collapse. Moreover, also the effectiveness of connection between r.c. tie-rods and masonry walls poses some crucial issues.

With reference to the roof reconstruction, particular attention has to be paid both in order to avoid a strong seismic loads increasing and to improve the connection with the masonry walls.

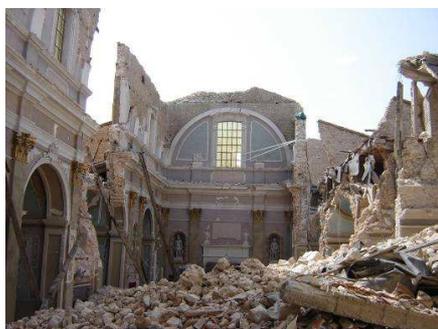
Due to L'Aquila earthquake (April 6, 2009), severe collapses interested Santa Maria Paganica Church (as shown in Fig. 5), which in particular occurred in: the dome and dome cladding, the whole roof (with exception of the apse), the upper part of the lateral wall on left side, the gable of façade.

Figure 5: Damage internal overview of Santa Maria Paganica Church

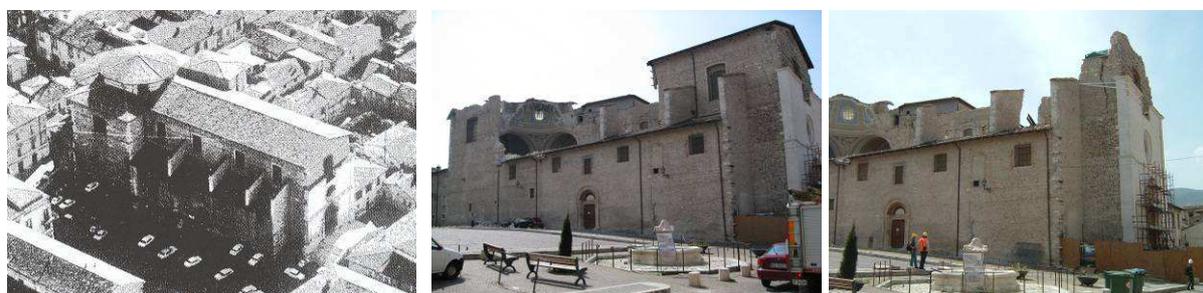
Indeed, the actual damage state has been reached by two subsequent phases (see Fig. 6): in particular, after the main shock of 6 April, a roof portion lived on, then the subsequent shocks caused the disastrous worsening of actual damage pattern.

Figure 6: View of Santa Maria Paganica Church (from left to right): historic view before the earthquake; damage state after the main shock; damage state reached after subsequent shocks

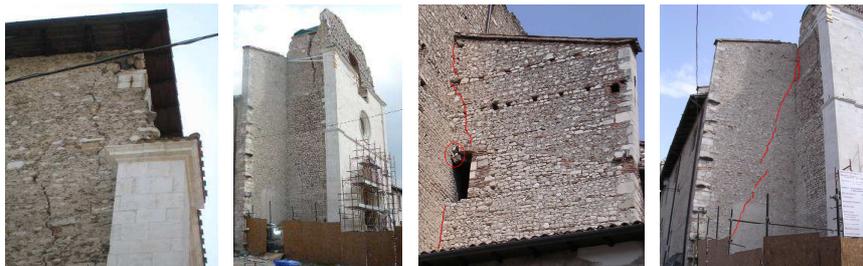
Figure 6: Details on the damage pattern associated to façade overturning (left, before and after the main shock) and to the transversal nave's response (right)

With reference to issue b), in addition to the asymmetric restrain (which seems explain also the heavier damage occurred on left side) offered to the transversal nave's response, it is worth noting the difference between actions oriented towards outside or inside. In fact whereas outwards it was possible count on the effectiveness of buttresses, inwards only the wooden tie aligned on buttresses and the r.c. struts of roof (which replaced the original wooden trusses) could offer a poor restrain to the out-of-plane response of nave's walls. This supposal is confirmed by the collapse occurred towards the inside and by the orientation of some cracks occurred in buttresses.

With reference to the weaknesses highlighted on the transversal nave's response, after having verified the actual effectiveness of buttresses (verifying the need of increasing their section and improving the connection with the nave's walls), the seismic response towards actions oriented inward has to be improved. Regarding this, firstly it seems important improving the flexural stiffness of masonry portions between two adjacent buttresses; as an example, possible strategies should be the insertion of light tie-rods or steel flats posed on two side of masonry panels connected by bars. This latter solution seems particularly attractive since it allows to both overcome difficult issues related to the anchorage to masonry and reduce the effective height of wall. Secondly, in order to improve the inwards out-of-plane walls response, the structural system founded only on buttresses effectiveness seems inadequate: thus in addition to the improvement of the connection between buttresses and nave's wall (as an example by replacing wooden ties by steel elements), the introduction of further structural elements seems necessary. In particular, a possible solution is that of inserting internal transversal arches in correspondence of buttresses.
