Structural Restoration of Historical Constructions Built with Gypsum Pillars and Floors for New Standards of Living

Abstract: Tía Cayetana's inn is an old road motel erected at the end of the 19th Century at Torrebaja (Spain). This inn was built using local vernacular construction techniques, i.e., with a structure made of gypsum pillars, and floors built with beams and gypsum vaulting. The facades and interior walls were built in a combination of stone masonry for the basement and either rammed earth walls or thin stone slabs wall for the upper parts. The local city hall bought the building and entrusted the rehabilitation of the building to the authors of this paper for its future use as a four-star hotel, i.e., the same use for the building more than one hundred years after its original completion. The authors of this paper made an exhaustive study of the fabrics of this building, its construction, material pathologies... and, taking into account these data, elaborated the restoration project for the building that previewed the use of the same original structure made of gypsum to be reinforced with compatible techniques. This article introduces the analysis of the local constru

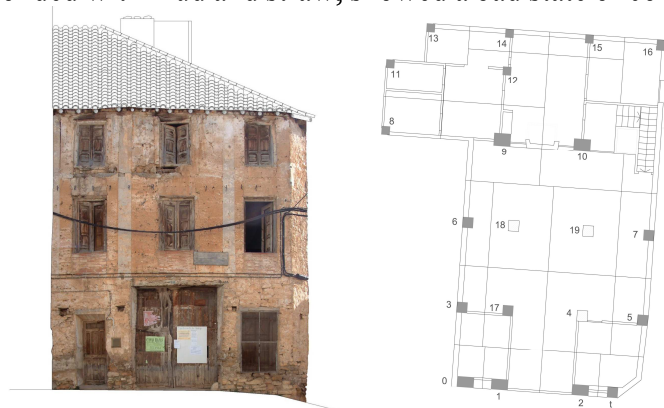
conservation. Nevertheless the rain has washed some of the mud mortar away. The upper floors' façades are built mainly with stone slabs vertically set bonded and slightly coated with gypsum, and there is also a small part built with rammed earth (Fig. 1a). They are in good condition although show lack of maintenance and need of small repairs. Wooden beams and joists that form the floors were affected in some degree by rot because of water infiltration. Being built with gypsum, floors' jack vaulting was also weakened by water. Indeed, the roof, built with pine wood beams and purlins, reed and curved tiles bonded with mud and straw, showed a bad state of conservation, with plenty of leaks.

Figure 1: a. Façade previous to restoration. b. Ground layout with existing and added pillars

Therefore, it may be considered that the self-weight has increased 2.00 KN/m², and the overload 0.50 KN/m². Three new pillars n. 17, n. 18, n. 19) have been inserted in the restoration project in order to reduce the excessive span of 8 m of some of the existing beams and, simultaneously, to reduce the load surface area of the adjacent pillars (Fig. 1b).

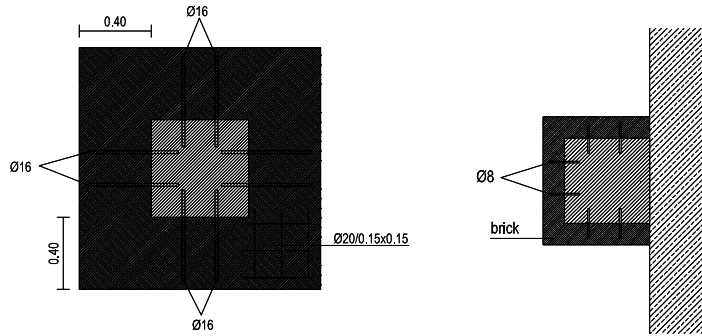
Figure 2: Enlargement of structural elements. a) Section of peripheral pillars. b) Foundations

Pillars that increase their section. Besides, some of the peripheral pillars, either with smaller load areas like n. 7 or the same load area like n. 5, whose strength could be already justified with the previous two explanations, have been anyway reinforced increasing their section with anchored brick masonry as shown in the drawing (Fig. 2a) in order to give better support for their respective beams, reducing simultaneously the stress on them.

been surrounded by a rectangular ring of reinforced concreted 40 cm wide, connecting the former and the new foundation through corrugated iron bars 16 cm diameter in each of the four faces (Fig. 2b).

The surface area of the historical foundations was $0.40 \times 0.40 = 0.16 \text{ m}^2$. The new surface area of the reinforced foundations is $1.20 \times 1.20 = 1.44 \text{ m}^2$. Therefore, the contact surface with the ground has been increased up to 9 times, so that the pressure on the ground has become 9 times smaller.

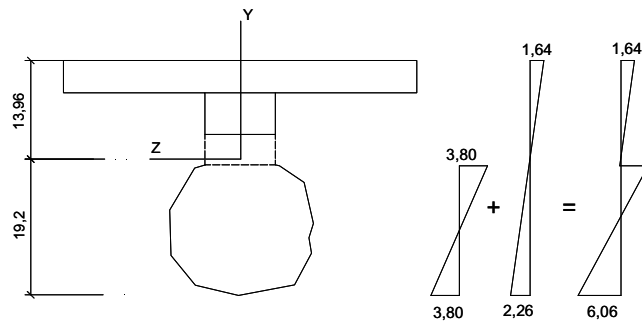
The final estate of the joists in the reinforced floor and its maximal stress is as follows (Fig. 4a):

$$\sigma_{m,d} = (3,80 + 2,26) \times 1,44 = 6,06 \times 1,44 = 8,73 \text{ N/mm}^2$$

Figure 4: a) Reinforced joist's stress under service, b) Reinforcement of the floors under construction

Thus, the calculation stress has been reduced a 70% [8.73 N/mm² in front of 12.77 N/mm²] in the final situation compared with the original floor.

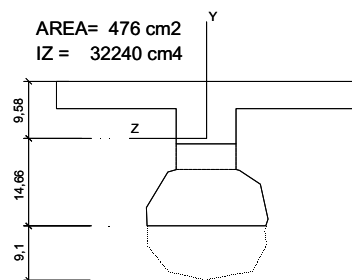
Figure 5: a) Joist's carbonization previewed depth, b) Reinforcement of the floors coming to an end

Stability against fire. Given a required fire resistance of 120 min, the carbonization depth (UNE ENV 1995-1-2. Eurocódigo 5) in this case would be: $K_0=1$ and $\beta_n=0,7$ mm/min. The effective definitive depth = $0,7 \times 120 + 7\text{mm} = 42 + 7 = 91$ mm. With this condition the resistant section of the reinforced joists has the following parameters (Fig. 5a):

With this values, the comprobation of the resistance against fire results in an acceptable behaviour against fire with a generous security gap (stress after the loss of material by fire 5.11 N/mm²)
