## **Cultural Heritage Buildings and the Abruzzo Earthquake: Performance and Post-Earthquake Actions**

**Abstract** The architectural heritage was seriously hit by the earthquake that occurred on April 6<sup>th</sup> 2009 in the Abruzzo region, especially considering the effects on a city with the size and with historical and strategic importance as a capital of a region, L'Aquila. The activities to protect that heritage have been centralized in the structure "Protection of Cultural Heritage" at Di.Coma.C. (Command and Control Quarter), managed by the Civil Protection Department. This allowed the cooperation among different involved subjects (Ministry of Cultural Heritage officers, experts on structural engineering from Universities and Fire Brigade teams), with their own specific knowledge. Keystone of the operating process was the standardization of the damage survey and of its immediate and correct interpretation, through dedicated survey forms for churches and palaces. The experience in the field of temporary safety measures was extremely interesting: ideas for engineering the process were developed, in cooperation with the work of the fire brigade men, that are highly experie

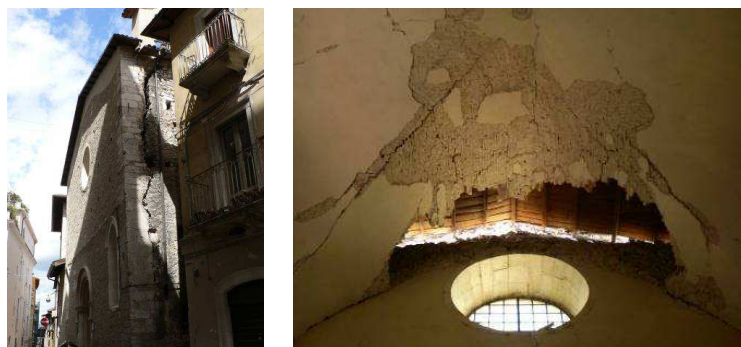
The systematic collection and data-processing of the damage survey forms will be followed by general considerations on the behaviour and specific vulnerabilities of the different building typologies. An initial analysis, carried out on a series of churches surveyed by the University of Padova during the first three months of activity, is given by (Costa 2009) and (Modena and Binda 2009). This analysis showed how the façade (Fig. 3 left) and the overhanging elements represented the main vulnerabilities of this building typology, according also to (Doglioni 1994). A high level of damage associated with high levels of activation (greater than or equal to 3 on a scale from 1 to 5) was also obtained for mechanisms related to vaulted elements (Fig. 3 right), which typically have high intrinsic vulnerability, often worsened by the constructive technique, resorting on the use of sailor brick masonry.

*Figure 3: Out-of-plane overturning of the façade, church of San Giuseppe dei Minimi in the historical centre of L'Aquila (left), and collapsed vault, church of Santa Maria del Soccorso in L'Aquila (right)*

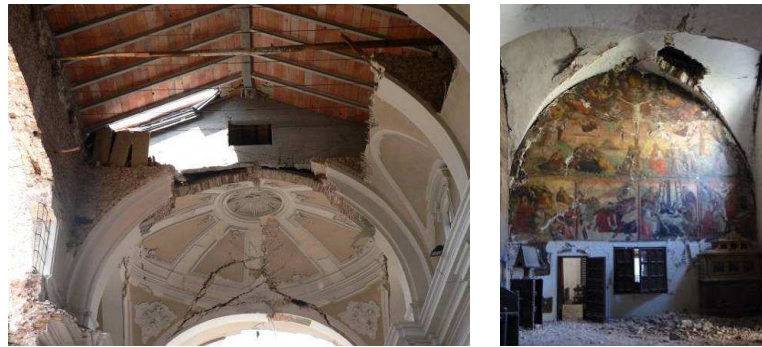
The effects of the wrong use of reinforced concrete are clearly evident (Fig. 5 left; Figure 17 above), in particular the replacement of wooden trusses in the roofs, and the substitution of timber floors, with reinforced concrete trusses and gables or reinforced concrete slabs and hollow tiles.

Another intervention very often observed is the removal of the tie rods connecting orthogonal walls: emblematic examples are the Spanish Fortress and the Church of Beata Antonia (Fig. 5 right), both of great historical and artistic importance.

*Figure 5: Inside view of San Marco's church (left) and of Beata Antonia's church (right) in the historical centre of L'Aquila: in the Beata Antonia's church the Fire Brigade provisional interventions repositioned the removed tie rods*

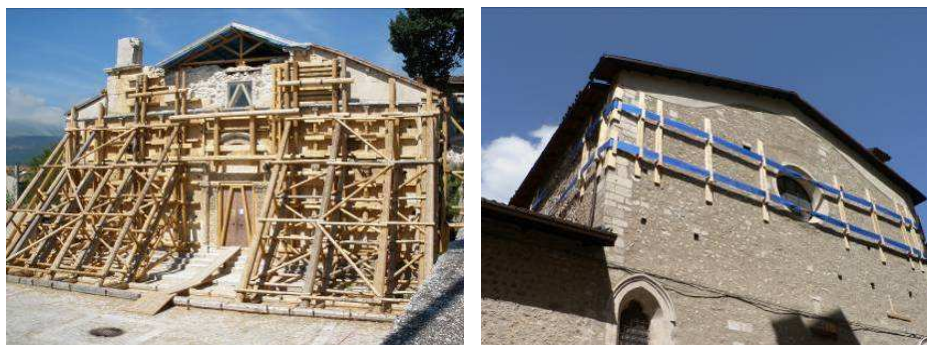
The most widespread provisional interventions are those referring to the so-called first-way mechanisms, i.e. out-of-plane overturning of walls. These mechanisms are characterized by a load multiplier value which activates the mechanism, and then determines the collapse of the element, which is smaller than that of second-way (in-plane) mechanisms. These latter rarely evolve until the total collapse of the element. The provisional interventions to hinder overturning mechanisms of façades and perimeter walls can be performed in two ways: through traditional propping systems using wooden poles (Fig. 7 left) or by tying with steel cables or polyester bands (Fig. 7 right). These two interventions correspond to different structural approaches: the first is intended to partially restore the stiffness of the structure; whereas in the second approach, bands (or ties) elastically connect the various stiff masonry blocks, defined by the activation of seismic damage, which form the kinematic chain (Bellizzi 2000, Bellizzi et al. 2001, Dolce et al. 2002).

*Figure 7: Propping of the façade of Santa Giusta church in Bazzano (left) and polyester bands on the façade of San Giuseppe dei Minimi's church in the historical centre of L'Aquila (right)*

The preference given to the second method is determined by the considerations set out above. First, road practicability: interventions performed with traditional props imply that a large portion of ground surrounding the building is to be occupied, thus preventing the passage. In addition, the dense series of props need to be removed to carry out the final repair works. Interventions performed with bands or ties do not occupy the ground space and are minimal for the structures. In addition, their application and subsequent removal is faster. However, the use of polyester bands is based on the assumption that the façade is not disassembled, and forms a clearly defined rigid rotation mechanism. From a structural point of view, an intervention with bands or ties connects rigid blocks identified by cracks due to earthquake. The damaged structure has a lower overall stiffness than before the earthquake, and

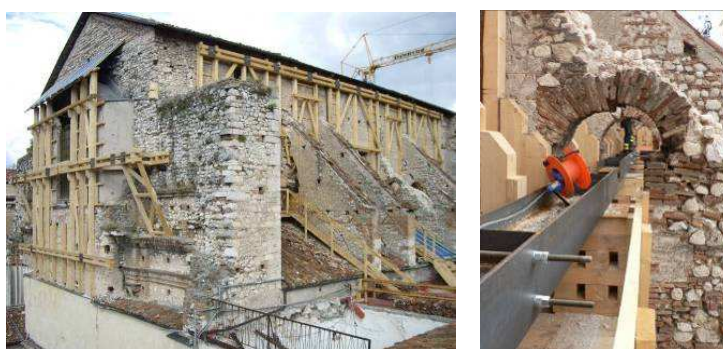
*Figure 8: Intervention on Santa Margherita's church in the historical centre of L'Aquila*

As an example, two main mechanisms were identified in the church of Santa Margherita: transversal response of the nave and overturning of the apse. Two separate interventions were thus carried out. The side walls were connected by metallic wire ropes anchored to a steel counter beam placed in the upper part of the walls, in correspondence of the vault (Fig. 8), the apse was connected by metallic wire ropes to the walls which separate the nave from the lateral chapels.

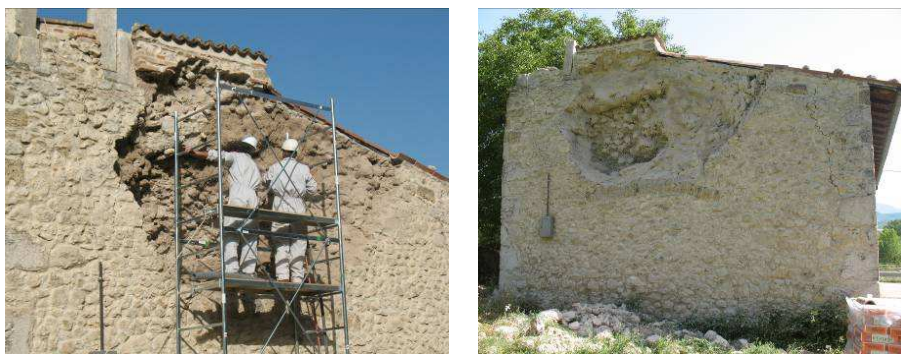
The local collapses due to poor quality and irregularity of masonry suggested to intervene extensively by consolidating the non-collapsed portions of masonry with a surface rendering, based on natural hydraulic lime mortars with fast hardening and reduced shrinkage, which can be subsequently integrated into the restoration interventions (Fig. 10).

*Figure 10: Surface rendering on the apse wall of the Madonna della Prata church in Tussillo village: realization of the intervention (left) and concluded intervention (right)*

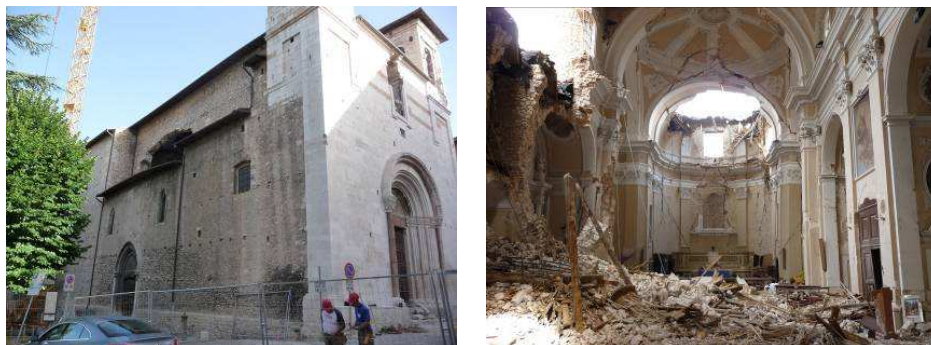
*Figure 12: St. Mark church in L'Aquila: external (left) and internal (right) views*

The church reported severe damage in the apsidal and transept area, where the external walls manifested a visible outward overturning, involving the four pillars sustaining the dome. Also the transversal response of the church proved to be inadequate, since most of the vaults collapsed, such as a big portion of the external wall, at the clerestory level (Fig. 12 left). Severe damage was finally reported in the vaults of the apse, of the presbytery, in the triumphal arch (Fig. 12 right).

In this church, such as in many others of the area, the original roof had been replaced by a heavy and stiff roof made by precast reinforced concrete beams and hollow tiles, with an upper layer composed by a concrete slab.

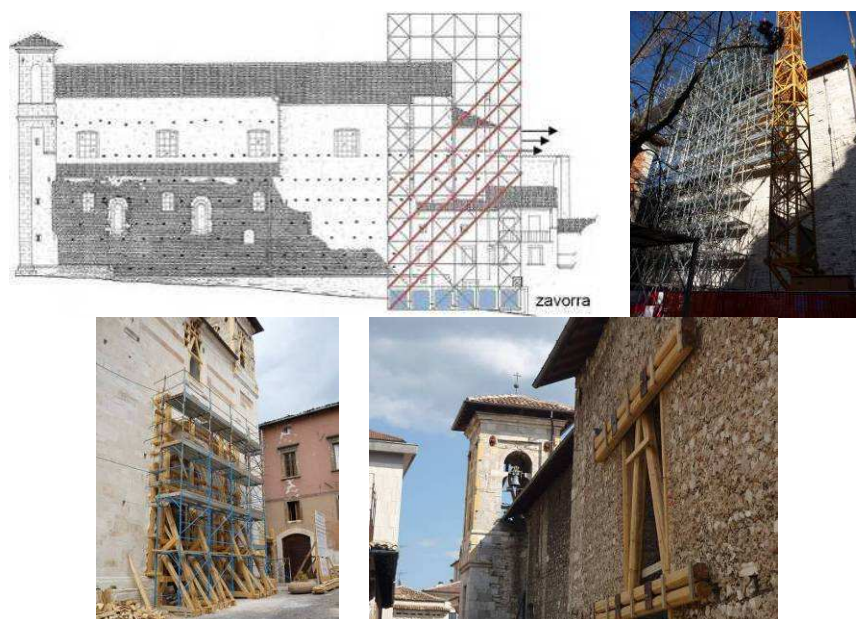
*Figure 13: St. Mark Church: initial provisional strengthening interventions*

The initial provisional strengthening intervention was financed by the Veneto Region: works started on the 4th of July and were completed in November 2009. This first intervention aimed at counteracting the most critical collapse mechanisms, such as the apsidal and transept walls overturning. This intervention entailed the construction of a retaining scaffolding made of hollow pipe steel trusses, constituting a portal spanning across the church. Two lattice towers were built on the two sides of the church, subsequently connected at their top by an open web girder, in its turn connected to the masonry structures of the church.

Further interventions in the façade area were made to counteract the overturning of a significant portion of the right side wall external veneer. Wooden struts were employed to counteract this mechanism and to sustain the stone elements of the valuable church portal, disconnected by the seismic motion. The façade was hooped on two levels with steel cables, positioned to avoid the progression of shear damage. Finally, several openings were propped, and the façade bell-towers were hooped at the level of the belfry (Fig. 13).

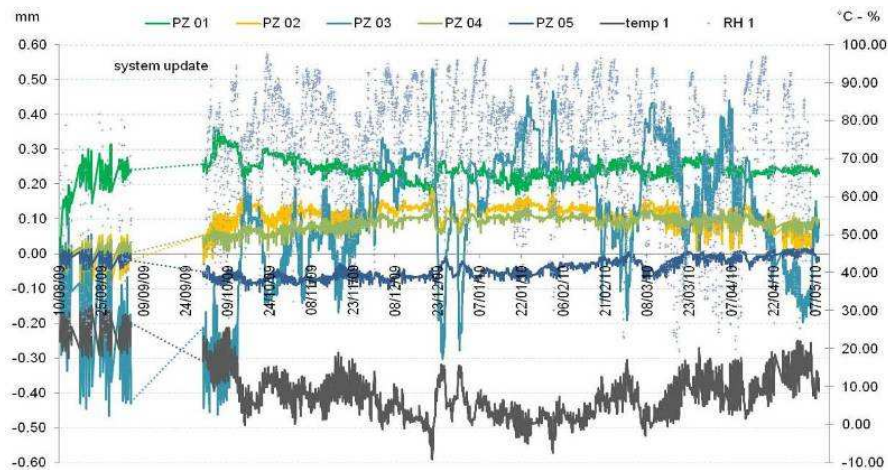
The monitoring system was installed the 10th of August 2009. Displacement transducers data – up to January 2010 - are plotted in the graph of Fig. 15. In these first months, any worsening of the crack pattern can be excluded, confirming the effectiveness of the adopted provisional interventions.

Figure 15: St. Mark monitoring system: plots of the displacement sensors data vs time

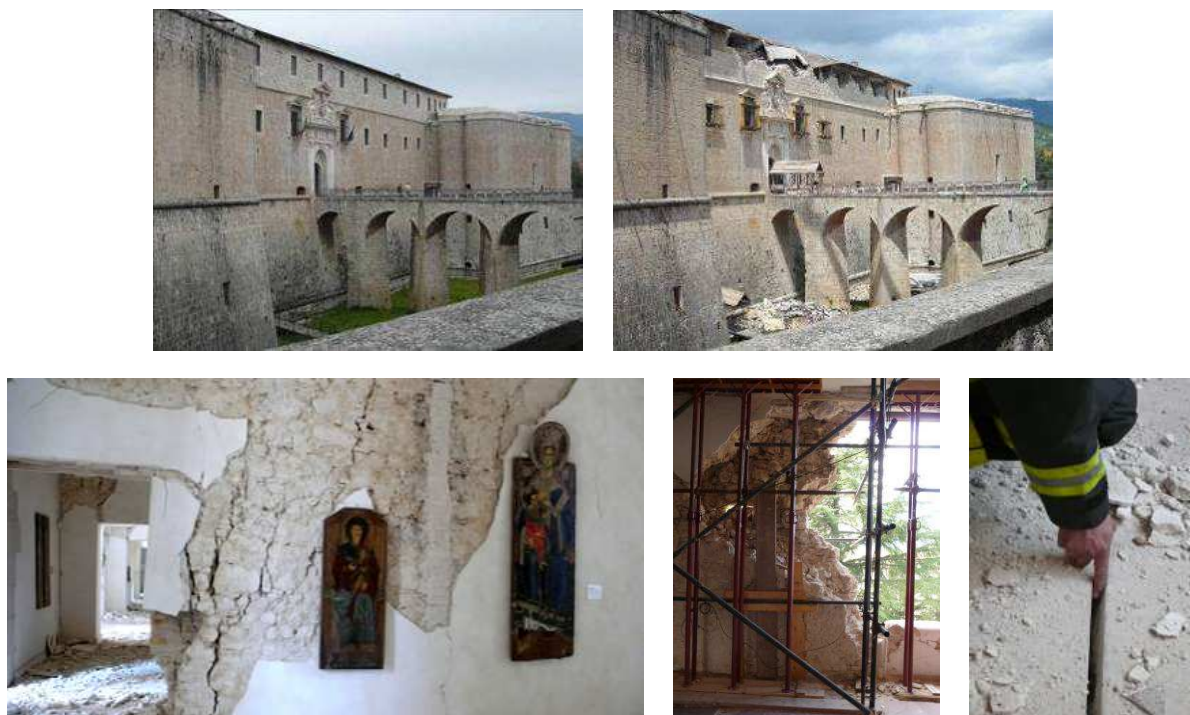
Following the 6th of April 2009 earthquake, the fortress was seriously damaged, especially in the upper floors. According to the damage survey form for palaces used in the inspections (Model B-DP PCM-DPC MiBAC 2006), overturning and flexural mechanisms on the external walls, shear damage in the external and internal walls, damage to vaults and arches, local collapses of floors and vaults, corresponded to the worst activated mechanisms (Fig. 17). Damage was remarkable both for intensity and distribution, and was considered so serious to likely prejudice the overall stability of the building.

*Figure 17: Above: view of the L'Aquila castle (Spanish fortress) before and after the earth-quake; below: severe damage recorded in the internal area of the S-East wing*

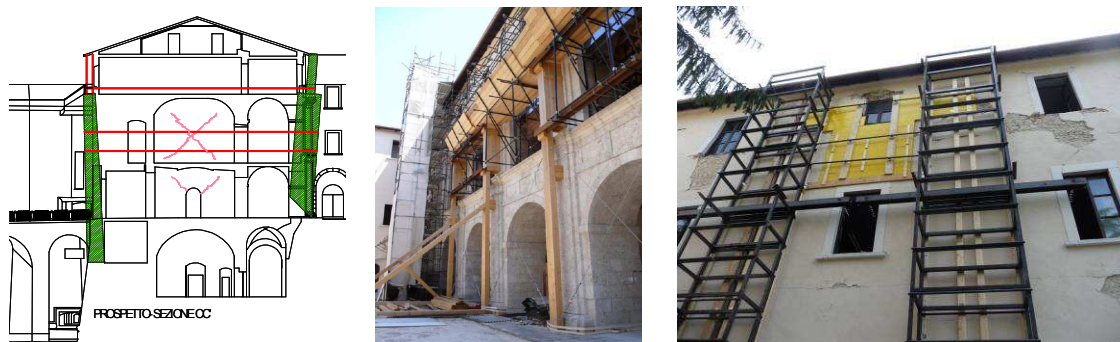
*Figure 18: Provisional interventions: connection of the internal and external façades*

Provisional interventions were carried out on the S-East and S-West wings of the fortress, by groups of specialized Fire Brigades men. The structural stability was provided by connecting the internal and external façade by means of stainless steel cables, to avoid the incipient overturning mechanisms. In the S-East wing the roof was partially rebuilt using hollow section steel trusses and light wooden covering structures. In the S-West wing, steel frames were positioned in contrast to the external and internal façades before tensioning the cables (Fig. 18).

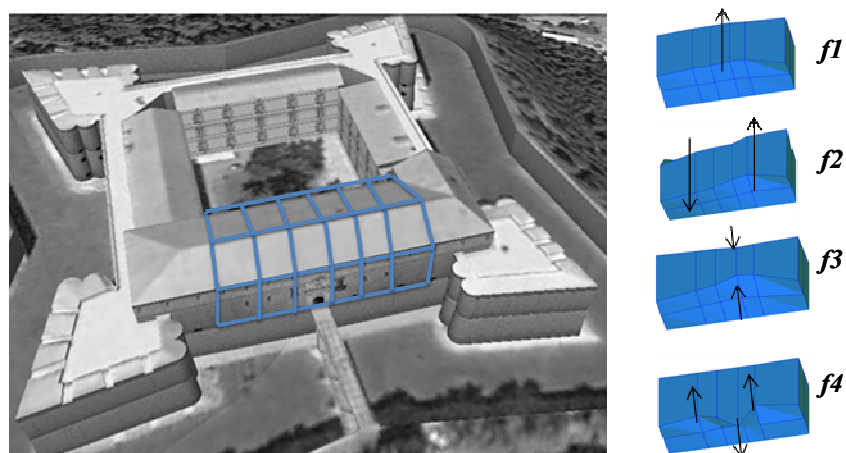
The frequencies and mode shapes emerged from the experimental investigation activities carried out before the installation of the monitoring systems (September 2009) are reported in Fig. 20. During the period of monitoring no significant seismic events were recorded (a power line suspension between 4th and 14th of January did not allow to record the 12th of January 2010 Ascoli Piceno events). Monitoring results show that the dynamic response of the monument vary with the environmental conditions. The natural frequencies tend to increase with the temperature (Casarin et al. 2010b), but fortunately a change in the structural response due to worsening of the damage state can be excluded, at present.

Figure 20: Mode shapes emerged from the dynamic data acquisition
