Pathology of the Katholikon of Hosios Loukas Monastery and Preliminary Structural Analysis

Abstract This paper summarizes the work carried out in the Katholikon of Hosios Loukas Monastery with the aim to study the pathology of the monument. The load bearing structure of the church is briefly presented along with its historical pathology and damages observed after the 1981 earthquake of Boeotia and slightly deteriorated since then. Finally, the results of a preliminary analytical study performed with the purpose to interpret the observed pathology are also presented.

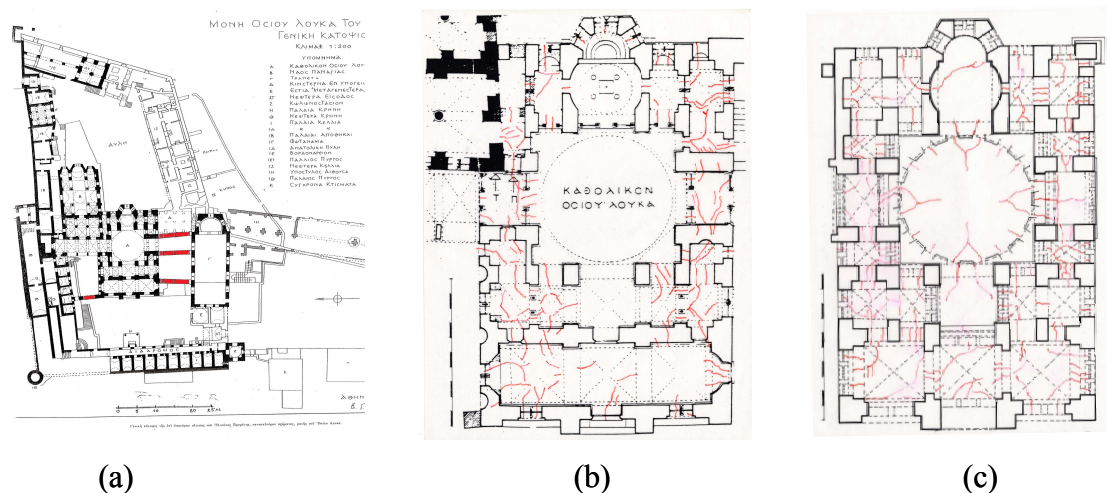
Figure 3: (a) General plan of the Katholikon and adjacent structures (Stikas, 1970) and crack pattern on the intrados of the vaulted roof of the ground floor (b) and of the gallery (c)

After the Boeotia or Kaparelli 1981 earthquake some hair cracks appeared in the vaulted roof of the monument; the damages became more apparent after the 1995 (Aegion) earthquake and continue to slightly deteriorate until nowadays. In Figure 3b a survey of the cracks of the intrados of the vaulted roof of the ground floor is presented, while in Fig. 3c the cracks of the intrados of the vaulted roof of the gallery are shown (Miltiadou-Fezans 1999, reported on the drawings of Stikas and Schultz & Barnsley). The cracks have max width 3mm, and they are deteriorating from the exterior to the interior and from the lower to the upper parts. They have appeared in almost all the groined vaults and arches around the central core, as well as in the intrados of the dome. As proved by the comparison with old photographs (Stikas, 1970) and technical reports (Eugenios, 1921) many of the cracks coincide with the old ones, as they appeared in almost the same position. Some cracks are present as well in the masonry walls. The most apparent are situated on the west façade of the monument, the SW corner pier and the east wall of the narthex, showing once again the vulnerability of the west part of the monument, already proved by its historical pathology, presented above.

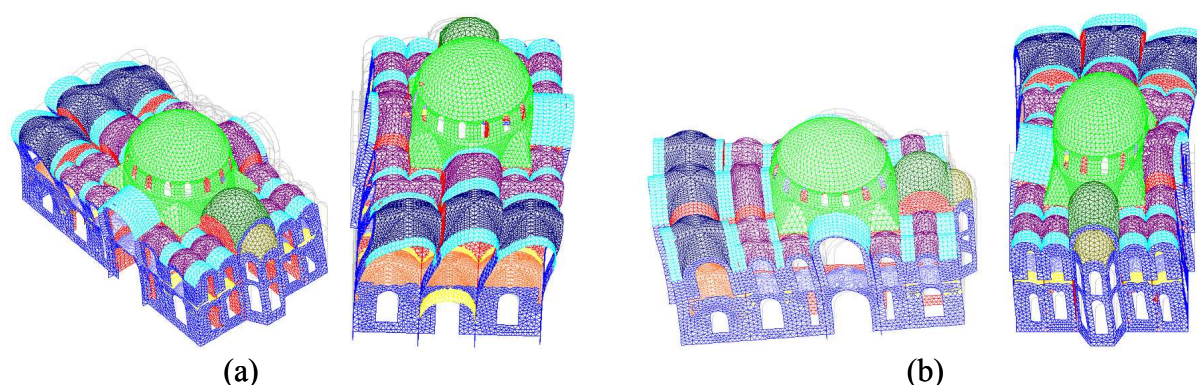
Figure 5: (a) First mode of vibration (N-S axis), frequency equal to 2,34 Hz. (b) Second mode of vibration (E-W axis), frequency equal to 3,05 Hz

A calibration of the model was attempted, on the basis of in situ measurements of its dynamic behaviour. The monitoring system installed in the monument since 2002 has recorded the response of the church during several earthquakes of medium to low magnitude. Figure 5 shows the deformed shape of the model following the first and the second modes of vibration. It can be observed that the

calculated frequencies (see Fig. 5) fit quite well those measured to be equal to 2.611Hz along the N-S axis and 2.638Hz along the E-W axis of the church (Mouzakis, 2004). On the basis of this calibration, the mechanical characteristics of the various parts of the monument were finalized

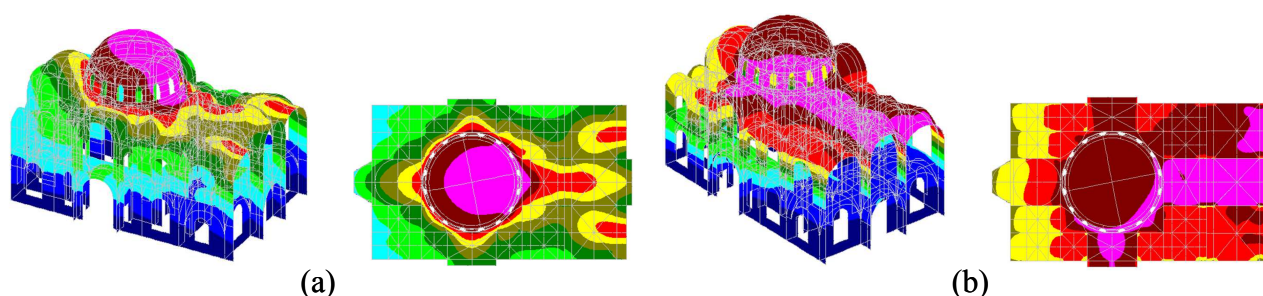
Displacements-Deformations Although elastic analyses were carried out and, therefore, deformations are underestimated, it was proven that there are vulnerable regions (such as zones of support of domes and vaults on vertical elements, as well as the western part of the church), where the deformations are rather pronounced (Figure 6a and 6b). This result is in accordance with the aforementioned historical and recent pathology.

Figure 6: Isovalues of displacements (a) under self weight (g_1 , $\max=6,2\text{mm}$) and (b) under self weight and seismic actions ($g_1+e_y+0.3e_x$, $\max=29,7\text{mm}$)

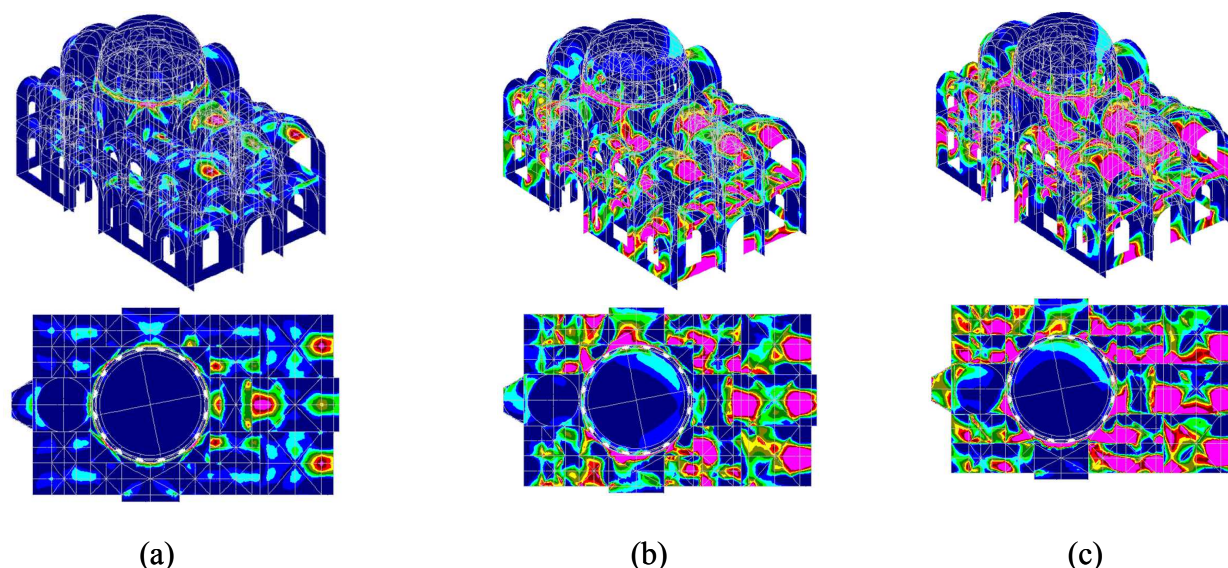
Figure 7: Isovalues of tensile stresses (view from NW and above): (a) under self weight, $g_1 / \max 0,55 \text{ MPa}$, (b) under self weight and seismic actions $g_1+e_x+0.3e_y / \max 1,39 \text{ MPa}$, and (c) $g_1+e_y+0.3e_x / \max 1,86 \text{ MPa}$

Stresses As expected, similar behaviour is observed when maximum tensile stresses are plotted. In Figure 7, stresses over a limit of 0,3 MPa are indicated with the same colour (pink), to allow for comparison between various load cases. Although the tensile strength of various types of masonry is not expected to be higher than 0,1MPa (based also on laboratory tests), a less conservative value of 0,3MPa was selected just for the clarity of the images. Actually, Figure 7a shows the isovalues of the tensile stresses (on the interior face of shell elements) under the self weight of the structure. One may

observe that, even without the seismic action, there are regions in which tensile stresses larger than the 0,3MPa limit are developed. Critical regions are located in several parts (e.g. in the supports of vaults, in arches, as well as in the western part of the church). Again, this result seems to be in accordance with the observed pathology. Needless to say that, the situation becomes significantly more critical when seismic actions are taken into account (Figure 7b and 7c).
