Long-term Reliability of Historical Monuments Built with Low Quality Sandstone

VERSTRYNGE Els^{1, a}, SCHUEREMANS Luc^{1, b}, VAN GEMERT Dionys^{1, c} and BOUREL Evert¹

¹ Dep. Civil Eng., KULeuven, Heverlee, Belgium

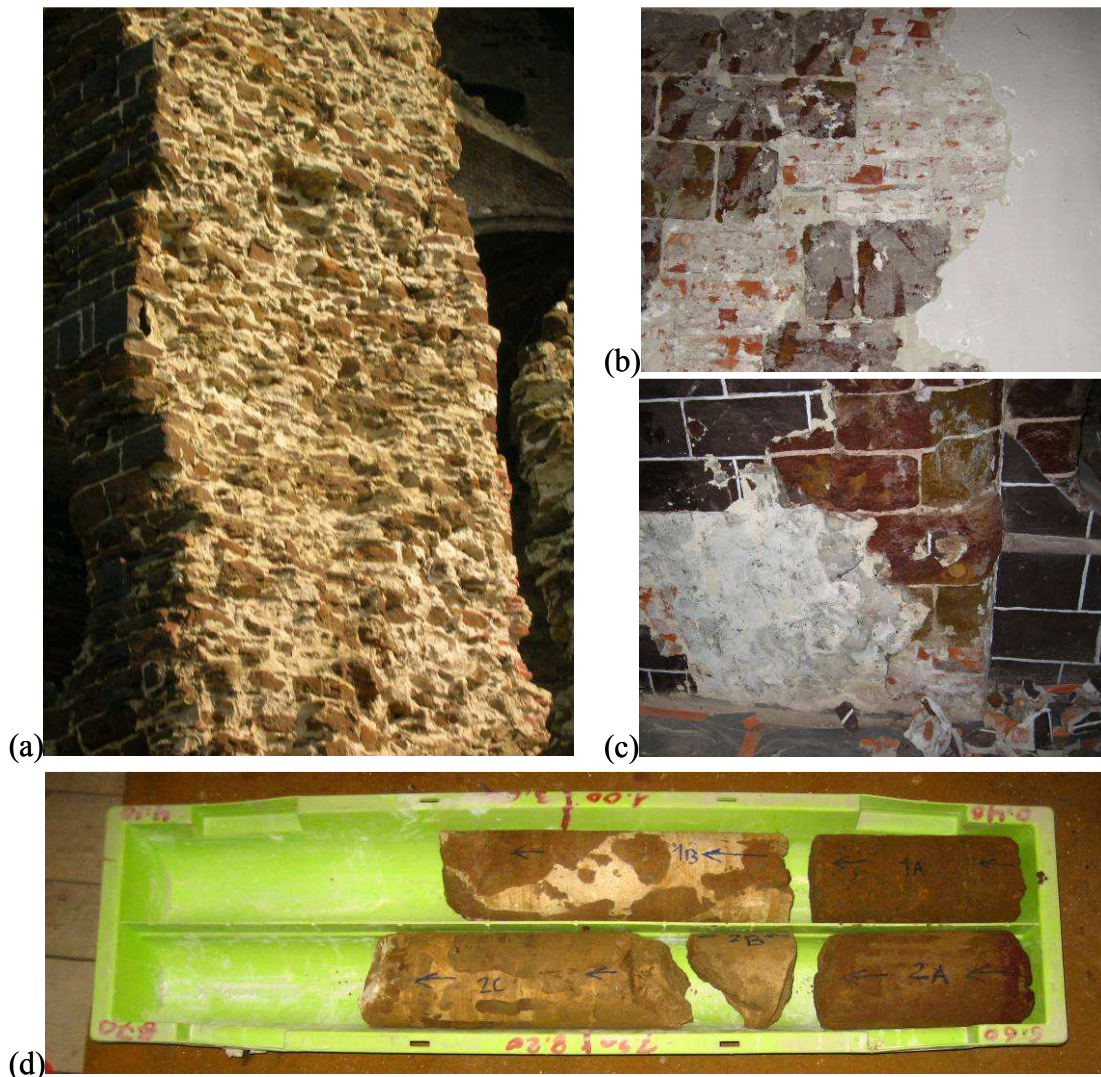
The ferrous sandstone (in Dutch: ijzerzandsteen) which will be discussed in this paper was frequently used for monumental buildings in the 14th-16th century in the central regions of Belgium. The regions where it was used correspond largely with the areas of local exploitation. However, at this moment, exploitation sites with good quality stone in adequate quantities are lacking and restorations are often done with debris material from other monuments. In the late 19th and 20th century, it was even common practice to replace damaged stone material with infill brickwork. (Fig. 1b and c)

The sandstone contains iron fragments, which cause its typical brown-red colour. The sandstone has rather poor mechanical characteristics: it has a low overall compressive strength and there is a large scatter on these strength values. Additionally, the sandstone easily absorbs water, which reduces the strength even further. According to common practice, the structural elements built with ferrous sandstone are often composed as three-leaf masonry, consisting of two outer layers with better quality stonework and an inner core with sandstone chunks and large amounts of lime mortar (Fig. 1a and d).

Figure 1: Cross section of a wall built with ferrous sandstone (a). Restorations with brickwork (b) and cement mortar (c): both only visible after removal of the plaster, however, large cracks in the plasterwork indicated these anomalies. Samples obtained by core drilling in three-leaf masonry (d), the outer leaf (right parts) and part of the inner rubble masonry (left parts) are visible

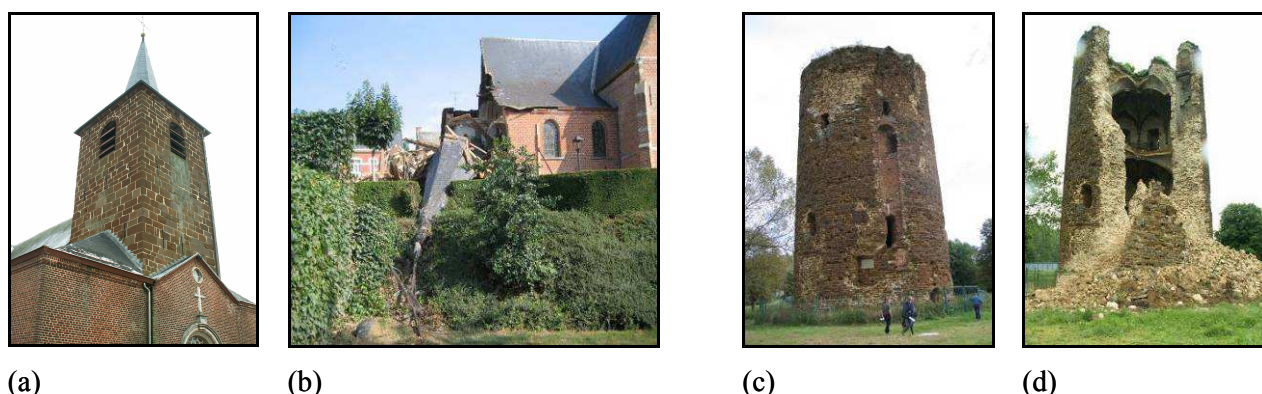
complete collapse of the Bell tower of the Sint-Willibrordus Church at Meldert (Fig. 2a and b) and the partial collapse of the Medieval Maagden tower at Zichem (Fig. 2c and d), in Belgium. Both collapses occurred in 2006.

The bell tower of the church at Meldert consisted of three-leaf masonry, which was composed of two outer leafs in ferrous sandstone and an inner core with rubble masonry of smaller sandstone chunks and large amounts of lime mortar. A visual inspection of the supporting corner pillars of the church tower revealed a large amount of vertical cracks, indicating that the tower was heavily loaded and suffering from time-dependent creep deformations. Adaptations carried out in the past, such as the increase of entrance openings and the removal of sandstone from the outer leaf for rectification had increased the stress level at the base of the tower and reduced the inner coherence of the masonry (Verstrynge et al. 2010b). The tower collapsed at 6th of July 2006.

The Maagden tower partially collapsed at 1st of June 2006 under comparable circumstances. Again, no sudden disturbance of the acting forces could be pointed out as having caused the collapse. The tower was also composed of three-leaf masonry in ferrous sandstone, which appeared to be in bad condition. A high dead load acted on the base of the tower, especially in the area where the cross section of the wall had been reduced by a staircase opening. It was at this point that the wall collapse was triggered.

Figure 2: Examples of recent collapses: Bell tower of the Sint-Willibrordus Church at Meldert, Belgium (a and b) and Maagdentoren at Zichem, Belgium (c and d), both collapsed in 2006

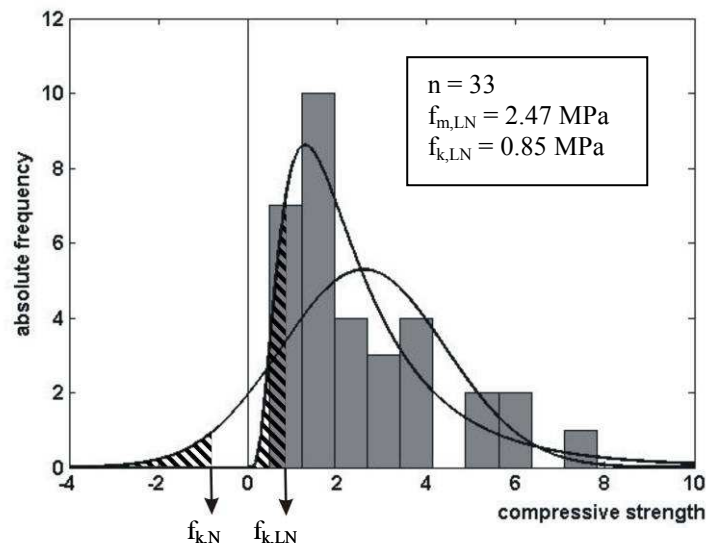
Alarmed by the collapse of the bell tower of the church at Meldert and the collapse of the Maagden tower at Zichem, the bell tower of the Sint-Eustachius church at Zichem was investigated, as this tower was built with the same sandstone material and showed a comparable damage pattern. From this monument, core samples were taken to measure the compressive strength of the ferrous sandstone. A total of 33 core samples were taken, with diameters of 45mm and 133 mm. A histogram of the results of the compressive tests is given in Fig. 3. The results are fitted with a normal and a lognormal distribution function to enable the calculation of a characteristic value, f_k , as indicated in the Eurocode (EN 1990: 2002 (NL)). The characteristic value is the compressive strength which is exceeded by 95% of the experimental results. The normal distribution does not show a good fit to the experimental values. The characteristic value of the normal distribution ($f_{k,N}$) is even negative and therefore physically impossible and not suited to be used for stability calculations. The lognormal distribution clearly shows a much better fit to the results and has been proven in literature to be adequate for modelling the low compressive strength values of masonry (Schueremans 2001). The mean compressive strength of the sandstone, according to the lognormal distribution function, is 2.47 MPa and the characteristic strength ($f_{k,LN}$) is 0.85 MPa.

It can be concluded that the ferrous sandstone has a very low compressive strength and a large scatter on the average strength value. This complicates stability calculations and it would therefore be a good option to incorporate this scatter in the assessment by means of a probabilistic analysis.

Figure 3: Experimental results of compressive tests on sandstone samples, together with normal and lognormal distribution and indication of characteristic strength f_k

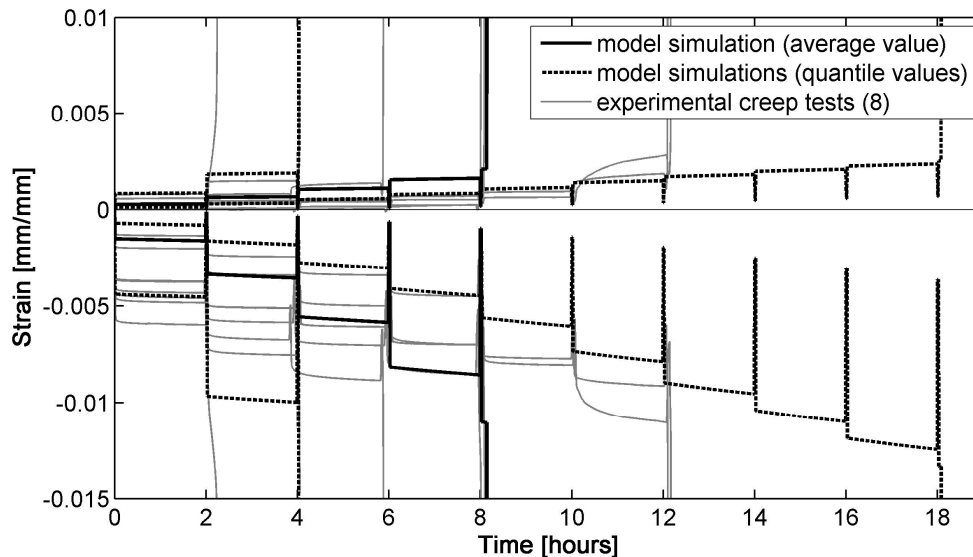
In Fig. 5, the creep model is used to simulate the experimental creep results. The input values for the model variables are calculated as the average values of all tests (Bourel 2010). Therefore, the model indicates the “average” creep behaviour and deviations on this behaviour can be incorporated in the analysis as the scatter on the input variables is known. This is illustrated with the dotted lines in Fig. 5, which are model simulations made with the 0.05 and 0.95 quantile values of the compressive strength, f_c , and the Young’s modulus, E^M . The compressive strength largely influences the time to failure, while the Young’s modulus has a major influence on the strain prediction.

Figure 5: Experimental results and simulation of accelerated creep tests. Dotted lines indicate the upper and lower bounds of the simulation, made with the 5 % and 95 % quantile values of model variables f_c and E^M

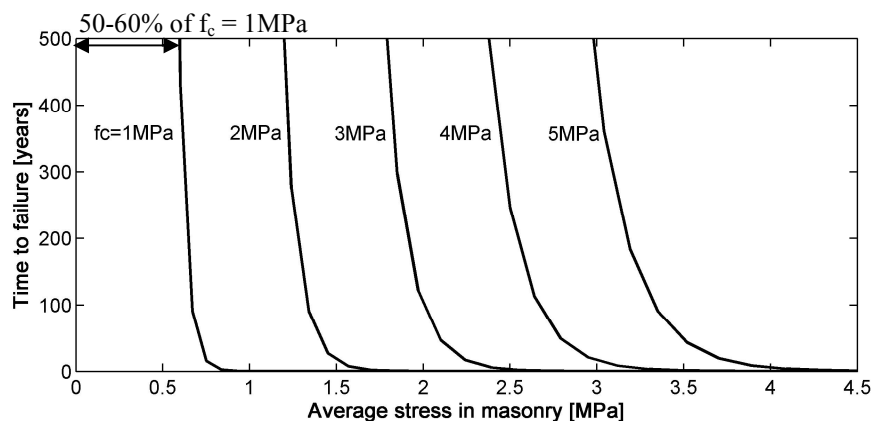
Additionally, the model can be used to predict the time to failure under a sustained stress level, due to creep damage accumulation. It has to be remarked that this analysis does not include additional deterioration effects or cyclic loadings. The failure time in function of the stress level in the masonry is indicated for a range of compressive strength values in Fig. 6. A stress level of 50-60 % of the compressive strength, f_c , should not be exceeded to prevent creep damage accumulations. This level is not often exceeded in masonry constructions, however, stress concentrations or deterioration can cause local spots where creep deformations lead to stress redistributions and damage accumulations.

Figure 6: Failure time in function of the stress level in the masonry, indicated for a range of compressive strength values
