Structural Changes Effect on Deflect of Tower St. Jiri on Prague Castle

Abstract The basilica st. Jiri on Prague Castle has two towers and three bodies. The north tower is deflected from vertical about 450mm. During the last measurement it was found, that the walls were diverted too. The reasons and beginning of fault genesis have not been known yet. It can be larger self weight of tower then weight of navy. It leads to different settlements during homogenous foundation conditions. The next reasons are not clear. I investigated: tower weakening by the door opening, influence of inside vault over middle navy, foundation conditions. The results obtained from numerical model show that every mentioned reason contributed to the deflection of the tower.

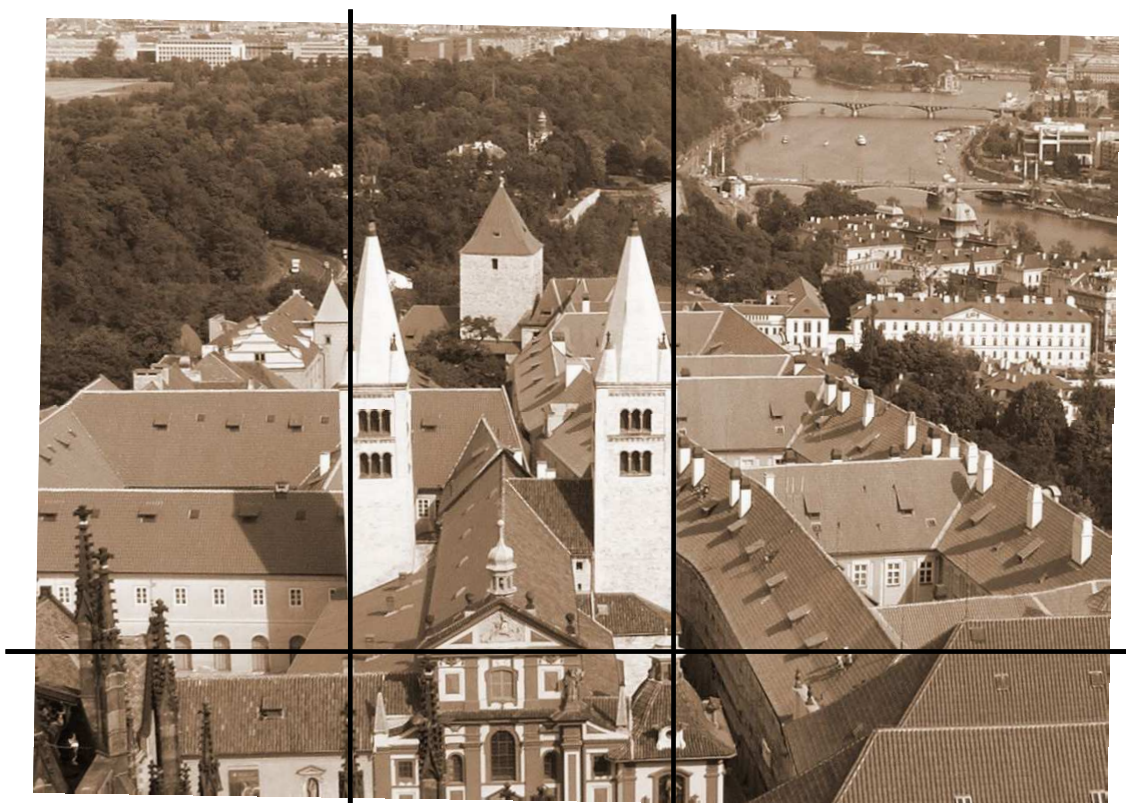
The basilica st. Jiri on Prague Castle is very important historical landmark (Fajman et al. 2010). During years was made lot of changes on it, which left a lot of problems. The most important failure is the north tower deflection from vertical – see Fig. 1. The horizontal forces from heavy vault were specified as the main reason of problem during reconstruction in the late 19th century. In that time the vault in central navy was taken out. The last rebuilding was in sixties 20th century and the tower was stiffened and the foundation was improved. Nowadays is not clear if the way of the last reconstruction was necessary and suitable. Even is unclear if the deflection will go on. This was the reason for the monitoring of the tower. At the same time the numerical models were created, which should give us the answer to the question: “Why the tower is deflected?”

Figure 1: Situation in 2009

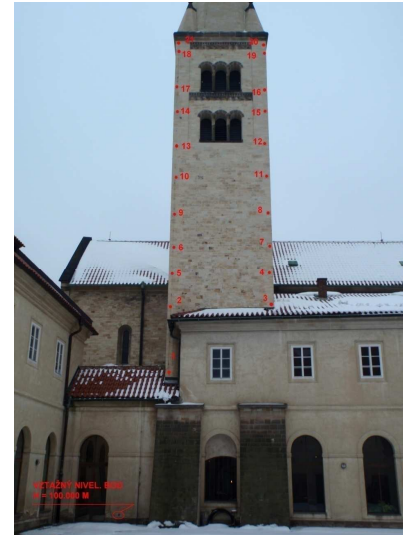
Later the repair of north tower proceeded in some phases (stages). At first in 1947 the north tower were supported by two new concrete structures (Fig.2). In 1969 bottom of the north-eastern tower part was removed and its foundation was deepened. Then new concrete column was built and was covered by stone.

Figure 2: New pillars in 1947

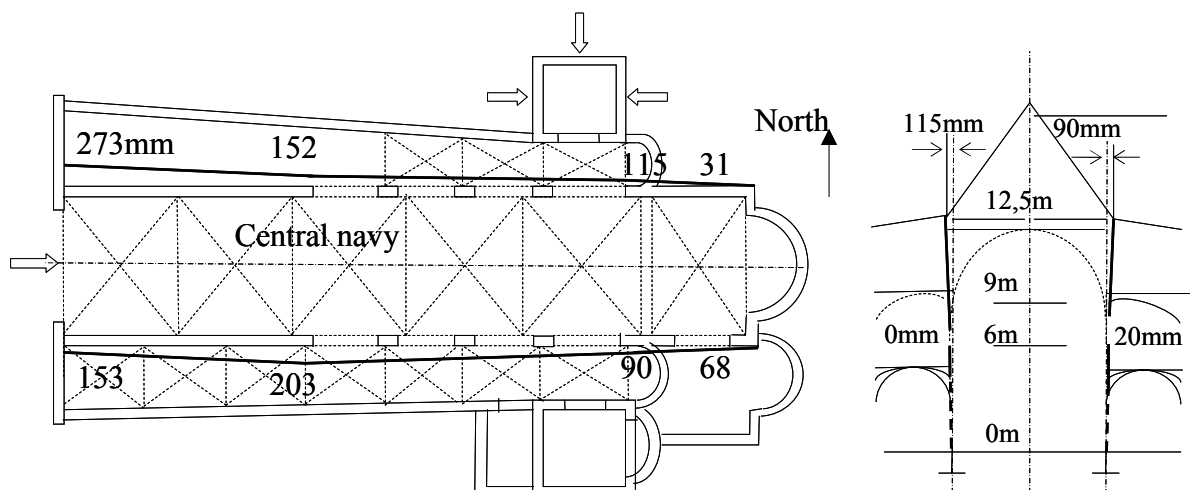
Diversion of the north tower is observed long time. Builder Mach measured displacement on weather moulding 0,28m during his reconstruction. Later, the diversion was measured 0,4m during the reconstruction in sixties. The question is if the expanded displacement could be real during such a short time. The difference could be caused by the wrong interpretation of measurement (e.g. the different points were measured). At present time the displacement is 0,45m on the northeast edge of weather moulding and 0,54m on the northwest edge of weather moulding.

It is not clear, from historical observation, if the deformation process is finished or is in progress. The same measurements were made in 2000-2002 but the results did not answer to it. It led to the new geodetic surveying. The tower and wall position were measured in 2008. From results it is evident that the tower and walls are diverted, but in various ways. The next outcome shows that the upper half of walls are more deformed then the bottom half which points to the problem with vault horizontal forces. The tower is uniformly deformed as a rigid body which can correspond to the problems with foundation and vault horizontal forces.

Figure 4: Declinations

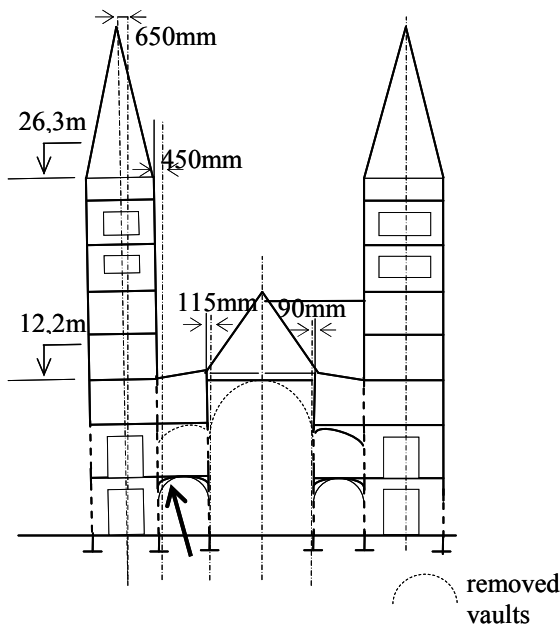
We can search sources of tower diversion in some planes. At first it is necessary to focus on historical construction activities. The original church was expanded spontaneously, some walls was founded on the older walls with unclear foundation conditions. The next problem of the similar buildings with non-uniform distribution of weight is differential settlement during homogenous parameters of foundations and subsoil. In this case it leads to different vertical displacements between heavier tower and navy. The serious problem is soil degradation. It is evident from

geological section (0,00-0,80m foundation arenaceous marl quarry, 0,80-3,67m deluvial silty soil, 3,67-8,00m alum slate). Actually, the weathered subsoil reaches to 3,5m of depth.

Figure 5: Declinations and cracks

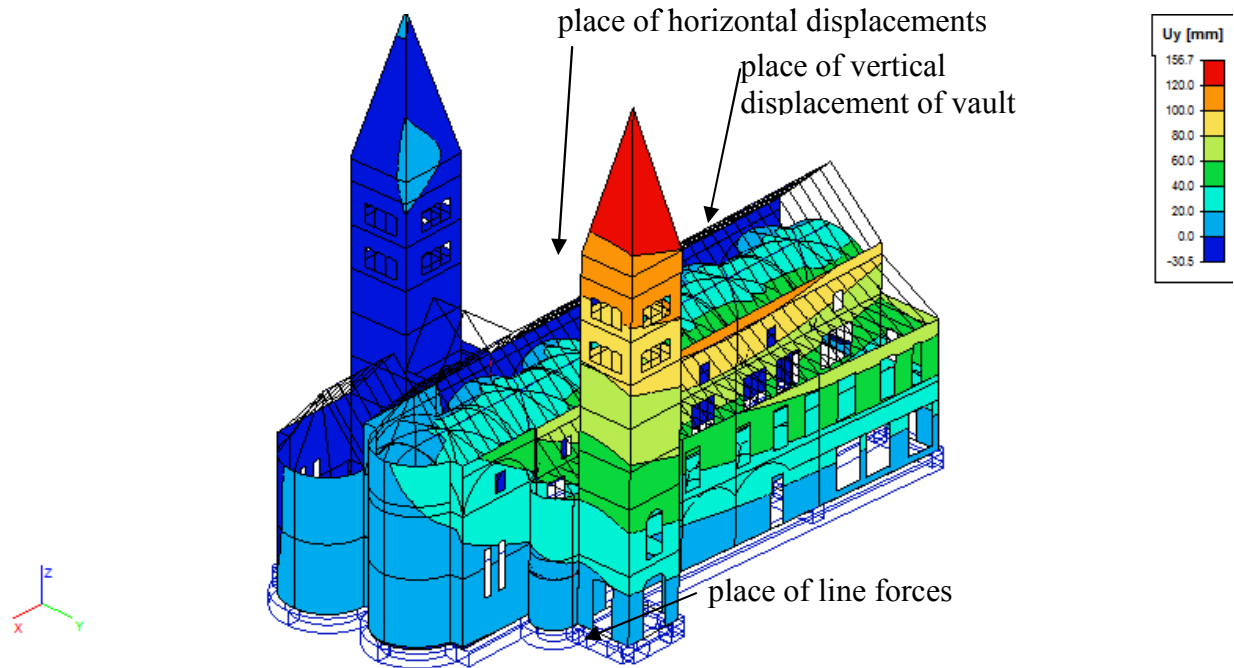
Figure 6: Horizontal displacements and positions of table values

- Historical construction activities
 - door openings significantly increases compression stress in wall from 0,6 MPa to 4,2MPa, but not deflection,
 - central vault expands of tower horizontal displacement less then 20%.
- It was verified, that non-uniform distribution weight leads to the tower horizontal deflection.
- Imperfections of walls (second order effect) have a similar impact as horizontal forces of vault.
- Change of stiffness foundation has the biggest impact to the horizontal displacement at all.
- The final displacement when all effects are considered together is bigger then sum separated effects. It means that structure is subjected to geometrically and materially nonlinear behaviour.
