# **Structural Analysis of the Bell Tower of the Basilica De La Merced of Lima**

**Abstract** The Bell Tower of the Basilica de la Merced de Lima is a monument with its own personality in itself, was built by master masonry Alonso de Morales as contract signed May 12, 1589 whose original is in the General File Nation of Peru. Until now has been repaired several times due to damage to large earthquakes that destroyed the city of Lima in more than one occasion.

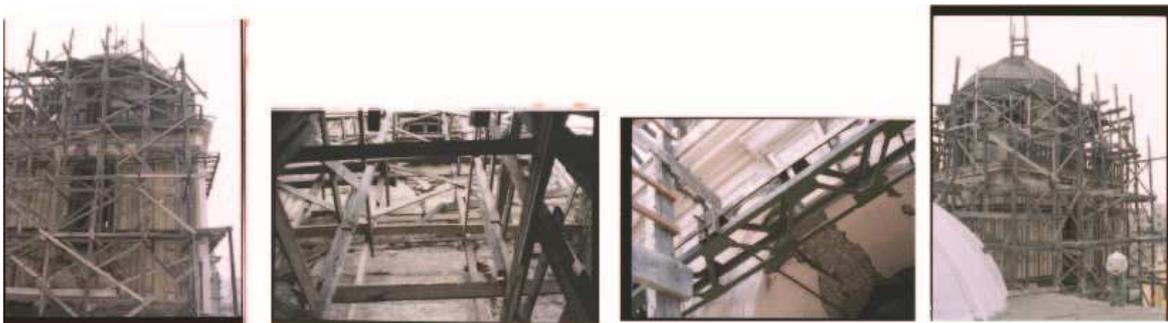
The structure presented cracking in the walls, in the bases of the pillars, in the arches, and between vain to everything long of your development, we must consider that has been repaired in several occasions and has supported at least fifteen earthquakes of high magnitude.

Figure 2: Views of structural damage of the year 2005

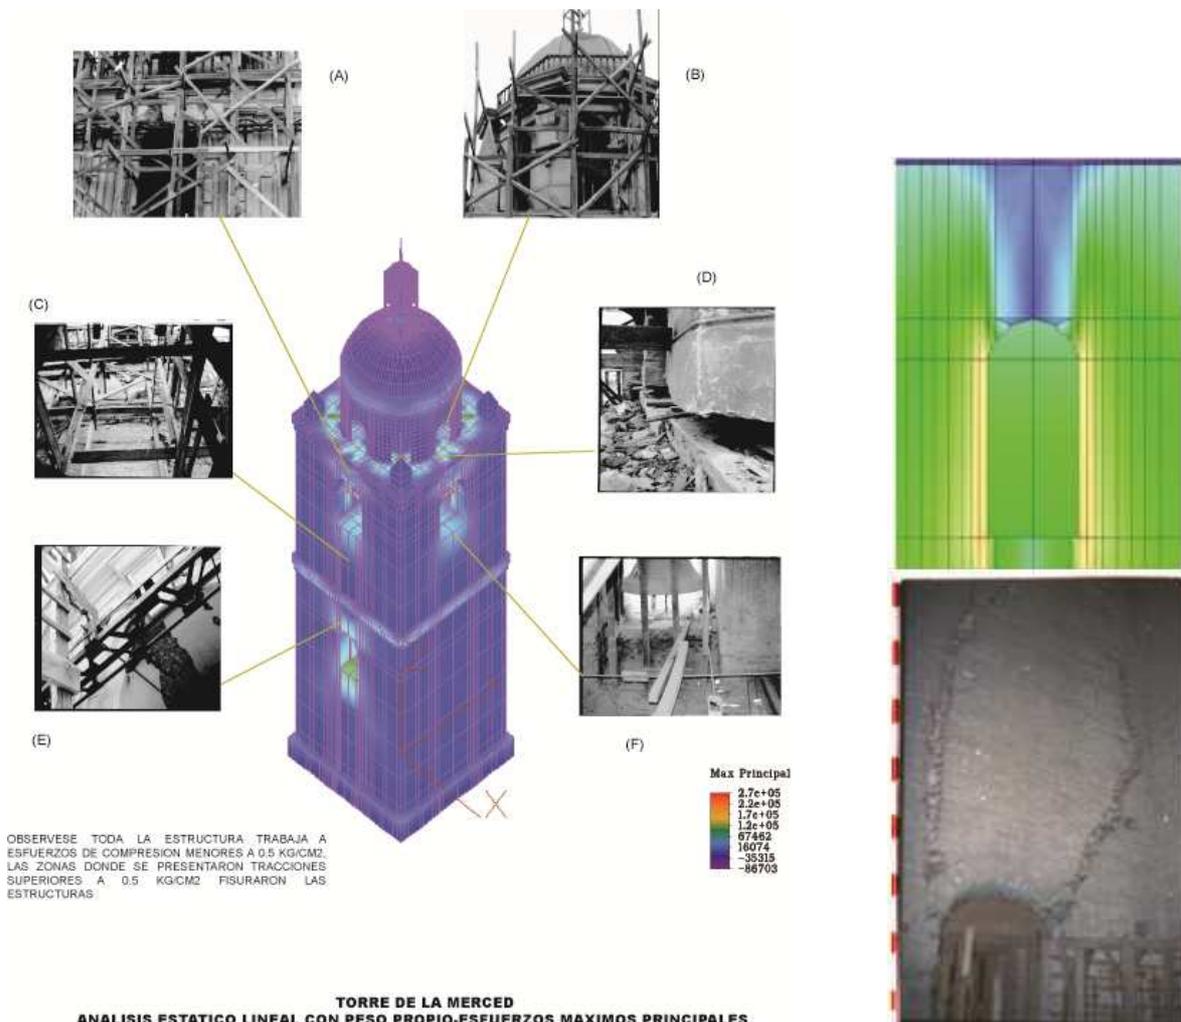
Lateral displacement at the level of the dome was caused by the shifting of the 8 pillars, have been previously collapsed due to low capacity to shear stresses, it would explain the presence of pieces of wood embedded in the pillars, which would give better performance and flexibility. However, effects of the earthquake produce shear stresses on the order of  $1.3 \text{ MPa}$  ( $13 \text{ kg/cm}^2$ ).

Even for low-intensity earthquakes, the limited capabilities of the pillars is easily exceeded, which agrees with the observed damage.

The tower has a fundamental vibration period of 0.36 seconds, is very rigid. The vibration modes were primarily the lateral and torsion were fewer in number. The masonry building has good capacity for shear stresses resistant and is below the allowable capacity. However, stresses originated in the key of the arches, with values exceeding 0.1MPa (1 kg/cm<sup>2</sup>), exceed the capacity of unreinforced masonry.

Figure 4: Shear stresses concentration and damage agreement

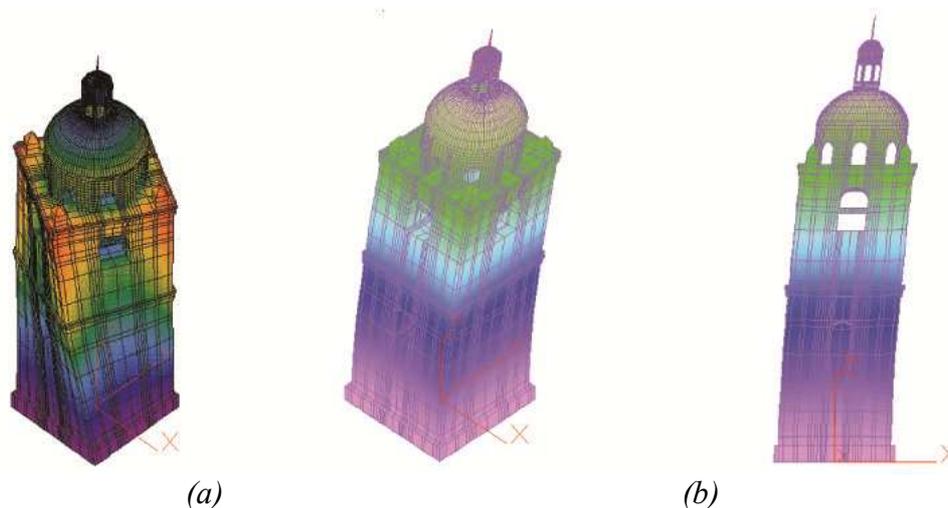
The analysis results show maximum lateral displacements of 15 cm in the dome area at 9 cm from the wall. They are related to insufficient lateral stiffness at the pillars and the dome, which was probably made of brick and collapsed to be rebuilt several times.

Figure 5: (a) *Vibration Mode: 3th mode,  $T= 0.2 s$*  (b) *Deformed shape for modal superposition, maximum displacement: 0.15 meters*
