Preliminary Observations on the Structural Condition of a Byzantine Monument in Historic Peninsula of Istanbul: Pantokrator Church

ALMAÇ Umut

Faculty of Architecture, Istanbul Technical University, Istanbul, Turkey

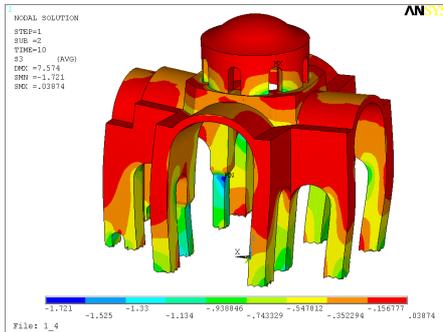
Figure 8: Max compressive stresses on southeast pier

The stress distribution of the structure under its own weight indicated that the maximum compressive stresses appeared at the southeast pier which has vertical cracks (Fig. 8). As expected, the values of tensile stresses which dominate the barrel vaults and the arches that connect the piers to the perimeter walls were not big enough to provoke damages that would lead the structure in to a vulnerable condition. One of the important results obtained from the analyses was the displacements

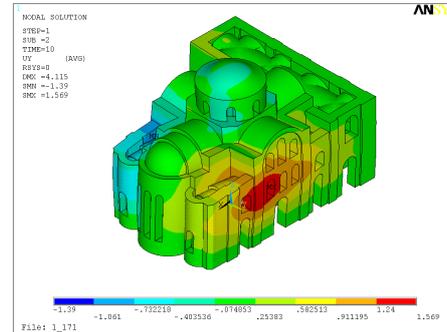
Figure 9: Displacements on transversal direction

on the transversal direction corresponding to the eastern piers (Fig. 9). As the structure lacks tie beams between the piers and walls, there is no effective system that could prevent the displacements and secure the monolithic behavior the structure.

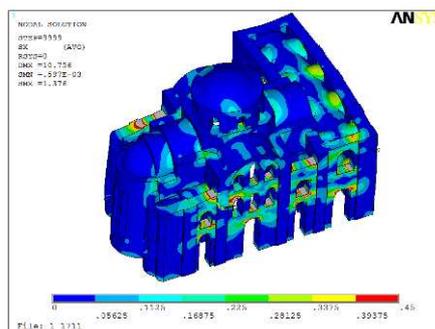
Figure 10: Tensile stresses between west wall and cross vaults of the gallery

Earthquake loading computed in the longitudinal direction (EW) indicated that due to the out of plane mechanism of the west wall, the tensile stress distribution between cross vaults and west wall could possibly cause a crack pattern that runs through the vaults parallel to the west wall (Fig. 10). This mechanism matches the crack pattern of the gallery vaults which were repaired during the conservation works between 2001 and 2005 (Fig. 11). The results of the analysis indicated also relatively high shear stresses on northern and southern walls but the damages should be expected on the secondary load bearing elements such as tympanums.

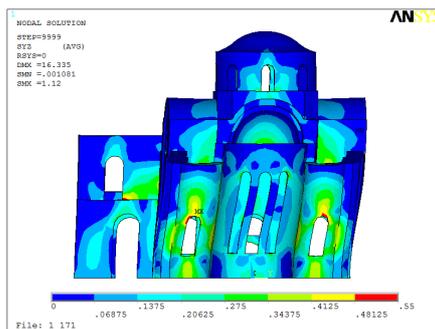
Figure 12: Eastern façade of the building

Shear stress distribution of earthquake loading computed in the transversal direction (NS) demonstrated that the eastern wall was subjected to high values of stresses in comparison with other parts of the structure (Fig. 12). During the earthquake excitations, pastophorion walls probably would be affected by a crack formation that begins from the ground and reaches to the upper parts of the wall running through the openings. This result also verifies the damaged condition of the eastern wall which was repaired during the conservation works, carried out by professors Metin and Zeynep Ahunbay in 2005 (Fig. 13).
