## **Restoration and Strengthening of a Historical Structure in Antalya - Turkey**

KOÇAK A<sup>1,a</sup> and KILIT Z<sup>2</sup>

<sup>2</sup>Kilit Construction, Antalya, Turkey

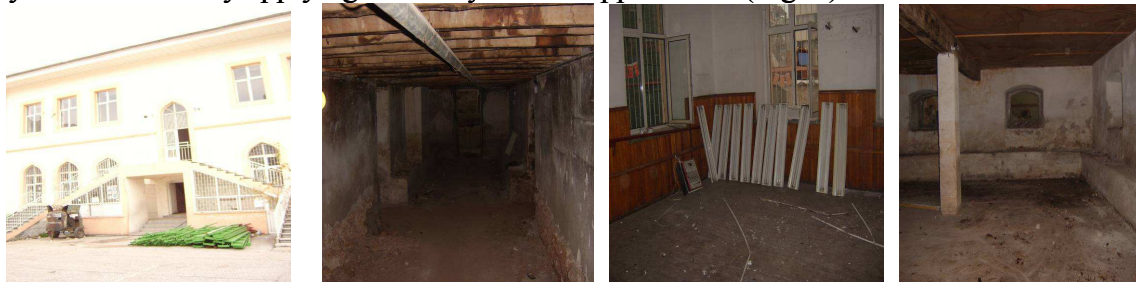
Figure 3: Picture of existing situation of structure

Result of burning next wood house, fire had started into school in 1989. it has been determined that ground floor and first floor of room in north west corner completely had burned, and some part of corridor and roof paneling and coating of the same room had burned also. After fire in 1989, wood beams have been consolidated and floor coating had been renewed. Fire and construction work that made after, get many harm to original of structure. It has been determined that was made first thin grout after grained paint on grout that occurred from sand, chaff and lime, almost whole doorjambes and floors was broached or broken, locked stairs that made by cutting from limra stone, first was lay over bulk mosaic and after wood.

Moreover it has been observed that west, east and south balconies was fell down, and reinforced concrete stairs was made instead of it, some part of ground floor windows was closed with brick., original roof covering and garden walls was changed.

The biggest harm that made, is transforming of U plan to rectangle by structure up annex 1 floor that is reinforced concrete onto ground floor. Even though reinforced concrete construction put onto columns, it was determined that all windows and balcony doors that U plan involved, stayed into conveyer brick walls by applying mixed system in upper floor. (Fig. 3)

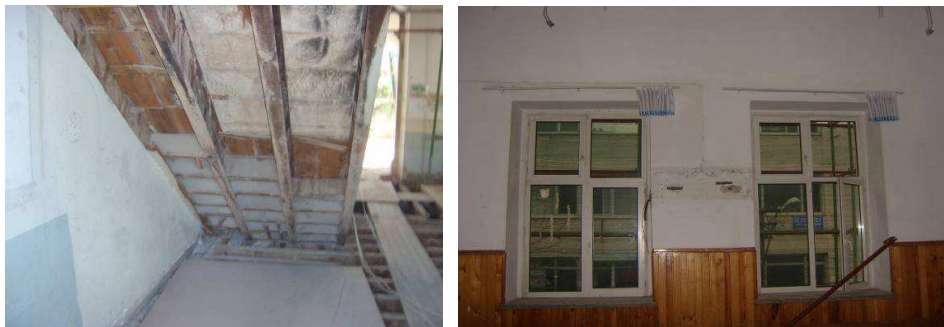
Figure 7: Existing situation of stairs and windows

Because stair NPI 240 limon beams (made by German in 1860) was exposed corrosion and jagged and mostly broken in order to make bulk mosaic stair, all of them was renewed based on main measure and equipments. Because barriers was broken and decomposed, stairs and profiles has been renewed fit with original. Anchor shutters (ground floor) have been ripped completely that put on windows carpentry. All windows have been renewed completely fit with original both reason of decomposing that occurred lack of care and climate holes.

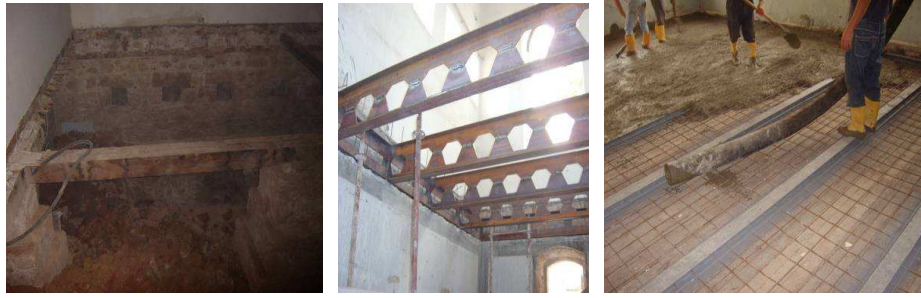
*Figure 8: Removing of the damaged floor and making of the new floor with extra steel bars*

When floor covering that made later has ripped, it has painted with wood protector by cleaning because beams of conveyor cedar wood nervure has been perfect condition when floor conveyor that is in + 4.90 (first floor) elevation was ripped. It was determined that Into basement (+0.29), floor conveyor that made or found also was drawn up, north west room that had fired and beams of conveyor corridor cedar wood nervure was be harmed from fire largely, reinforcing disorderly, some part of them was decomposed. It accepted with statically that change of wood nervure beams that used for this floor with steel beams in same measure. (Fig. 8).

Equipment has been put between mesh steels that used on covering; concreting has been done 10-12 cm on equipments. (Fig. 8).

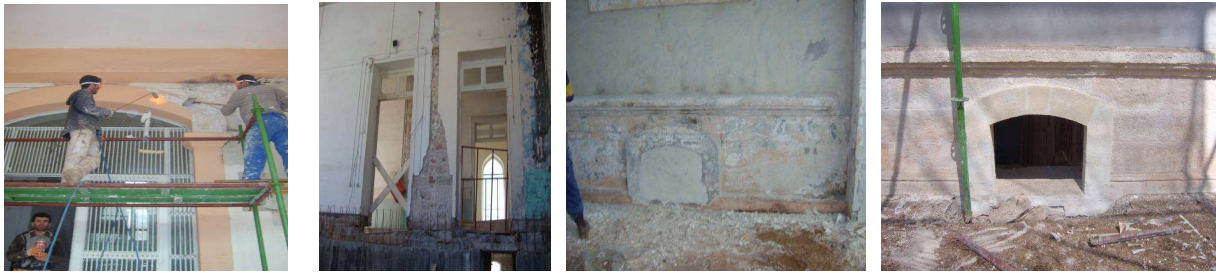
Because all roof covering painted again and again, wood lost its feature, and some breaks occurred, it has been changed with same measure and form wood. Although roofs has seemed as painted in measured drawing and restoration projects, result of chemical analyzes, it has decided that protect all roof with using wood protector, because has determined wood gloss in first coat of roof paint. In entrance of structure, Limra doorjamb and other küfeki doorjambs, profiles and grouts on wall covering was ripped, grained paint under the grout was cleaned by raking. Broken and completely (all ground floor and balconies) removed doorjamb was repaired and renewed with method of decompose. (Fig. 9 and Fig. 10).

*Figure 9: Picking up grouts and paints*

*Figure 10: Opening of Closed Windows*
