Istanbul Grand Bazaar Evacuation System Vulnerability Assessment

YÜCEL Gül^{1,a} and ARUN Görün^{1,b}

^{1,2}Faculty of Architecture, Yıldız Technical University, Istanbul, Turkey

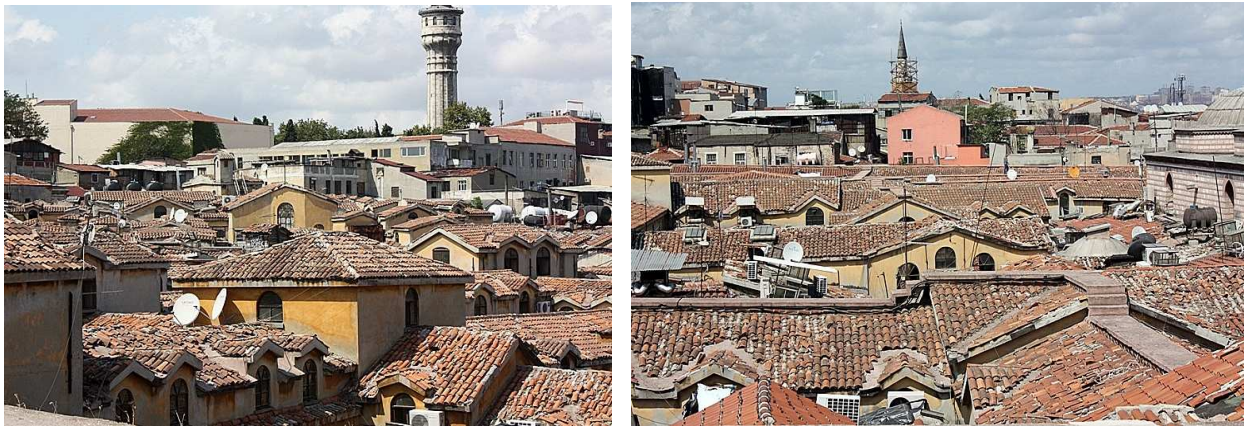
Figure 2: The Grand Bazaar roof (Photo by Gül Yücel, 2008)

The Bazaar's roof covering material is tile. During the investigation, it is seen that the roof maintenance is insufficient (Fig. 2). The rain water of the roof is discharged to underground drainage system by the gutters landing into the bazaar. The rain stream coming from the roofs of different levels and the leakages of the channels revealed problems in many areas.

In the sense of physical features and problems, water insulation problems of the roof must be initially solved and structural safety must be provided by repairing structural cracks. The maintenance of windows which enable natural illumination must be done and a system must be developed for their open-close positions.

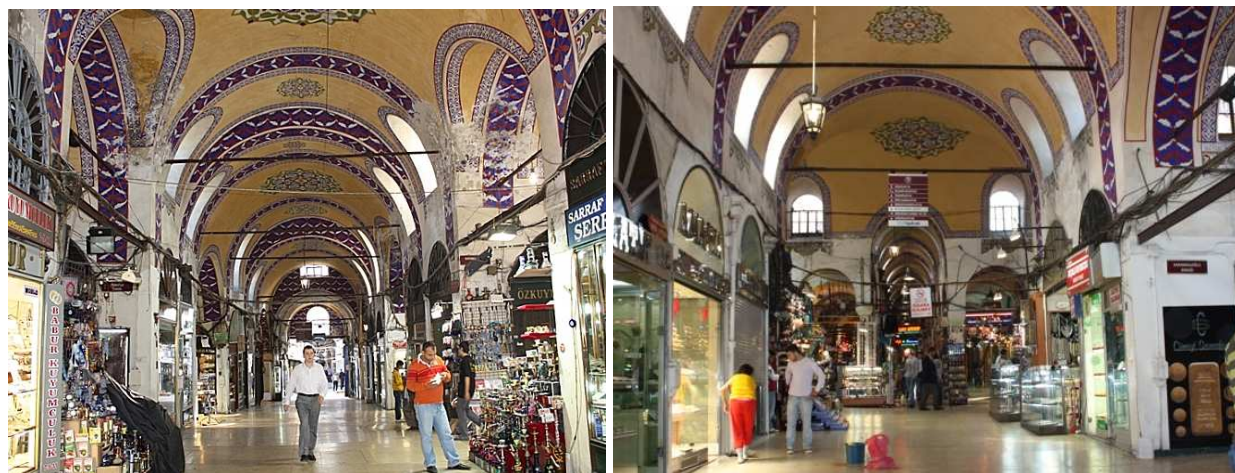
Figure 3: The Grand Bazaar street (indoor) (Photo by Gül Yücel, 2008)

Natural illumination, daylight, is taken from the windows organized on the sides of the vaults (Fig. 3). Besides, electricity is used for the illumination of the shops and streets. Natural ventilation is provided by operable windows and bazaar exit doors which are open all day. Organization of the bazaar doors at different levels, provide good air circulation in the streets of the bazaar. But in the shops, air conditioning systems are used. Such use of electricity sometimes results with the malfunction in electricity infrastructure. Besides, these additional units on the roof destroy the roof tiles.

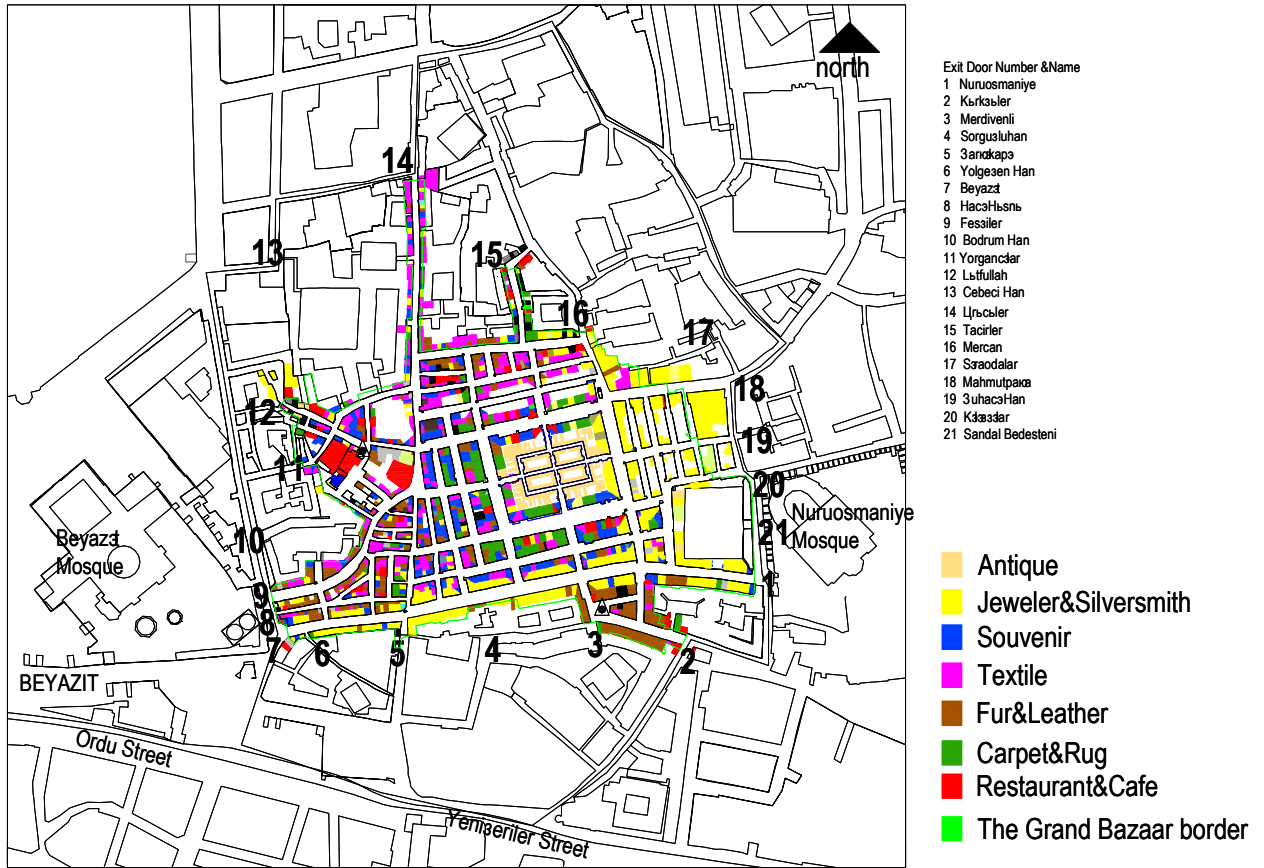
Figure 4: The Grand Bazaar plan with occupational distribution (Prepared by Gül Yücel, 2008)

The Distribution of Occupational Branches in the Grand Bazaar Although the names of the streets generally symbolize the products manufactured and sold in the bazaar; different usages parallel to current needs continues its existence inside the bazaar. Though food and drink service was limited with tea shops before, in the course of time its scope is broadened with restaurants. Though these restaurants had to use electricity for cooking, usage of bottled Liquid Petroleum Gas (LPG) is observed as well. The existence of such shops especially around the exit doors will influence the safety of escape way negatively in case of emergency. Jewellery shops with valuable metals, antiquarian, carpet-rug stores, and leather confection trade centres are grouped in specific streets. Recently confection sector has found a place in the body of bazaar and is added into the traditional shopping structure of the bazaar (Fig. 4).

The distribution of the usage types is very important in the sense of pedestrian density and fire safety. Especially the food and drink areas must be situated in the specific points and must not prevent evacuation through the exit doors.

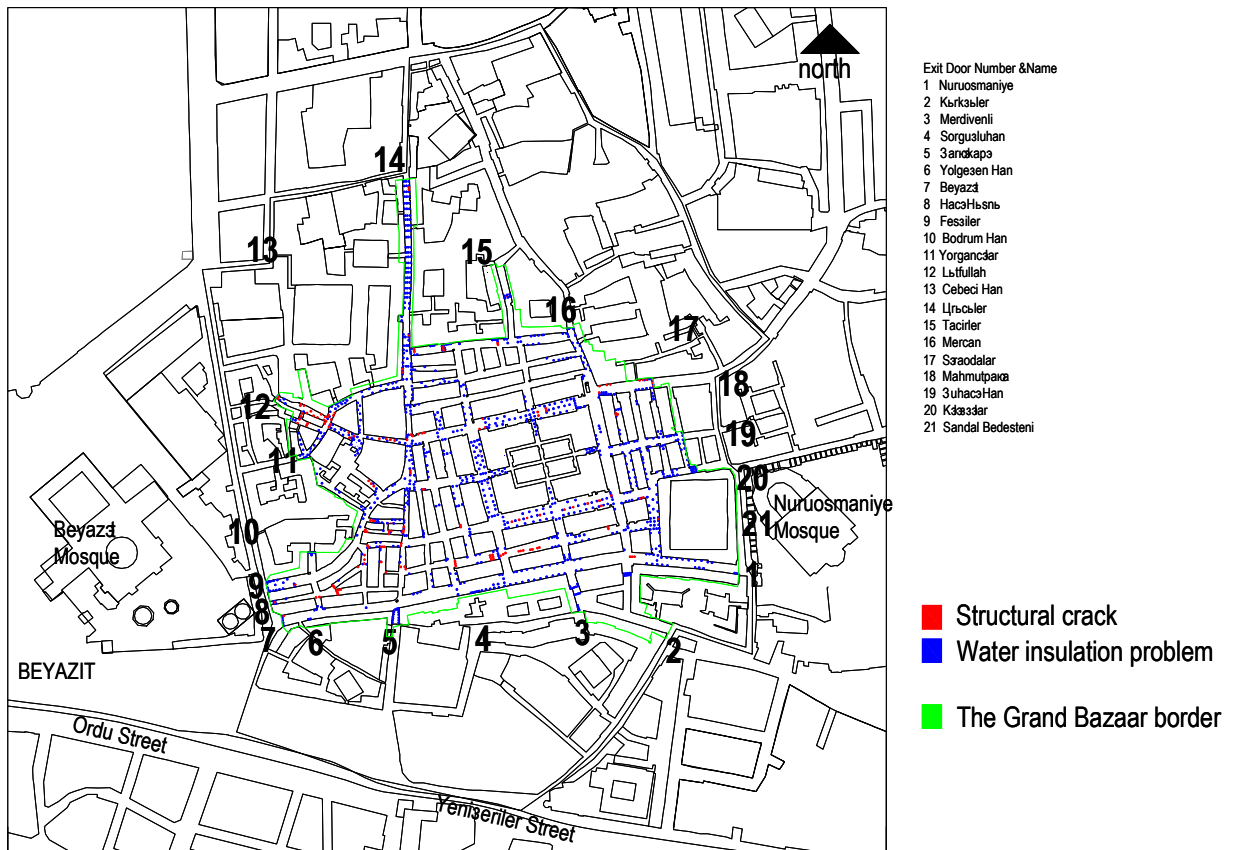
Figure 5: The Grand Bazaar plan showing the water insulation and distribution of structural cracks on vaults and exit door numbers (Prepared by Gül Yücel, 2008)

Constructional Problems Physical features and problems about the exit doors and their surroundings including the roof, ceiling and walls are evaluated through the existence of humidity and constructional problems. The problem of insufficient rain water insulation of the roof often results with stain on the vaults over the streets, degradation of the paint, cracking etc. The structural cracks observed on the walls and vaults are seen together with water insulation problems. The cracks are generally parallel to the vault curvature starting from the window openings at both sides of the vault and in the direction of vault length on supports and at the top. This indicates that there might be a soil settlement problem due to the leakages in the underground drainage system.

During the inspection, it is seen that the water leakage problems are in a wide area and cause structural deformations around Cevahir Bedesten (Old Bedesten), Yağlıkçılar Street, Yorgancılar Street and Sandal Bedesten Street (Fig. 5). Repairing the water insulation properly is of great importance to save the structural system of the Grand Bazaar.
