Seismic Damage to Churches: Observations from the L'Aquila, Italy, Earthquake and Considerations on a Case-study

A Case Study: the Church of San Biagio Amiterno

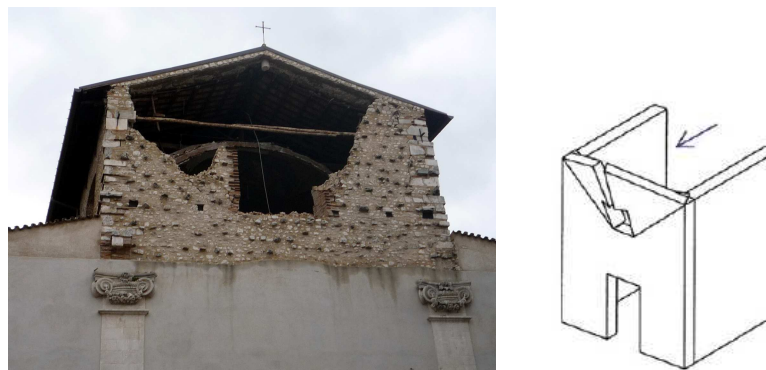
The Observed Damage The main damage occurred after the main shock and consisted in the out-of-plane collapse of the upper part of the façade and of the corresponding infill in the church interior, Fig. 2. Debris have cumulated outside and inside. Failure occurred according to a well known mechanism, also represented in the figure.

Figure 2: The façade top (left) and corresponding collapse mechanism (right)

In the current case, however, the main triggering cause of collapse seems to be the insufficient restraining of the collapsed part. By examining the collapsed area of the façade and the lateral walls, while no significant longitudinal displacement of the heavy concrete roof was noticed, the borders of the collapsed area revealed a particularly weak restraint situation. The façade top could be roughly considered an elongated plate, where the lower border, corresponding to the upper side of the large façade window, was basically free. At the top, the plate was very likely weakly connected to the new concrete roof. The roof border could be inspected by close after the collapse and showed no significant remains of interconnection. At the lower border just above the window, the presence of a timber tie-beam linking the lateral walls and visible in Fig. 2 constituted an additional discontinuity within the masonry. On the left side looking at the façade, a discontinuity in the masonry was present before the seismic event and is recognizable in pictures as well as in older drawings, like that in Fig. 1.

The border restraints resulting from this entire picture were very loose and probably incapable of resisting strong out-of-plane forces. In fact, collapse followed these borders, including the discontinuity on the left, as may be seen by comparing Fig. 1 and 2. The masonry tooth seen in the figure was subsequently removed, to avoid danger of further collapse.

The façade mechanism pointed out here has been further confirmed by performing its limit analysis. The procedure, implemented by Modena et al. (2004), requires defining all the contributions in terms of forces that derive from weights, possible thrusts, ties, and from inertia. In spite of uncertainties, results are usually meaningful especially in comparing different possible mechanisms for the same macroelement. In this case the mechanism that actually developed had a low collapse coefficient that fully justified the outcome in relation to the level of the L'Aquila earthquake.

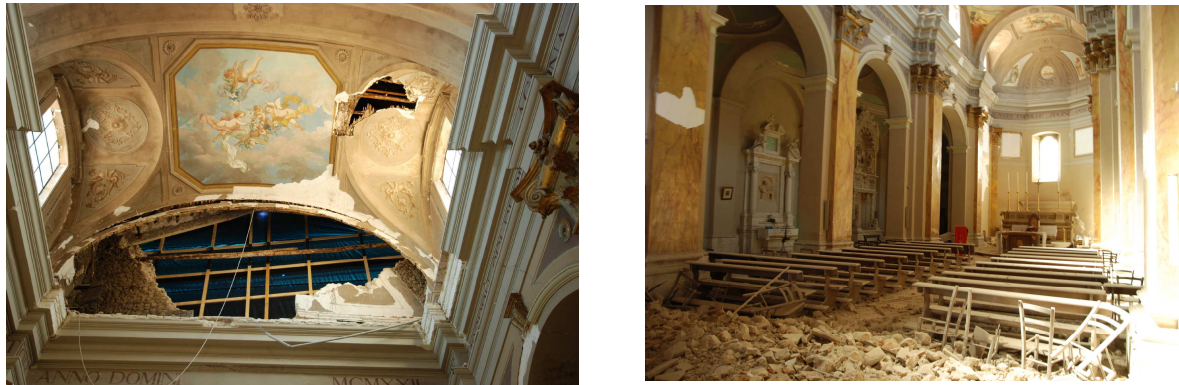
In the church interior, local collapse occurred at different spots of the barrel vault over the main nave, bringing into evidence its cane structure, as may be seen in Fig. 3. This damage was likely due to debris falling from the roof area and breaking through.

Figure 3: The damaged interior

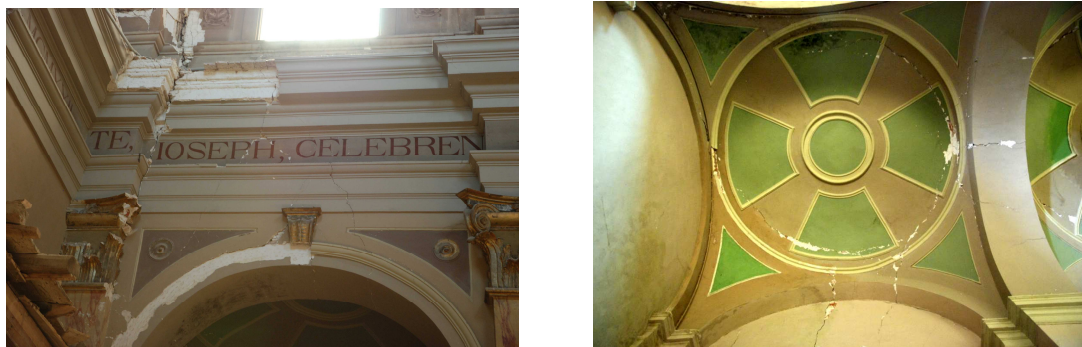
- in the lateral walls of the central nave, above the arches, where cracks developed systematically from the arch key area to the windows above with a moderate slant with respect to the vertical direction. An example is shown in Fig. 4, left;

- in the lateral naves, where all the spherical vaults over the chapels cracked along a parallel just above the base; additionally, the arches between chapels were cracked at the key, in a system connecting with the vault cracks. In Fig. 4, right, an example of the vault-arch crack system is shown;
- in the exterior walls of the lateral naves, where widespread cracks appeared, these cracks seem, however, narrower and more shallow;
- at the base of the pillars, with generally thin vertical cracks. Damage was mainly found in the layer of stiff decorative plastering, which at places detached into bubbles and broke off in others. No systematic inspection of the inner structure was possible.

Figure 4: Cracks above the arches of the main nave (left) and in the vaults of the lateral ones (right)

Considering the entire building, both the collapse of the tympanum and the general crack patterns that developed in the interior appear associated to an important motion in the longitudinal direction, normal to the façade and along the nave. A global longitudinal mechanism concerning 3-nave churches and involving the same structural elements as in S. Biagio, i.e. lateral vaults, nave walls, and pillar bases, had been observed in other seismic events and was reported as a possible reference case in the damage evaluation form, although for a different vault shape (PCM-DPC 2006,a). The effects of motion in the transversal direction were less visible, probably also as a consequence of some degree of continuity offered by the location of the structure within a block. Yet, some effects were evident, witnessing the occurrence of a significant component of motion also in this direction. An example is found at the first arch between main and left naves: the through-crack that developed from the key upward shows clear sign of lateral sliding.

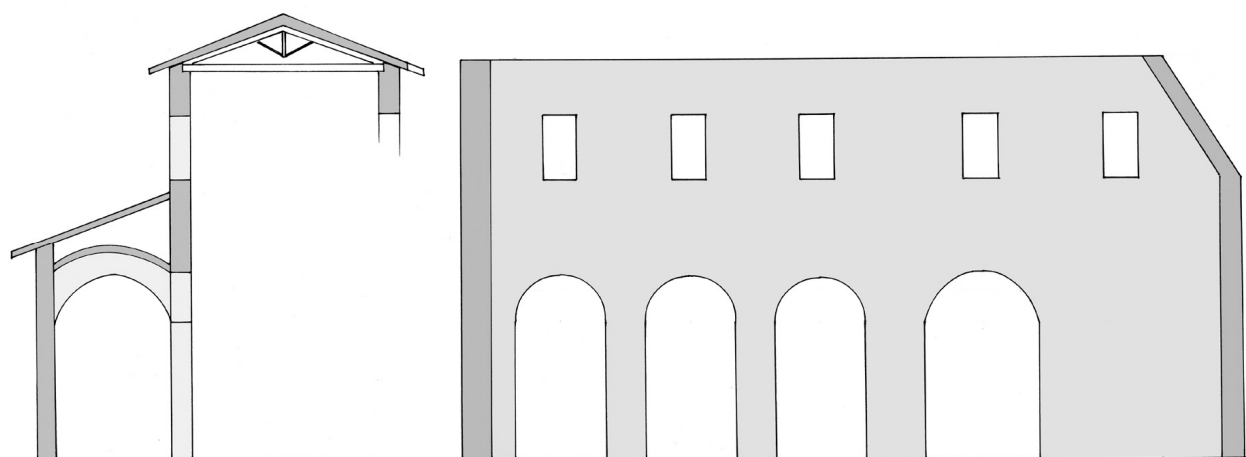
Figure 5: Transversal and longitudinal sections

In order to identify possible repair and strengthening strategies for the church as a whole, attention need to be focused on the two main longitudinal walls that border the central nave. These walls are the main resisting system of the entire complex, providing support to arches and vaults and to the roof structure. The longitudinal view of these walls is reported in Fig. 5 together with a transversal section showing the openings, i.e. the large windows, in the upper part and the arches in the lower.

As mentioned above, the church seems to have suffered the effects of motion in the longitudinal direction, which has been approximately the direction of propagation. Initial considerations and first computations, however, suggest that the structure is more vulnerable in the transversal direction. Considering the unrestrained upper part of these walls, above the lateral naves, that extends for approximately 6 m, a simple overturning equilibrium would result in a low collapse acceleration of the order of 0.15 g. The simple analysis of the structural masses has shown also that the weight increase due to the roof concrete slab is limited, compared to the weight of masonry walls underneath.
