Damage Assessment of Historic Earthen Sites after the 2007 Earthquake in Peru

CLAUDIA N and CANCINO B^{1,a}

¹The Getty Conservation Institute, Los Angeles, California, USA

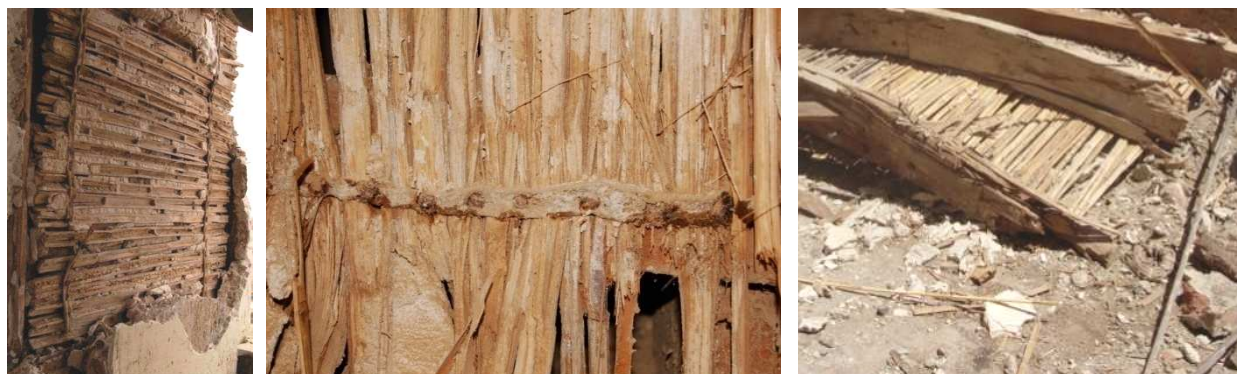
Quincha Deterioration Mechanism Most of the visited sites damaged by the earthquake were constructed with domes, vaults and walls made of *quincha*. Regular maintenance of these structures was expected during the Peruvian ancient and colonial times, including the occasional replacement of the wooden structural elements, cane reed and leather straps. With time and lack of maintenance, wooden elements were damaged by the presence of termites and the connections started to fail. The leather straps became brittle and the reed cane detached from the structure losing its flexibility and tensile strength. The state of deterioration of this construction system influenced the way buildings performed during the Pisco earthquake (Figs. 2-4).

Figures 2 (left): Detail view of cane reed after mud plaster detachment, Church of Chilca

Figure 3 (center): Detail of leather straps, Cathedral of Ica, Ica

Figures 4 (right): Detail of deteriorated wooden arches at Church of San José, Nazca

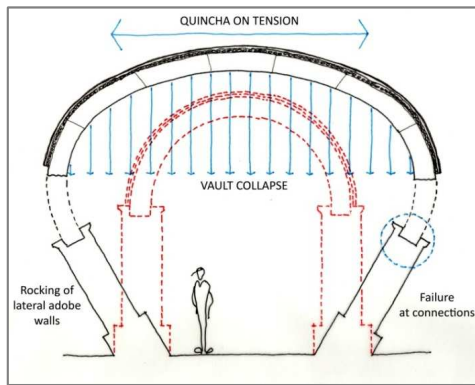
Partial or Total Vault Collapse As mentioned before, wooden structural elements and the cane mesh of the *quincha* were heavily damaged by termites. In the case of the vaults, the damage was observed at the wooden arches and at their connections to the top of the adobe walls, pilasters and front facades. Another pre-earthquake condition contributing to collapse is the presence of a heavy layer of dirt or cement mortar over the vault, probably due to lack of or inappropriate maintenance respectively. At the moment of the earthquake, the vault tried to restrain the rocking of the walls, adding stress to the deteriorated trusses and their connections until failure (Fig. 5).

*Figure 5 (left): Failure scheme mode of quinchá vault
(Drawing, C. Cancino, 2009)*

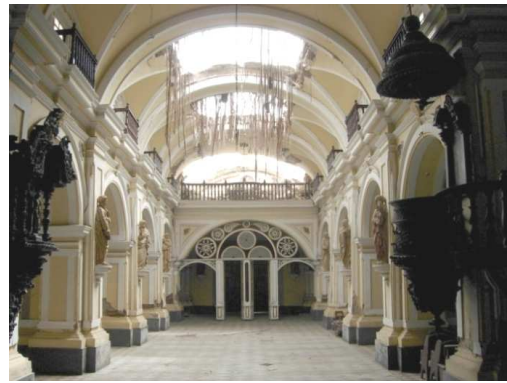
At the churches of Coayllo, Guadalupe and Humay, the presence of reinforced concrete arches at the end of the vaults stiffened the structure at both ends which in conjunction with the deteriorated arches induced the *quincha* vault to fail. At the Cathedral of Ica, the architectural configurations of the building as well as its maintenance helped to partially withstand the earthquake. The better seismic performance of preserved arches, the presence of the lunettes and side chapels between them prevented the total collapse of the vault (Fig. 6).

*Figure 6 (right): Cathedral of Ica after the Pisco earthquake,
where arches and lunettes stopped total collapse of quinchá vault
(Credits: J. Paul Getty Trust, 2007)*

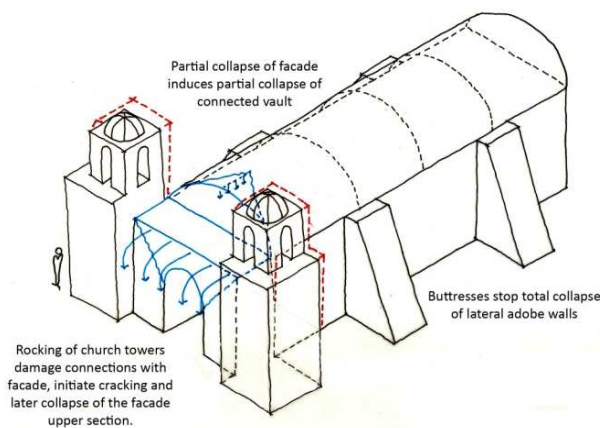
Out of Plane Collapse When entire vaults or domes collapsed, it was clear that walls (front facades or lateral walls) rocked until connections failed resulting in partial or total vault collapse. In the case of the Church of Guadalupe the concrete tower pounded the earthen façade until collapse of its upper section inducing partial collapse of the vault (Figs. 7, 8).

*Figure 7 (left): Façade failure as seen at the Church of Guadalupe, Ica
(Drawing: Claudia Cancino, 2009)*

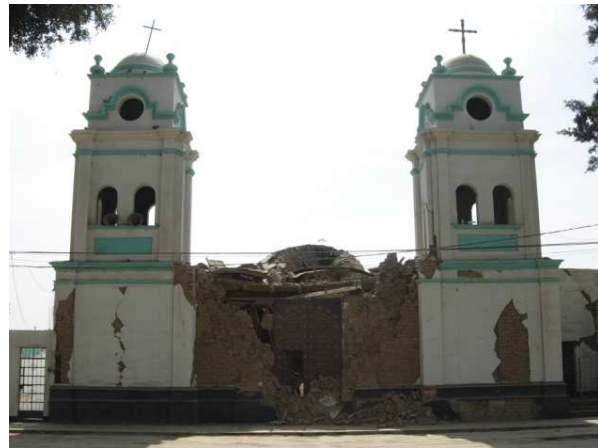
*Figure 8 (right): Church of Guadalupe after the Pisco earthquake where out of plane collapse of front facade induced partial collapse of the quinchá vault
(Credits: J. Paul Getty Trust, 2007)*

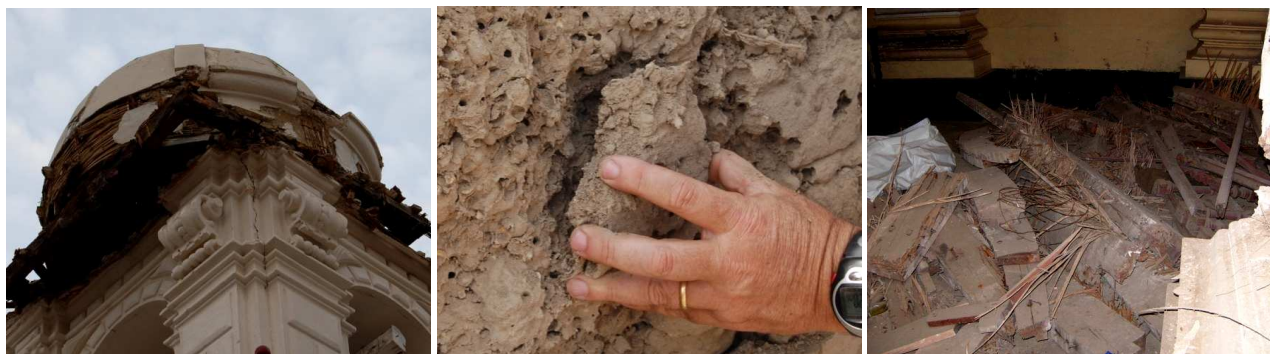
Figure 9: Upper dome of Hacienda San Jose Chapel: Connections deteriorated inducing loss of structural integrity (Credits: J. Paul Getty Trust, 2007)

Figure 10, center: Beetle damage at the adobe walls at the worker residences of the Hacienda Arona y Montalván (Credits: INC Lima, 2007)

Figure 11, right: Termite damage on wooden framework at Cathedral of Ica, Ica (Credits: J. Paul Getty Trust, 2007)

- Loss of structural integrity and lack of connections between damaged wooden elements of *quincha* vaults, pillars and walls, which isolated parapets, partitions, and façades, affecting their stability. (Fig. 9)
- Non-repaired structural cracking and weak mortar-block adhesion strength.
- Moisture damage to the *quincha* and adobe walls.
- Beetle damage in adobe blocks that reduced wall strength. (Fig. 10)
- Termite damage on the wooden framework of the *quincha* walls, which contributed to partial or total collapse of entire structures. (Fig. 11)
- Addition of different building materials and systems into the structure.
