Study on Relationship between Elastic Wave Profile and Stones' Condition in Angkor Monument

Keywords: Angkor Monument, masonry, elastic wave, deterioration

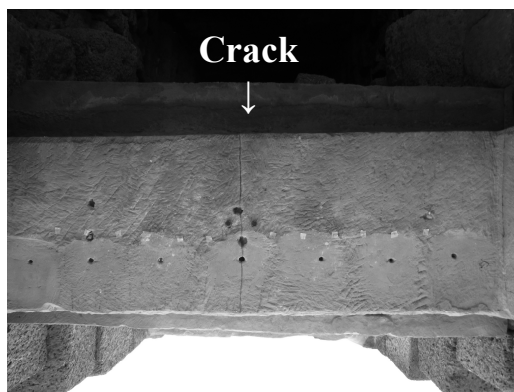
Figure 9: Beam of tower N1 western opening
(upward view)

Result of Sandstone Beam of Prasat Suor Prat Tower N1 Now, examination of a beam of western side of Prasat Sour Prat tower N1 is described. After the tower was restored, a crack was observed at the center of this beam (Fig. 11).

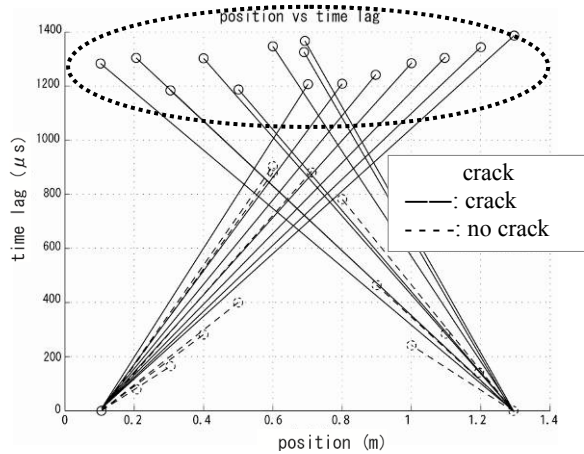
Figure 11: Position vs time lag

Normalized time history profile of elastic wave at each measured point is shown in Fig. 10, in which higher number of vertical line means the span between the first terminal and second terminal. In Fig. 11, the vertical axis shows the time lag between two terminals, and the horizontal axis means the position of two terminals. In comparison of solid lines (there is a crack) and dotted lines (there is no crack), it is resulted that the velocity of waves is lower and amplitude widely decays when there is a crack. This phenomenon was not occurred at a sound beam of northern opening where we conducted same examination. Fig. 12 also proves that velocity of wave with cracks is lower when span is same.

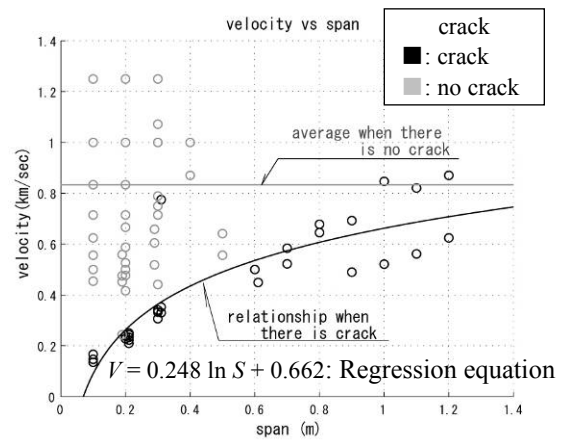
Figure 12: Span vs velocity

In Fig. 12, Eq.(3) shows that the velocity when there is a crack gradually converges to the average velocity when there is no crack as the span is longer. It means that the effect that the existence of crack decreases the velocity is reduced by the longer span. And, in Fig. 14, Eq.(5) shows the tendency of divergence decrease when there is a crack.

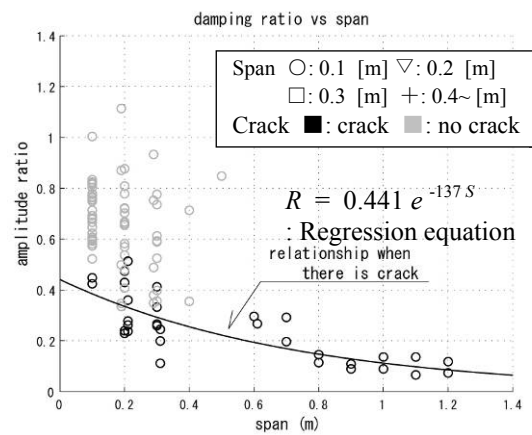
Figure 14: Span vs Amplitude ratio

As shown in Figs. 12, 13 and 14, when there is a crack between terminals, the regression equations of span S , velocity V and amplitude ratio R are represented as Eq.(3), (4) and (5).

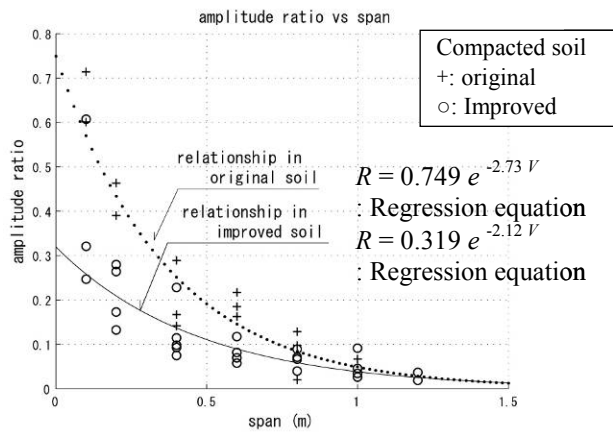
Figure 15: Span vs velocity

There is no large difference between both compacted soils' amplitude ratio (Fig.15). The velocity of improved soil is higher than one of original soil, which reveals that improved soil is more compacted than original soil. In addition, the place where we examined was recently re-constructed, and soil with calcium hydroxide, which was used for improvement of compacted soil, takes a long time to get strength enough. Therefore, we consider that the difference of velocity will be clearer if we test in an area taking an enough long time after improvement.
