## **Rehabilitation of Timber Structures and Seismic Vulnerability: a Case Study**

PARISI Maria Adelaide<sup>1,a</sup>, RIGGIO Maria Paola<sup>2,b</sup>,  
TARDINI Chiara<sup>1,c</sup> and PIAZZA Maurizio<sup>2,d</sup>

The occasion for applying the procedure to a heritage case study was offered by the rehabilitation now under way of a castle in the Trentino region, Italy. Castel Thun is an imposing building dating back to the 14th century. The timber roof trusses of the Loggia dei Cannoni (cannons loggia), in particular, were to be subjected to a very precise study of the geometry, of the characteristics of materials, of the details and state of conservation of the joints. Although the area where the castle is built is characterized by low seismicity, considering and possibly improving the seismic resistance of the structures would be required during a general rehabilitation program. A vulnerability assessment of the loggia roof structure was, therefore, performed with the double purpose to

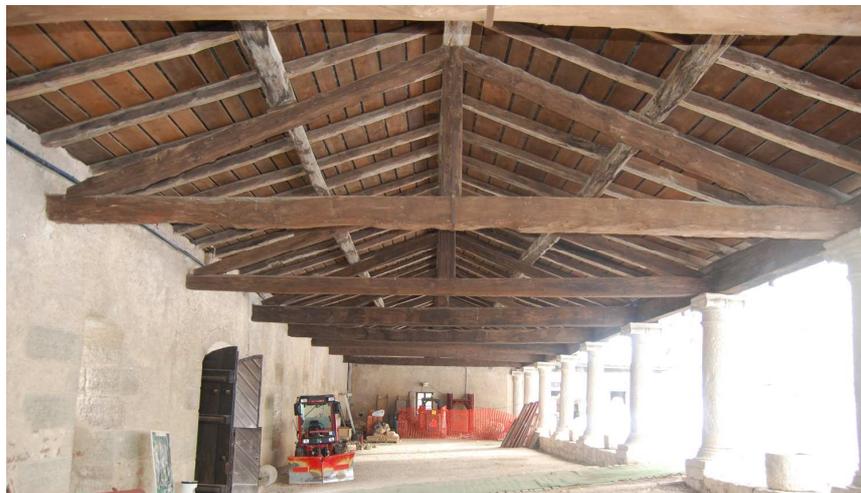
Figure 3: The Loggia, from east

Fig. 3 shows the structure concerned. The collection of data and information on the structure was the first step in the vulnerability assessment. Being performed by surveyors who were not the original developers of the survey procedure, this operation gave also some interesting feedback on the survey form (Fig. 4) that could be modified accordingly for greater clarity. Additionally, some points that had not been originally considered or sufficiently expanded and would not cover situations that occurred in the case examined stood out and brought to further modification. The most significant additions were related to the irregularity of member profiles varying along their span, the presence and type of previous strengthening interventions, and the need for indicating the quality of workmanship. The structure in exam was affected, indeed, by several irregularities and its quality was rather poor.

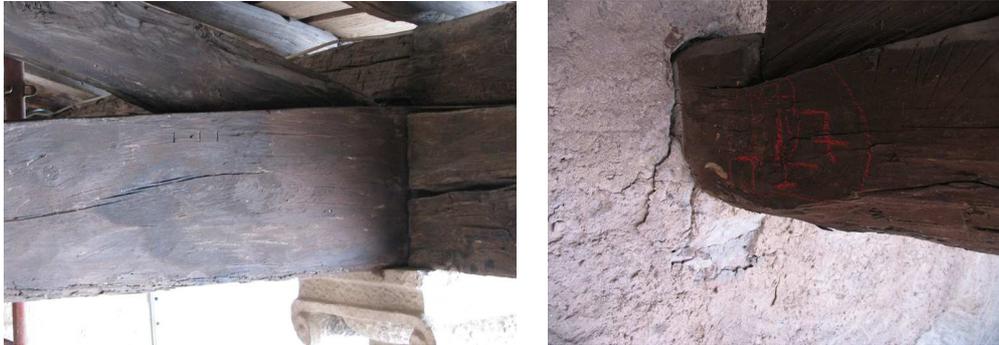
Figure 5: Truss supports; (left) with wall plate over a column; (right) into the northern wall

- truss elements had cross sections differing in size, aspect ratio and, at times, shape from truss to truss, but generally they were not insufficient;
- the fabrication of carpentry joints was rudimentary;
- the joints of rafters to tie-beams were mostly of the birdsmouth type; yet some nodes, (Fig. 5), had no indentation and the connection was based only on friction and on a limited number of nails; no other metal connectors had been applied, resulting in an unreliable assemblage;
- a similar situation was found at the connection of posts and rafters;
- a tenon - mortise joint connected the posts and tie-beams; some of the joints were closed with metal straps, loosely connected and intentionally inactive in normal working conditions.

- at the northern wall, tie-beams are built-in. The rafter to tie-beam node, however, is at a distance from the support, causing a bending moment on the wall as may be seen from damage in Fig. 5.
- on the opposite side, trusses are tenoned into a timber wall plate, which has a low degree of longitudinal continuity being formed by poorly connected or unconnected parts.

The situation of supports seems particularly critical, because their conditions point to a possible collapse mechanism. In case of loss of support from a column losing stability under horizontal forces, the segmented wall plate very likely would not be capable of redistributing loads to the remaining columns; one or more trusses, missing one bearing, would suddenly cantilever out of a wall that shows signs of damage already in the current conditions, with almost certain collapse of the truss-wall system. The rating is D.

The study summarized here has shown that the timber structure of the Loggia has a comparatively high level of seismic vulnerability, but has also indicated the critical aspects originating it. These causes of vulnerability could be mitigated with limited but well-addressed interventions.
