## **Seismic Vulnerability of Historical Structures: Damage State of the Abruzzo (Italy) Churches in the Sequence of the April 2009 Earthquake**

This paper focus on the effects of the 6<sup>th</sup> of April 2009 earthquake, that affected the region of Abruzzo (Italy), over the historical buildings of the region, in particular churches, by establishing a set of different objectives directed to the understanding of their structural behavior and to the assessment of the extent of post seismic damage in this structures.

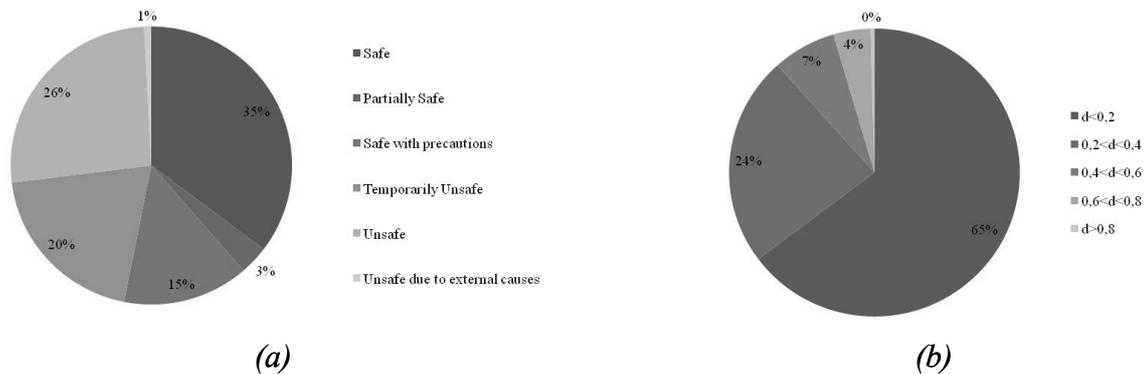
The UNIPD workgroup collaborated on the survey of 241 churches which corresponds to approximately 25.0% of all the surveyed churches, (Italian Civil Protection 2010). Of all the churches included in the database (241 in total) 35.0% were considered safe, 15.0% safe with precautions, 3.0% partially safe, 20.0% temporarily unsafe, 26% unsafe and only 1.0% unsafe due to external causes (Figure 2a).

In the following analysis, this interval of damage was divided in 5 subintervals, in order to allow a more intuitive interpretation of the results. From the analysis of the graphic presented in Figure 2b it is possible to conclude that the majority of the analyzed churches (65.0%) present a low damage index (below 0.2). A considerable percentage of churches (24.0%) are comprised on the 2<sup>nd</sup> interval of damage index (values between 0.2 and 0.4) presenting a medium level of damage. 7.0% of the churches present an intermediate index damage while other 4.0% reach values between 0.6 and 0.8, which are already very high. Less than 1.0% of all the surveyed churches have a damage index higher than 0.8, correspondent to a situation of almost total or even total collapse.

Figure 2: (a) Viability percentage (b) Damage index distribution

Although many times is expected a relation between the damage index and the safety, in this case this relation is not verified. However, it is possible to establish a direct relation between the damage index and the overall damage in the structure.

In the cases where a high damage index is obtained, it is almost sure that the church is unsafe, because it means that the entire church shows a considerable damage. In the other cases (when the damage index is low) two situations are possible. Either the damage is low/moderate but affects a big percentage of the church, or the damage is low or inexistent in the biggest part of the church, but shows a high value for a particular mechanism(s). In the first case, the church can still be considered safe, because the damages are not significant and probably will not lead to the collapse or unsafety of the structure. In the second case, although most of the church does not show a potential source of danger, a small part of it can be in danger, and it will define the unsafety of the whole structure, although in general the damage index is low. For this reason, it is not possible to define a direct relation between these two indicators (damage index and safety) but, instead, each case should be analyzed and studied individually.

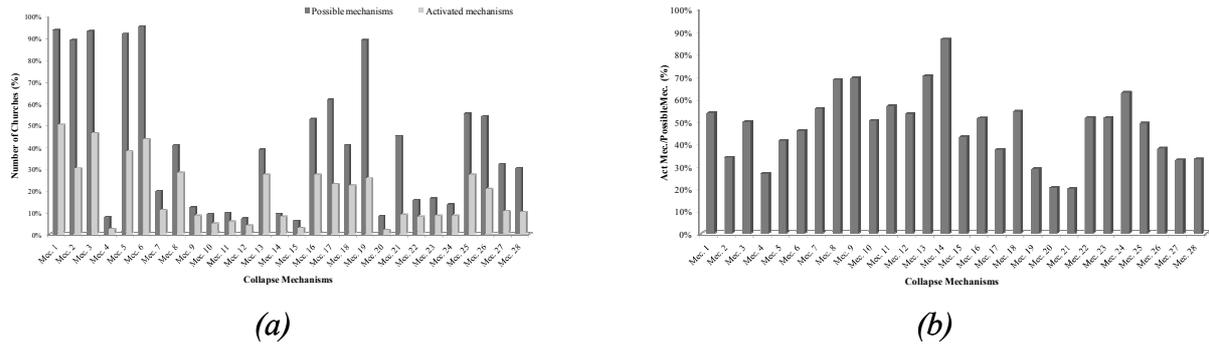
It is also interesting to analyze the most frequent collapse mechanisms that can be activated, depending on the church configuration, (Figure 3a). As expected, some of the mechanisms can be activated in most of the churches, while others are present only in on few.

The mechanisms number 1, 2, 3, 5, 6 and 19 appear as the most frequently possibly activated. These mechanisms are all related with the basic composing elements of a church, the ones that are always present: (i) frontal façade (the first three); (ii) nave, in particular its transversal response; (iii) lateral walls and (iv) roof. Most of the churches present in the database have only one nave, and this is the reason for the lower values of some mechanisms, which are only present in churches with more than one nave. This is the case of mechanisms number 7 (Longitudinal response of the columns) and 9 (lateral nave vaults). Also the mechanisms associated with the transept (10, 11, 12 and 20) have low values because most of the churches do not have this element in their structure.

In Figure 3b it is possible to analyze the percentage of activated mechanisms in the cases that it is possible their activation. According to the results although mechanism number 14 (related with the dome) is rarely possible, most of the times it is activated (around 85.0% of the cases). The most frequent mechanisms (number 1, 2, 3, 5, 6 and 19), although frequently possible to occur, are only activated around 50.0% of the times, or even less.

Figure 3: (a) Possible and activated collapse mechanisms. (b) Percentage of possible mechanisms in fact activated

It is notorious that all the mechanisms connected with the vaults (number 8, 9, 12, 18 and 24) show a percentage of activation between 53.0 and 69.0%, which is high. This is indicative of the vulnerability of the vaults, elements that are most of the times damaged. Also the triumphal arch (mechanism number 13) is activated most of the times, 70.0%, which is a considerably high value.

Conversely, the mechanisms related with the roof of the different parts of the church (number 19, 20 and 21) have low activation percentage (29.0% in the case of the central nave roof and equal or lower than 20.0% in the transept and apse cases).

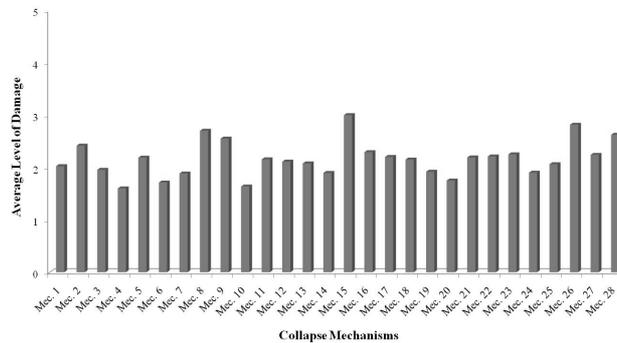
By dividing the total points of damage of each mechanism by the number of churches where the respective mechanism is activated, the average damage for each mechanism is obtained (Figure 4). Although the values are not uniform, they vary approximately between 1.6 and 3.0 in a scale between 0.0 and 5.0, where 5.0 correspond to the collapse of the structure.

Figure 4: Average damage for each activated mechanism

The mechanism 15, that regards the lantern, presents the higher damage index average ( $I_{dm} = 3.0$ ), and as so, it is possible to conclude that this is a highly vulnerable element. The projection elements, such as statues and pinnacles, also present a high vulnerability in agreement with its usual poor supporting and equilibrium conditions. The mechanism 26 related with these elements presents a  $I_{dm} = 2.82$ . Also in the case of mechanism 28, that regards the belfry, the average damage index is also relatively high when compared to the others ( $I_{dm} = 2.63$ ), and as so, presents itself as a very vulnerable element. In what concerns these two last mechanisms (26 and 28), their high level of average damage index and of activation is easily corroborated by the fact that, almost all the churches, that present this type of constructive elements, underwent an intervention that comprised their temporary stabilization, as part of the provisional post earthquake interventions, (Vigili del Fuoco 2010) and (Modena et al. 2009).

The mechanisms 8 and 9 (central and lateral naves vaults) show a high average damage index of 2.70 and 2.55, respectively, and are activated in approximately 70.0% of the cases.

On the other hand, the mechanism 4, that concerns the porch and the shear mechanisms in the lateral walls (mechanism number 6), present a low damage index average, as well as the transept and central nave roofs (19 and 20), what can be indicative of the lower vulnerability of these elements to the kind of loads introduced by this earthquake.

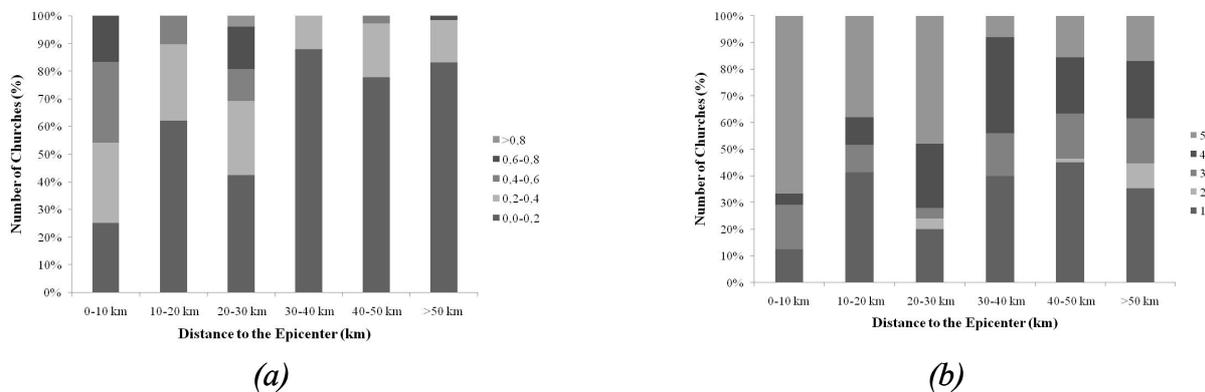
Figure 5: (a) Relation between the damage index and the distance to the epicenter. (b) Relation between the viability and the distance to the epicenter (1 - safe; 2 - partially safe; 3 - safe with countermeasures; 4 - temporarily unsafe; 5 - unsafe)

In Figure 5a it is possible to observe that, in the first area considered (up to 10.0km from the epicenter), the percentage of churches with a damage index below 0.4 is the lowest of all the considered intervals. Curiously, this is not the area that presents the highest damage index, but it is the area with the biggest percentage of cases in the range from 0.4 to 0.8, ( $\approx 55.0\%$ ), which is already a very high level of damage, indicative of which is the condition of the churches in this area, in general very damaged.

On the range from 10.0 to 20.0km its possible to observe a noticeable decrease on the damage index in respect to the first interval. Aproximatly 60.0% of the churches in this area show a damage index below 0.2 and almost 90.0% bellow 0.4. Only 10.0% of the churches present a relatively high damage index (0.4 to 0.6).

Between 20.0 and 30.0km, the damage index shows higher values, in some cases it even surpasses 0.8. There is also a high percentage of churches with a damage index in the range 0.6 to 0.8. These higher values can have different explanations, depending on each particular case, but many times they are due to site amplification effects, in particular areas, which lead to a higher seismic action in these locals and, consequently, a higher damage index in the correspondent churches. Another possible explanation, although not confirmed, can be related with the fact that these villages around the main city (L'Aquila) were in general reserved to people less wealthy, what can have imposed a poorer quality of the materials and the construction of the churches in these places and, consequently, a worst response to the earthquake. On the other side, the center of L'Aquila used to be occupied mainly by people with a lot of possessions, who could apply their money in the construction of strong and imponent churches that nowadays show a better seismic response. This question is here presented as an hypothesis, which could be an interesting subject to deepen in further studies. Still in this range (20.0 to 30.0km), aproximatly 70.0% of the structures present damage index lower than 0.4.

Between 30.0 and 40.0km the damage index reduces drastically, the same can be said for the sucessive considered intervals, 40.0 to 50.0km and >50.0km. In these intervals almost all the churches have a damage index below 0.4, being that 80.0 to 85.0% of the cases are under 0.2.

In Figure 5b the relation between distance to the epicenter and the safety of the structures is described. On the first three ranges, defined for the epicentral distance, the percentage of unsafe churches is higher, in particular on the first range (up to 10.0km from the epicenter) where the percentage amounts to 65.0% of unsafe with an adicional 5.0% of temporarily unsafe cases. On the epicentral range, 10.0 to 20.0km, the distribution of the safe (including the safe and the ones safe but with percautions) and unsafe (including the unsafe and the temporarily unsafe) structures is more or less 50.0/50.0. As for the interval 20.0 to 30.0km the percentage of unsafe churches (including the

temporarily unsafe) is similar to the percentage of the first interval with the difference that, in this case, the temporarily unsafe churches present a higher percentage ( $\approx 25.0\%$ ).

On the last three considered intervals it is noticeable a sharp reduction in the unsafe structures (variation between 8.0 and 17.0%), while the percentage of temporarily unsafe structures increased. On the other hand, the number of structures considered safe increased, varying between the 35.0 and the 45.0%.
