The Behaviour of S. Agostino Church during 6th April 2009 Earthquake in L'Aquila: Vulnerability and Damage Assessment

Abstract The church of S. Agostino in L'Aquila was built at the beginning of XVIII century, replacing an older church collapsed during the strong earthquake of 1703. The building has a central layout. During April 6th earthquake, it suffered many damage. The lantern collapsed. Severe cracks concerned the hall-drum-dome elliptical system, the apse and the bell tower. Moreover, the façade was subjected to an overturning mechanism. The elliptical layout of the building induced a mainly longitudinal seismic response. In the paper, an extensive description of the damage is provided. Moreover, the seismic behavior of the church is discussed on the basis of observation of damage and vulnerability features of the structure. A correlation between damage, vulnerability and seismic actions is finally proposed.

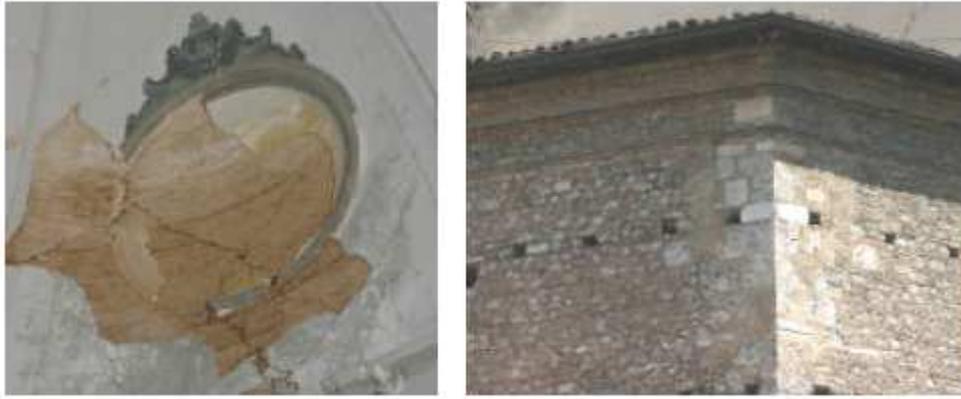
Figure 3: Material of the dome (left) and vertical walls (right)

The structure is made of masonry. By a visual analysis, it has been assessed that all arched or vaulted elements and lintels are made of brick masonry of good quality (Fig. 3, left), while vertical structures are made of rubble stone-brick masonry of medium quality (Fig. 3, right). The connections between vertical walls are made of good quality stone masonry.

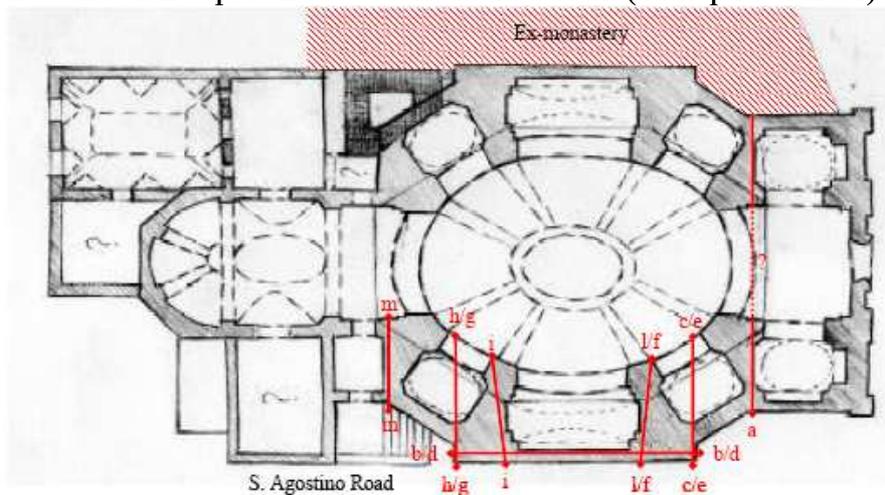
Figure 4: Scheme of assessed iron ties

In some case, typical wood ties are visible above lintels. Iron ties are not visible within the building; however, iron bolts visible on the external walls state their presence. Fig. 4 shows a scheme of the iron ties defined on the basis of visible bolts. The asymmetric distribution of ties may be observed: the ties are concentrated on the free side of the building, toward S. Agostino street. On the opposite side, adjacent buildings (ex-monastery of S. Agostino) contrast the movements of the church.

The main body of the church, constituted by the elliptical hall and dome-drum system, has bracings of different stiffness in the longitudinal and transversal direction. In fact, in the transversal direction, very stiff buttresses, together with adjacent buildings and ties, are present. In the longitudinal direction, only the walls of the apse and two walls in the atrium (both quite slender) act as bracing.

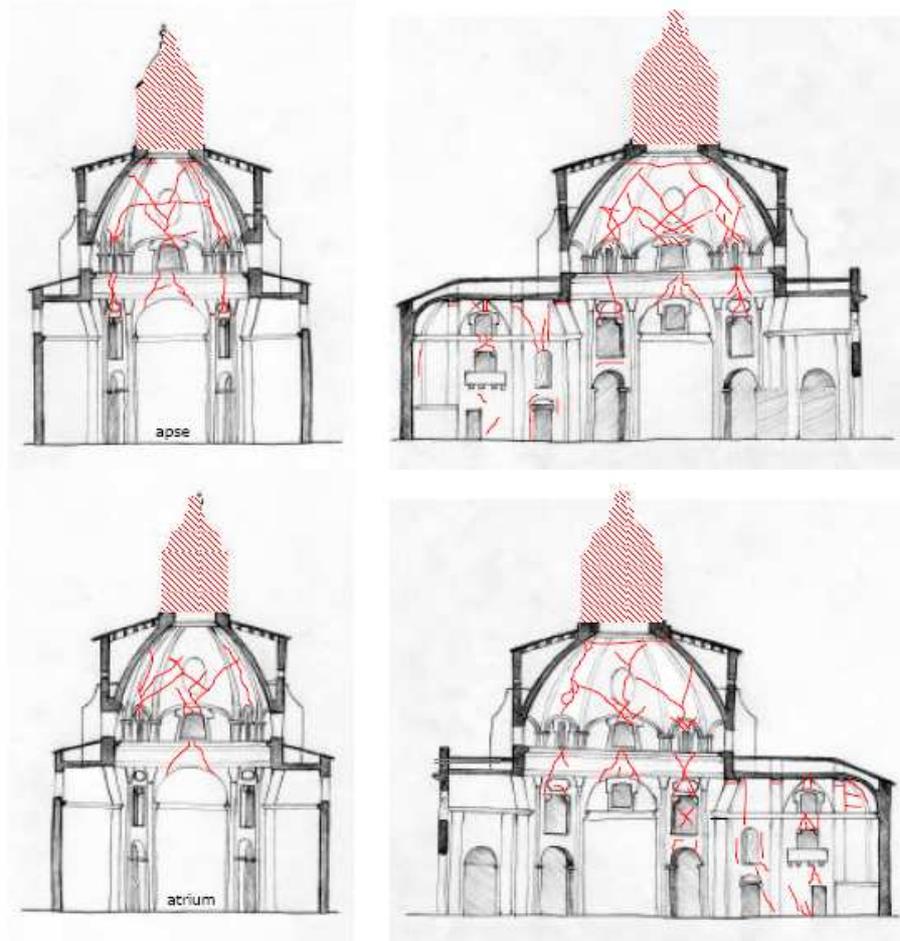
Figure 5: Crack pattern of the church.

Fig. 5 shows the damage pattern of the church after 6th Aprile earthquake. Main damage of the building occurred in the dome-drum system. The lantern totally collapsed. The dome and the drum has severe diagonal cracks on all sides, with particular concentration on the openings (Fig. 6a). Some of the lintels of drum openings collapsed (Fig. 6b). Moreover, a crack on a parallel of the dome developed on the side of the apse (Fig. 6c). Cracks are also present at the base of the drum, in the big arches separating the hall from the lateral chapels. Shear cracks on the lateral walls and the vault of the apse are visible. Finally, cracks denouncing a partial rotation of the façade are visible on the external walls.

The church was seriously damaged by the earthquake. Main damages occurred to the dome-drum system and to the lantern. The lantern, which was rebuilt in early '80, collapsed (the light steel structure was found at the base of the building after the earthquake). A complete analysis of the crack pattern shows a prevailing response along the longitudinal axis, along which the stiffness of the structure is lower. The calculation of the safety index showed that preventive analyses concerning the vulnerability of the structure and site hazard could have suggested the adoption of interventions to improve its seismic response. At present, possible interventions are: the injection of cracks and the external cerclage of the dome-drum system with FRP strings. The reconstruction of the lantern will require an accurate study to define its optimal weight and stiffness. Longitudinal steel ties should be finally inserted along the apse, presbytery and atrium walls.
