Seismic Vulnerability of the Dey's Palace (Algiers, Algeria)

AMINA Abdessemed-Foufa^{1,a} and HAYET Bendjedia²,

Keywords: Vulnerability, static weakness, wind-bracing, Palace of the Dey, Algiers, Algeria

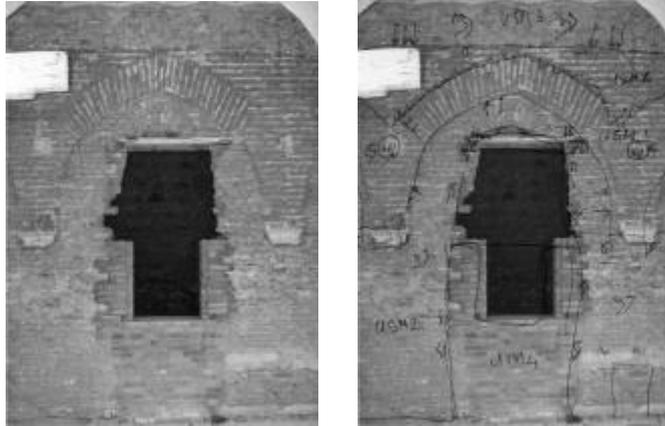
Construction of the Dey palace began on 1596-1599 as a janissary citadel. It involved, in the first place, the construction of the full perimeter, including magazines surrounding the patio, a walk way, the powder keg and the janissaries' *diwan's* room. This study on the palace showed that several actions of construction, demolition and rebuilding took place successively in time. Unfortunately, we do not have any dating. Only the materials and the techniques of construction have reveals these actions. The architectural stratification applied to the patio of the palace showed that constructive strata are characterized by negative and positive actions of construction and of transformation's actions which modified what existed. The periods of use which interpose between the successive constructive phases express by entropic degradations due to the use of the palace, as well as natural deterioration due mainly to the earthquakes and to the action of the atmospheric agents (marine salt). The architectural stratification thus appeared by layers; which represent different remanent parts of the various founder's shares which occurred throughout the history of this building as well as negative interfaces which are the demolitions traces. The example of the south-eastern part of the ground floor represents the negative interfaces because there were demolitions then positive interfaces representing the rebuilding of these same interfaces (Fig. 5). While the south-eastern face underwent

many phases of construction. On the part of this patio's frontage (gallery wall), negative interfaces due to the demolitions and positive interfaces due to the rebuilding of these same negative interfaces are visible. The architectural layers for this wall are laid out in various directions.

Figure 5: South-eastern frontage with the various layers and interfaces (Foufa 2006)

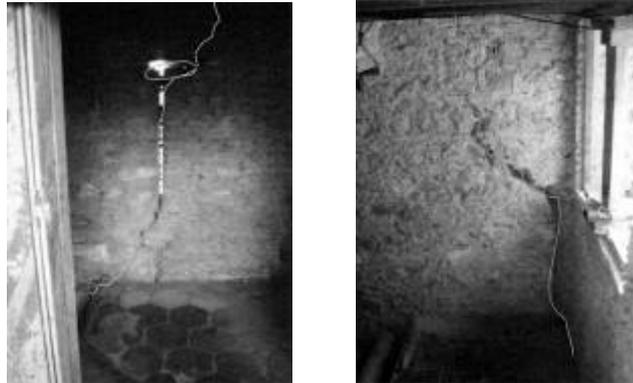
Cracking in Walls and Façade: Cracks exist in walls of both spaces. Vertical and oblique cracks have developed across the bricks masonry walls extending to all their depth and can be also

recognized in exterior. These cracks are due to the ageing of materials, the excessive loads and effects of the earthquakes (Fig. 7a). In the stair-well the orthogonal walls are not connected that induced the vertical cracks (Fig. 7b).

Figure 7: a-Vertical cracks; b- vertical cracks in the corner (Foufa 2006)

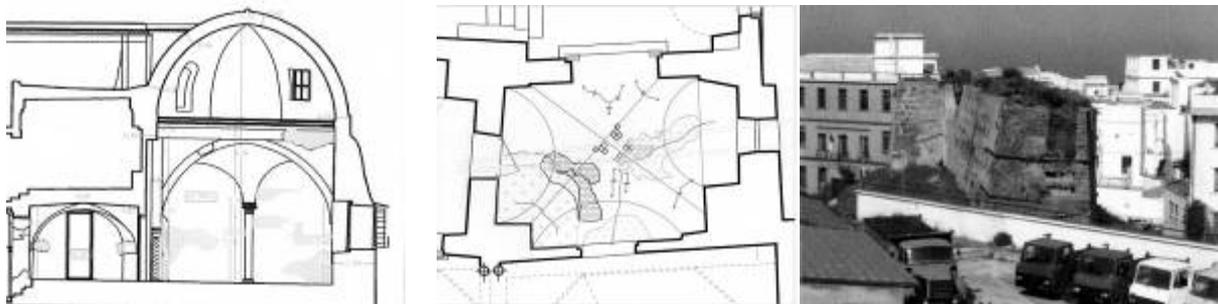
Cracking in Vault: In the cross vault of the music room (Fig. 8a), cracks have developed following the keystone of the transverse sides (Fig. 8b). These cracks are due to the horizontal displacement of abutment which is due to the destruction of the city-wall which acted as wind-bracing to this massive block of constructions (Fig. 8c).

Figure 8a: Section through the music room (PKZ 1980); b- Cracks in the cross vault. (Foufa 2006); c- External view since the room of music of the remainder city wall (Foufa 2006)

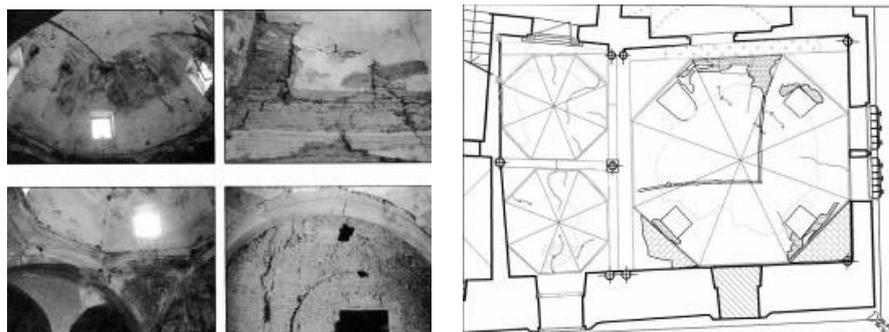
Cracking in Cupola: In the octagonal cupola cracks have developed following the transverse sides (Fig. 9a and Fig. 9b). These cracks are due to the horizontal displacement of abutment which is due to the destruction of the city-wall which acted as wind-bracing to this massive block of construction.

Figure 9: a and b- cracks in the octagonal cupola (Foufa 2006)
