Seismic Behavior of Some Basilica Churches After L'Aquila 2009 Earthquake

Abstract In this paper the seismic response of four church buildings in the l'Aquila April 2009 earthquake is analyzed. The buildings are: St. Giusta church, St. Maria di Collemaggio Basilica, St. Silvestro church and St. Pietro di Coppito church. The analyses are carried out by employing a "two-step" procedure suggested by the authors and already applied to similar case studies. The first step consists in three-dimensional linear analysis, while in the second step, two-dimensional non-linear analyses of macro-elements are carried out. The results coming from the two-steps, allow for understanding the observed damage and for approximately assessing the seismic level of the building.

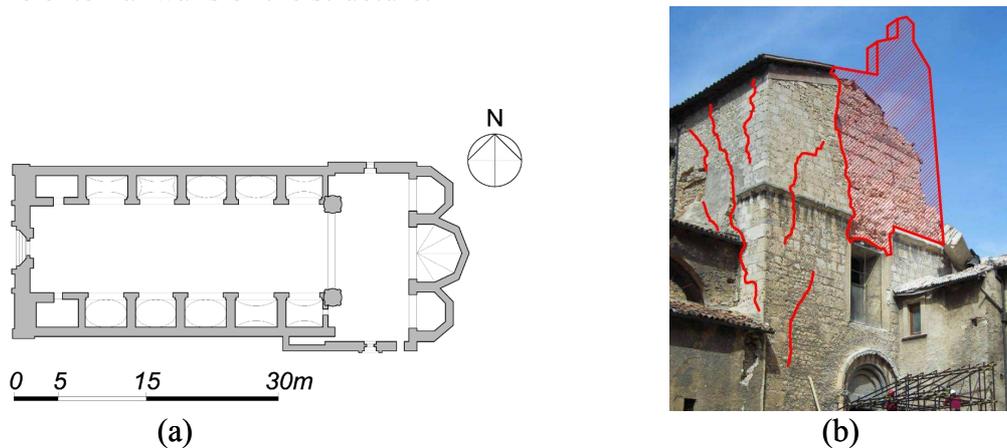
Figure 1: St. Giusta church: plan (a); damage at transept (b)

The severe damage due to the earthquake consists in partial collapses, essentially due to the overturning mechanisms of a portion of the apse and of the south wall of the transept (Fig. 1b); localised damages (crushing and disgregation) have been also noticed in the columns of the triumphal arch under combined compression force and bending moment.

Finally it has been observed a complete separation between lateral chapels and the walls of the central nave, probably due to the fact that the walls of the chapels were realized in a later phase with respect to the external walls of the structure.

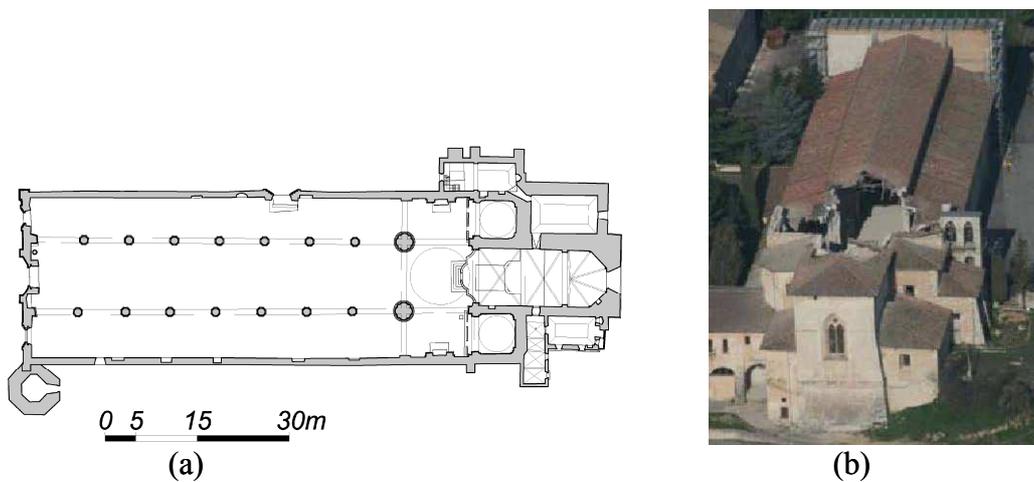
Figure 2: St. Maria di Collemaggio church: plan (a); collapse at transept (b)

The seismic damage is mainly concentrated in the zone of presbytery; in particular, total collapse of the transept and partial collapse of the apse have been observed. Also the pillars of the nave have suffered damage, namely vertical crushing cracks due to the longitudinal response and the significant vertical component of the earthquake strong motion.

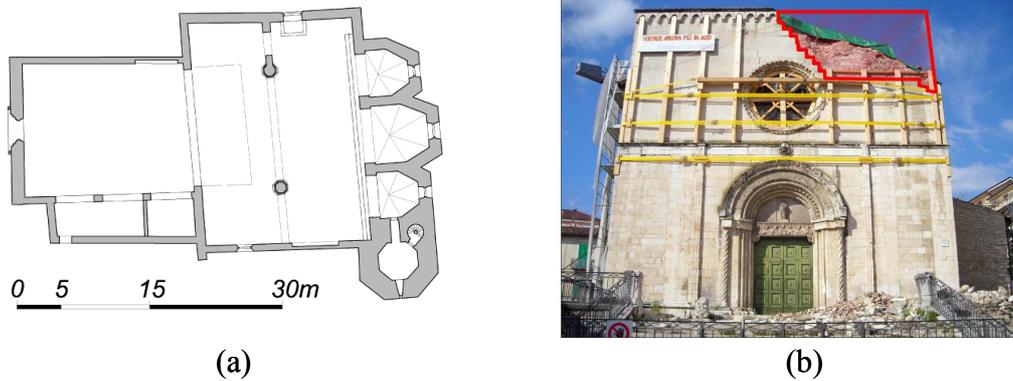
Figure 3: St. Pietro di Coppito church: plan (a); damage at the façade (b)

along one side only; also the transept is large and almost square in plan, while the apse is constituted by three polygonal chapels. The church has one of the rare bell towers in the city of l'Aquila. Similarly to the other cases, the masonry walls are realized in sack masonry and free stone, while the roof structures are wooden trusses, with the exception of the cross vaults covering the apse chapels. The severe damage consists in overturning mechanism of the façade (Fig. 3b) and in the partial collapse of the bell tower, that in turn has provoked the collapse of the apse roof.

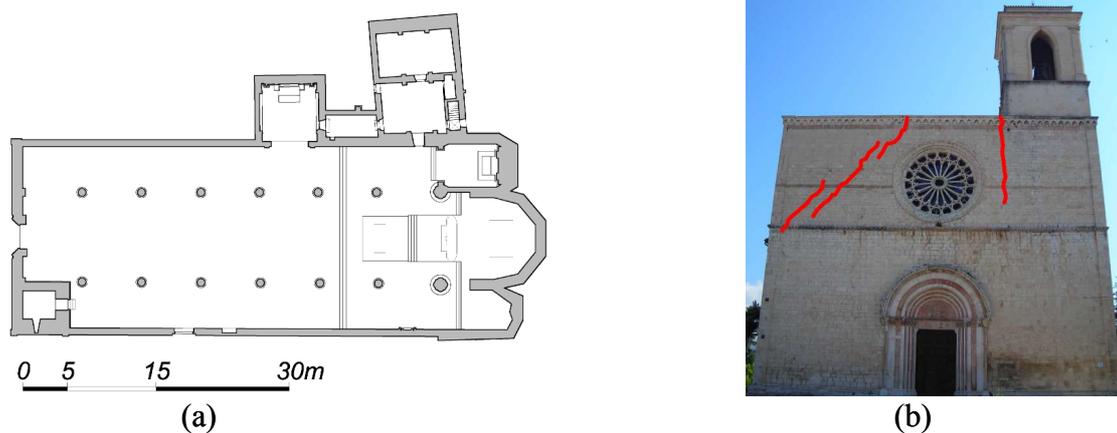
Figure 4: St. Silvestro church: plan (a); damage at façade (b)

With respect to the other case studies, the St. Silvestro church has shown very limited damage, mainly concentrated in the bell tower, where cracks caused by the seismic overturning moment can be observed. Also the façade shows some damage due to both the activation of partial out of plane overturning mechanism, and the dynamic interaction between the façade and the bell tower.

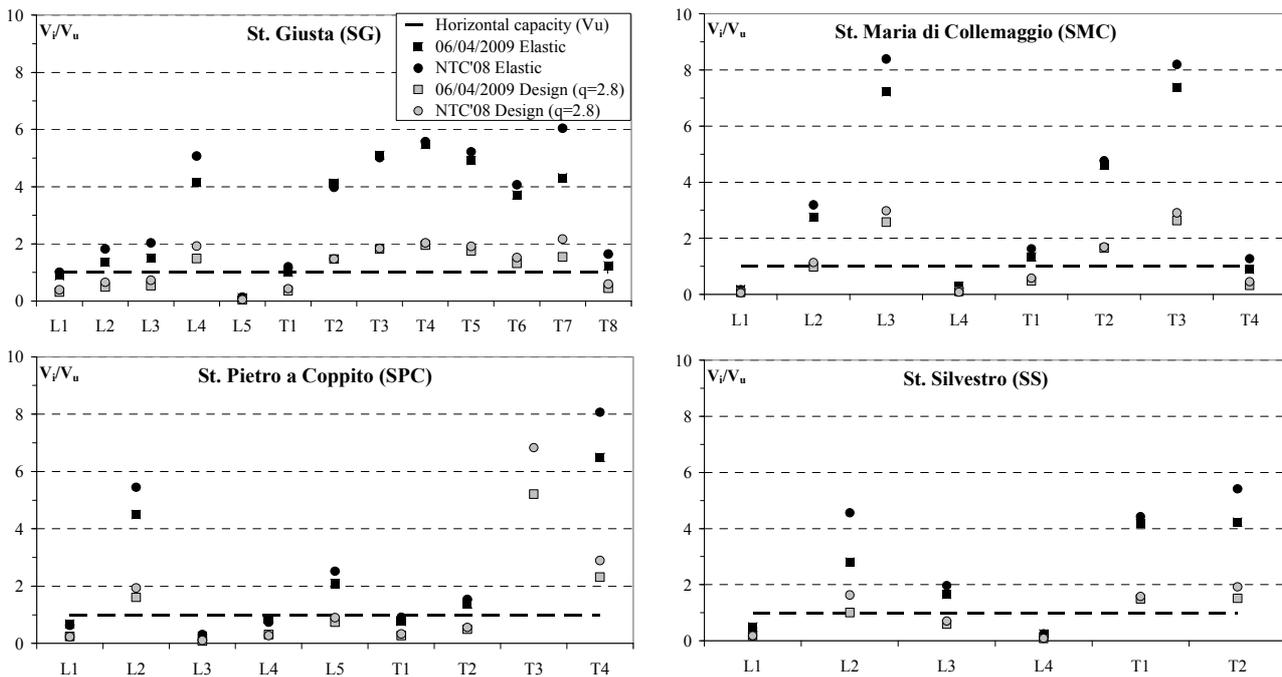
Figure 8: Macro-elements: ratio between horizontal strength demand and horizontal strength (V_i) capacity (V_u)

In Fig. 8 the ratio of strength demand (V_i) to capacity (V_u), is provided for each macro-elements; in particular the strength demand has been calculated both ad “elastic” and “inelastic” demand, i.e. according either to elastic spectrum or inelastic design spectrum.

It can be noted that, with the exception of some perimeter elements, the macro-elements of churches usually have a strength capacity smaller than the demand counterpart ($V_i/V_u > 1$). These results, together with the observed damage patterns, confirm the high seismic vulnerability of churches.
