Efficiency of CFRP Strengthening of Arches Tested by Failure of Historical Building after the Inappropriate Repair Intervention

Keywords: Masonry arches and vaults, CFRP strengthening, testing of repair efficiency

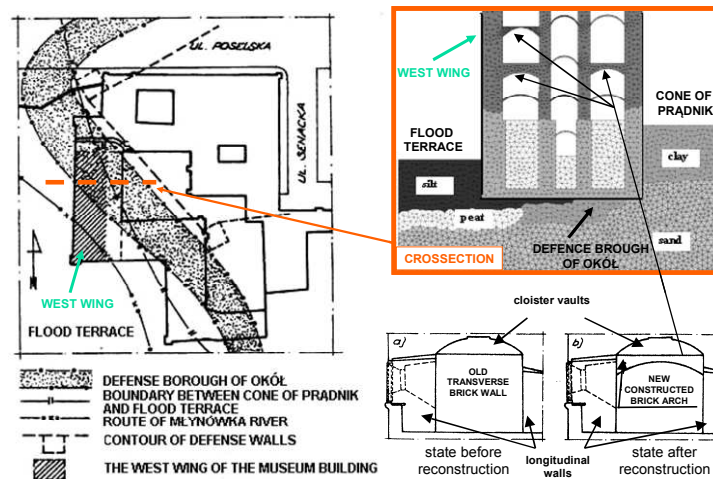
It counteracted huge uneven settlement of the West Wing because of weak layer of soil (peat) under foundation (Fig. 1). A trace of the past failure is visible in permanent vertical deformation of the masonry support of a rafter framing covering the structure (Wolski et al. 2006). Settlements investigated by geodesic measurements showed level differences of over 10 cm between the outside and interior walls caps (Fig 2a).

Figure 1: Location of the West Wing and states before and after reconstruction
- (after Ciesielski et al. 2004)

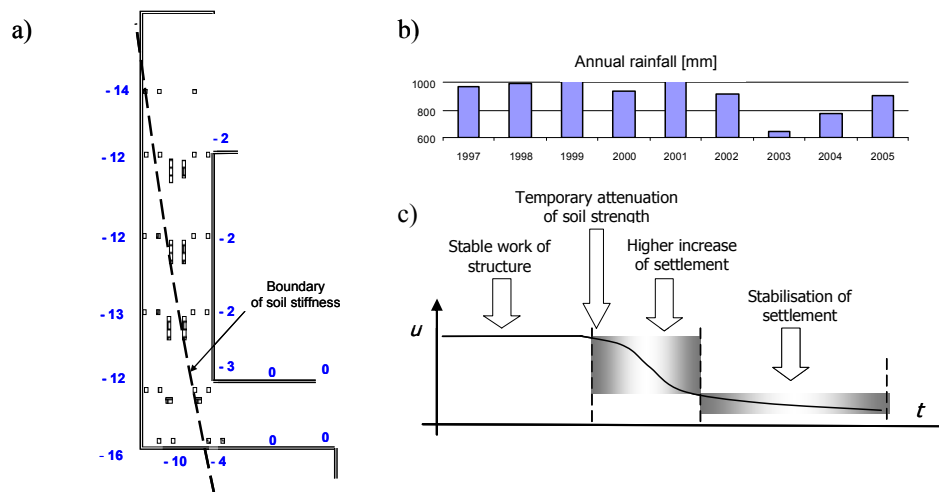
Figure 2: Distribution of settlement values (in cm) at caps of masonry walls of the West Wing (a), annual rainfall in Cracow in years 1997 – 2005 (b) and scheme of settlement process (c)
- (after Wolski et al. 2006)

Unfortunately, the other way of repair was chosen for realization by the administrative decision body, leaving out the given expert opinion. They decided to strength first foundation using dozens of micro-piles going through limestone foundations and next to stiff the whole structure. This decision caused dangerous results. In December 2006 was started constructing of micro-piles, causing vibration of whole structure (by limestone drilling) and liquefaction of the weak soil under foundation. Application of micro-pals weakened the peat soil layer causing rapid settlement of the building part of value 10 mm in two days (Fig. 4). The settlement started stabilizing up to value of 18 mm after six month (Fig. 2c) after stopping of palling.

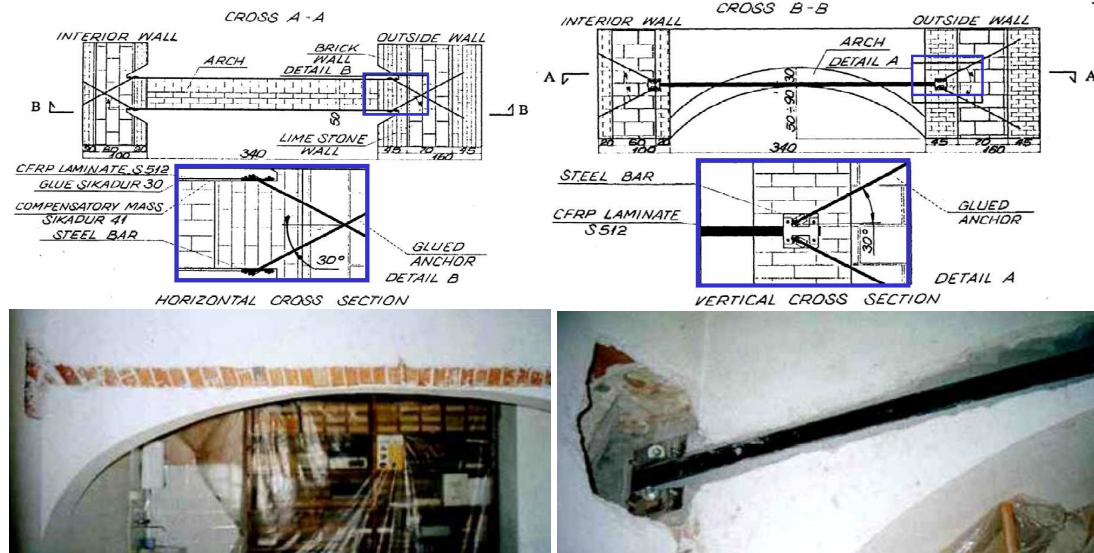
Figure 3: Strengthening of arches in the West Wing - (after Ciesielski et al. 2004)

appeared new fissures at the arches, indicating that the support balance of the strengthened arches was upset, generating additional deformation and stress in the CFRP laminates (see arches C and E in Fig. 5) and also in the anchors (Fig. 3). It should be noticed that work of the arches strengthening (Fig. 3) and constructed steel frames (Fig. 6) survived the structure from catastrophic consequences.

The weakest part of the strengthening system (CFRP laminates on both site of the arch - Fig. 3) is the anchorage in masonry walls, projected for the maximum longitudinal force of 78 kN, which corresponds to stress of 650 MPa for one CFRP laminate (23% of the ultimate strength). After rapid settlement, the fissures at arch E opened up to 0.424 mm (Fig. 5), causing the CFRP strain of 0.42%. Thus the calculated real longitudinal force in the strengthening system was of 82 kN, which overcomes the projected value of 7%. As a consequence, slip of anchors (0.084 mm) of arch E was occurred causing redistribution of stress in arches E and C working on both floors. It is visible in comparison of simultaneous deformations of CFRP laminates of arches E and C. The sum of elongation (Fig. 5 for 06.02.07) equal to 0.660 mm (0.424+0.236) was changed to the sum of elongation (Fig. 5 for 12.03.09) equal to 0.645 mm (0.340+0.305), indicating loss of deformation energy. This stress redistribution was caused by works stiffening the whole West Wing (2007-2009). Stiffening structure consisted of steel ring beams mounted on longitudinal bearing walls at the floor levels, joined transversally using of pre-stressed steel bars. This strengthening structure was hidden under plasters covering the historical building. Actually, the West Wing is stiffened as a box and protected against structural uneven deformations. The repaired rafter framing allowed for adaptation of the space for new utility rooms. A project of soil strengthening is still under construction.

First investigations carried out by experts from the Cracow University of Technology were lasting for over 2 years (1996-99). The final conclusion from observations was that the damaged structure works stable according to settlement (Fig. 4 – up to data 19.03.99) but cracks width were changing with temperature fluctuation causing growing trend of crack opening. Dynamism of this process threatened with loss of stability of arches and vaults, supported by strutting longitudinal walls (Fig. 5 – up to data 19.03.99). Strengthening of arches was projected in the year 1999 and constructed in the West Wing in the year 2002. It had to join the longitudinal bearing walls and cracked arches to allow them carry additional horizontal loads from thermal wall movements and from potential loads

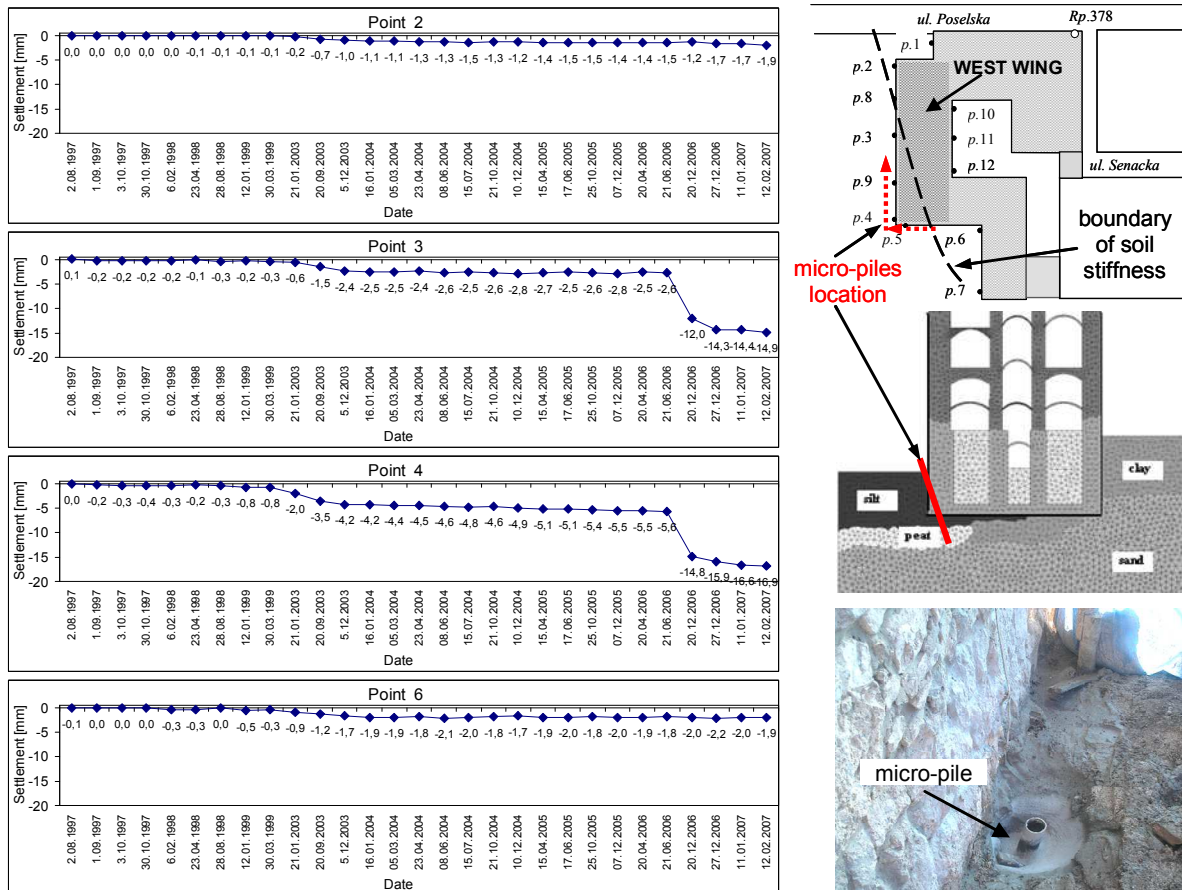
Figure 4: Settlement of the West Wing in the period 1997-2007 and location of micro-piles

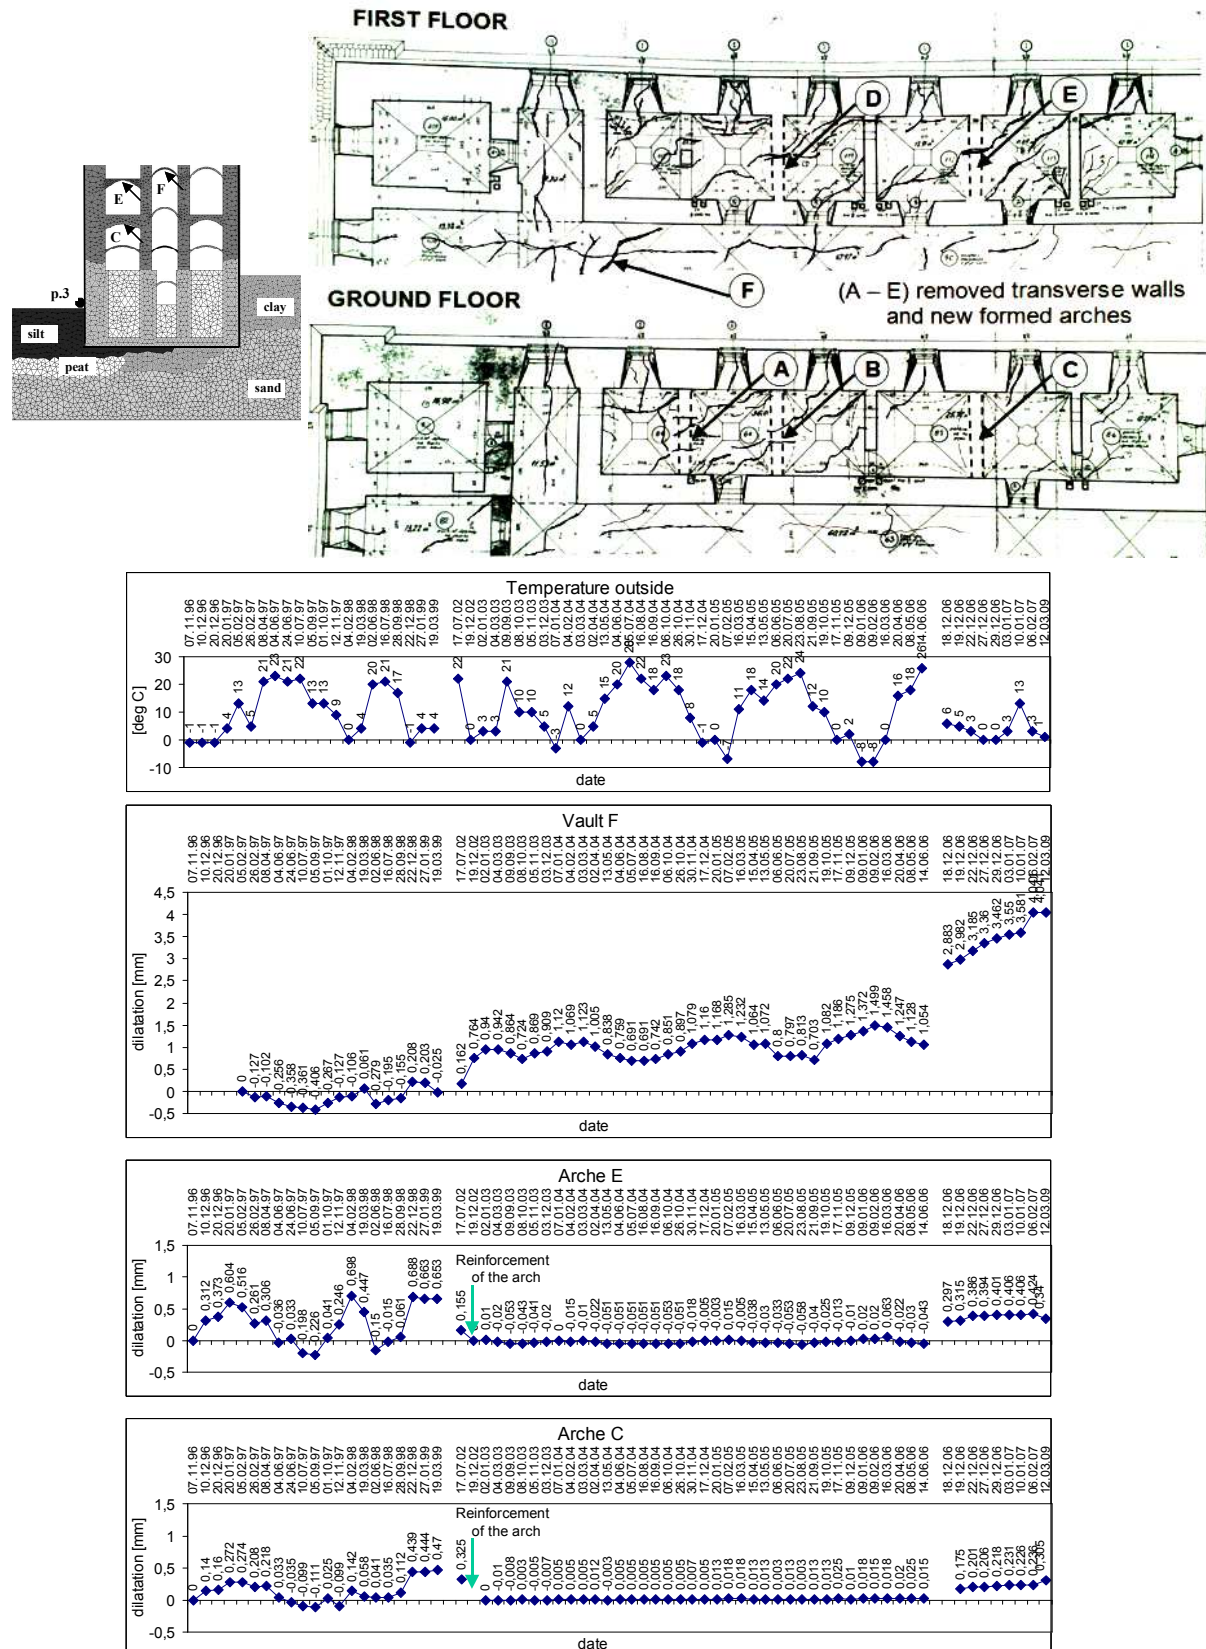
Figure 5: Changes of dilatation of fissures and cracks at the vault F and the arches C and E

Over four year's observations of changes in the width of fissures in repaired arches showed that the strengthening worked properly according to the designers' expectations. There was not observed any increase of fissures dilatation at arches (C and E in Fig. 5) after increase of settlement in the period 1999-2006 (Fig. 4), when such increase was observed at vaults (F in Fig. 5) caused simultaneously by settlement and season temperature changes (Ciesielski et al. 2004, Flaga 1998). The reason of small settlement in the period 1999-2002 was lowering of ground water level during constructing of a deeply founded hotel (at the distance of 400 m from the West Wing), but meaningful settlement in summer 2003 was caused by drought in Cracow with a consecutive stabilization after spring rainfalls in the year 2004 (Fig. 2b, 2c). One exception is observed in the case of the West Wing corner (point 4 in Fig. 4), where small permanent settlement appears, caused by the damaged drainage and sewage system, breaking foundation stability in weak soil layer build of peat (Fig. 1).

Because of this movement, new cracks appeared on vaults and walls up to 2.5 - 3.0 mm width and the old ones opened increasing they width of similar value (see vault F in Fig. 5). Additionally, there

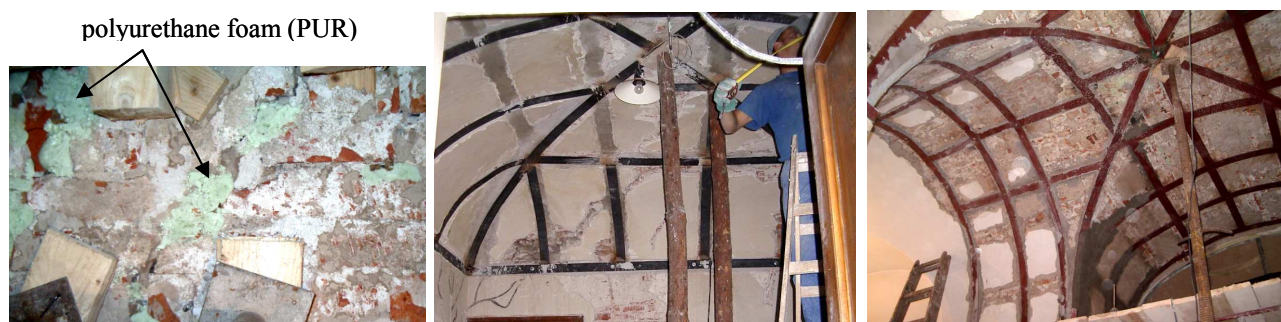
Figure 6: Repair of vaults using of PUR foam and strengthening using of steel frame

Worrying changes of crack dilatation in vaults and also observed character of damages and deformations forced realization of vaults structure inspection. It showed necessity of rapid repair of some cracked vaults, because they were about to collapse (bricks were kept in some places only by thick layer of plaster). Two kinds of minimum intervention have been applied in years 2003-2005. In the first case, main cracks were filled with PUR foam (in places where such intervention was enough) (Kwiecień 2004), making polymer flexible joint and retaining this way natural dilatation of damaged building (Croci et al. 2000, Kwiecień et al. 2006). In the second one, two vaults (one cloister vault over a room and one cradle vault over the corridors cross-section) were strengthened using of supporting steel frames (Kwiecień 2005), hidden under thick layer of plaster (Fig. 6). Both methods are reversible.
