Structural Evaluation and Strengthening of Zeynelbey Tomb in Hasankeyf, Turkey

TURER Ahmet^{1,a}

¹Department of Civil Engineering, Middle East Technical University, Ankara, Turkey

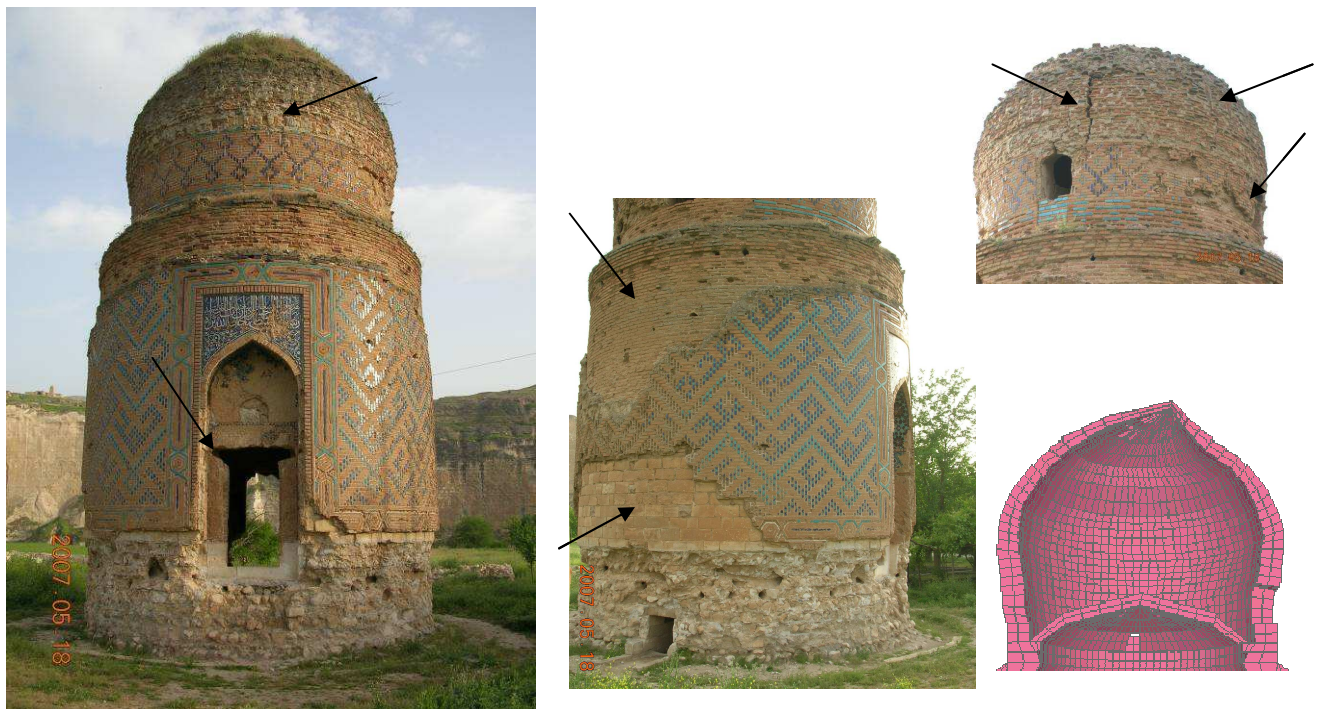
Figure 2: General view of Zeynelbey Tomb

The external view of the historic building manifests various problems mostly due to aging process and improper maintenance. The initial observation is the loss of section at the first 2 meter height of the building (Fig. 2). The section loss is significant at the base of the building which might possibly be

due to change of the river elevation and the first few meters of the structure being flooded by the river. It might also be possible that the lower part of the tomb was supported by large stone blocks in the form of stairs and has been taken by the locals as free construction material. It is also known that there have been interventions to support the lower parts of the tomb in the last decade using Portland cement which might have harmed the chemical composition of building material due to salt intrusion. The intervention using cement was later on understood to be unsatisfactory and removed away.

The dome of the tomb seems to have a slightly expanded (onion like) view. Existence of vertical cracks around the dome could be clearly seen from distance. Previous repairs by inserting bricks in the vertical orientation can also be identified on earlier cracks. Some vegetation growth at the top of the dome is also clearly seen from distance, which is an indication of material degradation (turning into soil) as well as root growth into the cracks of the dome. However, the exterior view of the bulging dome and vertical cracks is nowhere near as frightening as the view that was observed from the inside of the dome (Fig. 3). The cracks are much more pronounced and large in the vertical direction. The observation indicates that the tension stresses developing due to self weight of the dome and in the transverse direction causes the vertical cracks to form. The dome walls have a tendency to open in the peripheral axis as the cracks expand. The dome is now divided into about 8 vertical slices that are expanding outwards. The top portion of the dome is behaving differently since the close-to-flat top portion of the dome is more stable within itself due to better confinement and its self weight is pushing the sides outwards. As the sides of the dome are expanding, the circular region between the relatively vertical and relatively flat parts is cracking as well (Fig 3). When the bottom of the dome where the inner and outer domes come together is also severely cracked. The vertical crack opening between the two domes have a larger width at the top compared to the bottom of the crack indicating an outwards rotation of the outer dome's support. Furthermore, two holes at the top of the dome were determined. The larger hole is expected to generate a cause for instability by itself since it disturbs the stress flow in the dome structure. The edges of the hole can easily be eroded by the precipitation in the area.

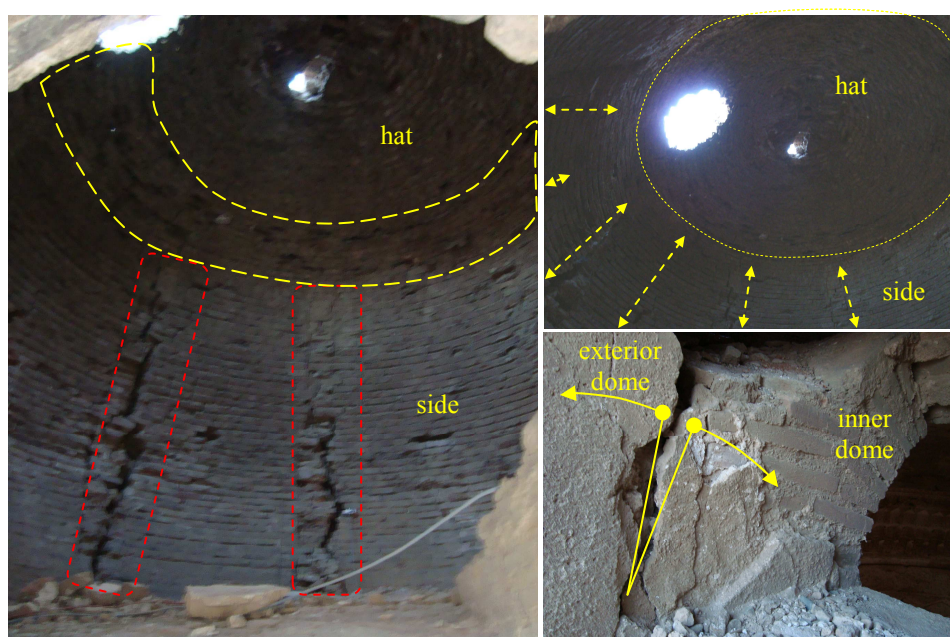
Figure 3: Inside view of the dome

The main behavior of the dome is identified to be peripheral expansion of the vertical walls of the dome. Overall degradation of the material in centuries and poor maintenance adds up to the vulnerability of the dome. The top portion, which might be called as 'hat', has the danger of collapsing downwards over the inner dome if the outer dome continues to expand. The expansion would leave the 'hat' being unsupported. The roots of the vegetation at the dome's top surface might also have adverse effect by their roots moving into the cracks and further expanding them.

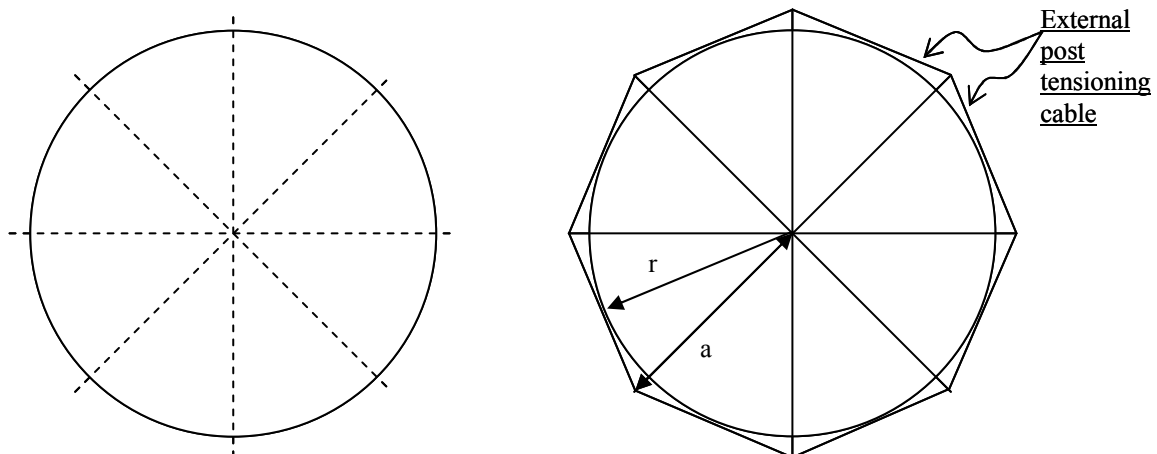
Figure 4: Put your caption here

The major and urgent structural problem of Zeynelbey Tomb is considered to be the expanding outer dome structure. Due to the expanding behavior, the top portion (hat) of the dome is under the risk of falling down over the inner dome. If the hat falls inside the dome, it would push the side and vertically cracked dome segments outwards; when crashes on the inner dome (Fig. 2, Fig. 3) it would also cause the inner dome to receive substantial damage or collapse. The secondary major problem is considered to be the lower part of the cylindrical main body, which has major section loss and material damage.

The strengthening strategy proposed for the exterior dome structure was peripheral post-tensioning (Fig. 4). As an example, barrels have wooden ribs that are placed side by side in vertical orientation. The post tensioning rings around the ribs apply peripheral pressure on the wood, which causes a stable structure even though the wooden ribs are not interconnected at their vertical joints. The cracks on the Zeynelbey Tomb's exterior dome are similar to those joints that exist in a barrel. If a peripheral post tensioning could be applied, that would prevent further expansion of the exterior roof providing a stable structure. If the dome cannot expand in the horizontal direction, the top (hat) portion is expected to stay in its current position as well. A light weight internal supporting structure is also suggested to for the hat portion to guarantee its stability.

The suggested external post tensioning is thought to consist of cables passing through eight vertical ribs which will press on the dome. The exterior surface of the dome is not smooth enough for a continuous post tensioning ring. Furthermore, it was not desirable to have full contact with the dome exterior surface. Most importantly, a possible peripheral ring could have slipped upwards not providing its post-tensioning duty. Placement of a horizontal ring would be suitable for post-tensioning application, which needs to be monitored continuously and fully adjustable over time as needed. Therefore, vertical ribs were planned at 8 locations around the dome with 45° intervals. The post-tensioning cables would pass through holes on the vertical ribs and can be easily tensioned to the desired force. The holes on the ribs were elevated to a distance of $0.0824 \times (r)$ as shown in Equation 1, so that the post-tensioning cable would not touch the dome and can be tensioned. The ribs were planned to have rubber surface to distribute the force evenly and without causing stress concentrations on the rough and uneven surface of the dome. Nevertheless, a cushion level of mortar is planned to be applied on the large voids on the dome at the location of the ribs. Such mortar application will not be placed on the brick tile motifs but at locations of heavy damage and large voids. The vertical rib structure is planned to have four pieces that are interconnected using three one-dimensional hinges (Fig. 5). The post-tensioning cables need to be tensioned in incremental steps. The force in the cables will be measured and changes over time will be monitored using a series of load-cells that will be connected to the cables in series. The crack widths will also be monitored during the strengthening process as well as in the future years to come.

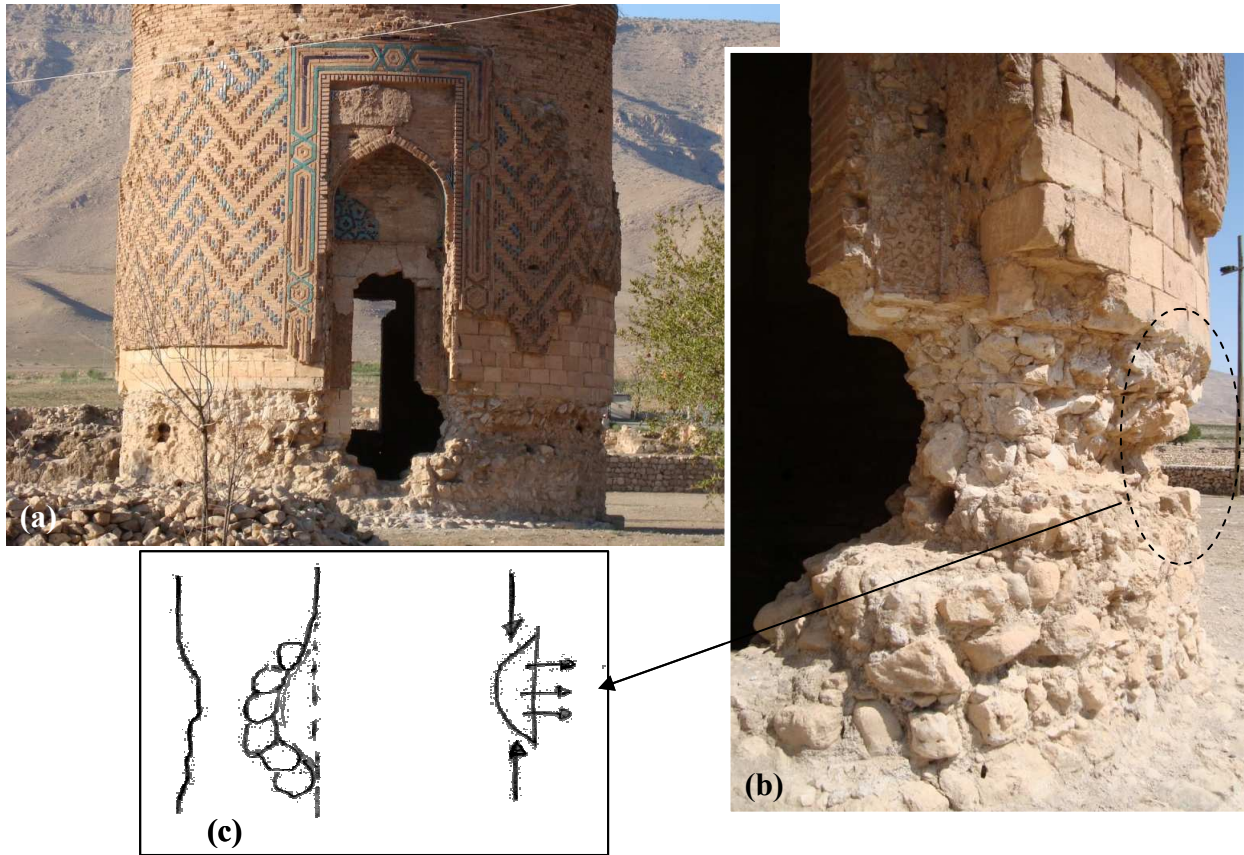
Figure 6: Put your caption here

The second major problem is considered to be the section loss at the lower 2m height of the cylindrical shaped main body (Fig. 6). If the missing parts of the wall are completed without any reinforcement, the completed segments are expected to fall out in time due to inclined surface and pushing action of the main wall (Fig. 6c). Peripheral reinforcement was initially planned to be placed at the outermost layer of the newly placed triangular portion keep those new addition parts of the wall in place by applying a confinement effect. However, the peripheral reinforcement has to be continuous and the door openings might be a problem. Furthermore, the rebar sizes were found to be quite large for using in a historical structure. Alternatively, short and perpendicularly placed rebars were planned to be used for keeping the new triangular shaped additional wall segment in place (Fig. 6b, c). The rebars were planned to be 8mm in thickness; therefore, a minimum length of 40ϕ diameter should be supplied to maintain proper development length. The bars' length need to be a minimum of 0.32m, thus the length of rebar that will be inserted to the old and new wall segments planned to be 0.2m long for a total length of 0.4m. The rebar dimensions will be the same everywhere, except their application density will be different as a function of the slope of the additional wall.

The slope calculation plays an important role on the shear and tension forces developing on the surface of the triangular shaped additional wall. Assuming that the pressure from the upper structure ($P_{vertical}$) will be approximately in the order of 300 kPa ($15m \times 20kN/m^2$); the pressure acting perpendicular and parallel to the surfaces can be calculated using Equation 2, which is derived using equilibrium of forces.

The calculations indicate that the density of rebars that will be placed inside the wall, perpendicular to the surface between the old and new wall segments will get higher as the inclination of the wall approaches to 45 degrees. The most critical value for tension is found to be equal to the pressure coming from the above. Considering 300 kPa of vertical compression, and 141 MPa allowable stress for the rebars, about 42 bars is needed for each $1 m^2$ area. If the rebars will be placed evenly, each rebar needs to cover an area of $241 cm^2$ or a square with each side of 0.155m. Therefore, each rebar having a total length of 0.40m is planned to be planted on a grid of $0.15m \times 0.15m$. The 8mm diameter rebars will be placed inside 0.20m deep drilled holes with proper mortar and other 0.20m long piece will remain inside the new wall to be constructed to fill the lost triangular shaped gaps (Fig. 6b, c).
