## The Research on the Rust of Reinforced Bar and the Strengthening Measures to the Existed R.C. Frame nearby the Sea

**Abstract** The netlike cracks along the rebars at the bottom of concrete slabs as well as the circular cracks around the columns and beams were found in an underground park, which is a cast-in-site concrete frame. The building was about 300 m away from the sea.

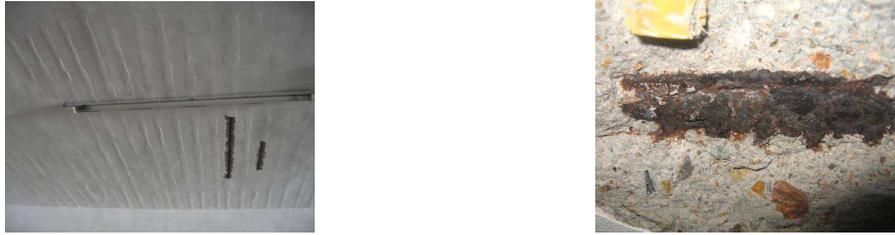
**Concrete Slab Cracked Seriously:** More than 70% of the slabs were found with longitudinal cracks, as shown in Figure 2.1-2.2. Some were found with concrete flake-off. It was also found that the thickness of concrete protection layers was smaller than 6 mm when diged up. The weight lost ratio of the rusted rebars was between 10% and 20%. The rusted rebars in the members with higher

concrete protectionion layer thickness were found with lower weight lost ratio. Rebars in good condition with concrete protectionion layer more than 15 mm were almost intact except a few slight rust spots.

Figure 2: (a) Phenomenon of slab crack-up (b) Rusted rebar status after the concrete is chiselled

Concrete carbonization was one of the necessary preconditions for rebar corrosion. However, the theory cannot explain the phenomenon described in Figure 2.1 that concrete around the rebar was not carbonized but the rebar had been rusted.

<i>Members and damage types</i>	<i>Retrofitting measures of durability or bearing capacity</i>
$C_{slab} \geq 30mm, C_{beam, column} \geq 40mm$	Remove old decoration layers and brush two layers of anti-rust reagent
$C_{slab} \geq 30mm, C_{beam, column} \geq 40mm, W \leq 5\%$	Chisel the outside concrete and remove rusts on the rebar; Spray C35 concrete and plaster it smooth to conserve.
$W_{slab, beam, column} \leq 5\%$ (Figure 5.1~5.3 were strengthening measures)	Chisel the outside concrete and remove rusts on the rebar. Spray C35 concrete and plaster it smooth to conserve. When the conservation of concrete was completed, CFRP was posted on the surface of members.

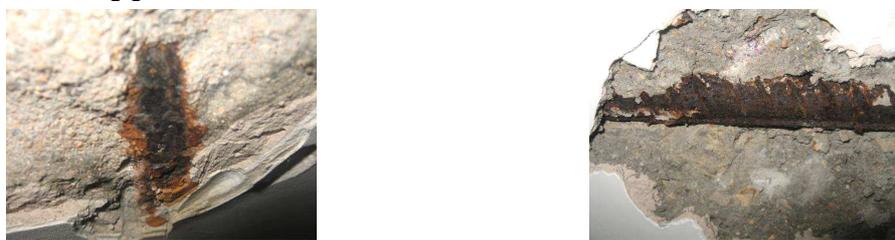
**Stirrups Severely Rusted and Longitudinal Rebar with Rust Spots in Beam:** Stirrups at the bottom of beam members almost had no concrete protection layers and the carbonization depth was up to 3 mm. As shown in Figure 2.3~2.4, the weight lost ratio of the rusted rebar was more than 40%. Longitudinal cracks along the rebars were found at the bottom of the beams. Concrete protection layers on both sides of the beams were all beyond 40 mm. The inspection to the samples drilled from the beam indicated that both the awkward had few rust spots. The drilled samples from the beams selected at random were found in good condition and was tested for the alkaline by using phenolphthalein indicator. The test results showed that the concrete protection layers were just partly carbonized as the concrete color was red in the distance of 8 to 12 mm to the surface of the rebar, but the rust spot and tiny radical cracks were found around the rebars, which indicated that the rebars were rusted being placed into the beam.

Figure 2:(c) seriously rusted stirrups at the bottom of beams

(d) tiny rusted longitudinal rebars at the bottom of beams

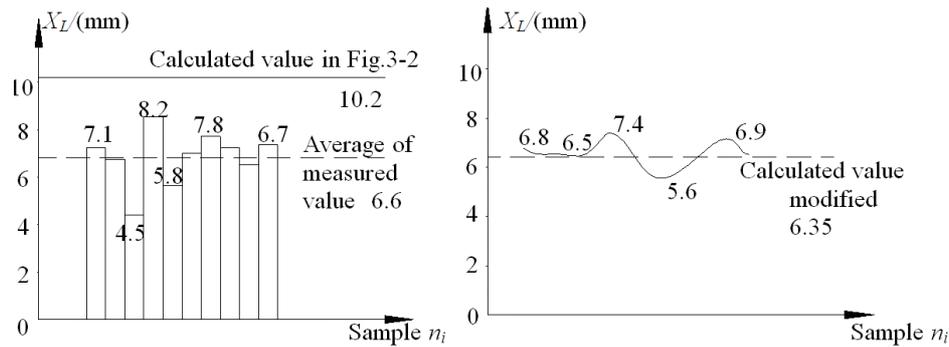
The procedure of calculating relevant parameters was shown in Table 3.1. Ignoring the influence of  $Cl^-$ , the theoretical values and inspection ones were shown in Figure 3.2. (Sample size  $n$  was 10, single sample size was greater than 100). Because the water-cement ratio was small and concrete had a brushing layer of 2 mm, the inspection results of the full carbonization depth were less than the calculated values in Figure 3-1. When the humidity increased, the partial carbonization depth reduced, so the formula was modified because the mathematical model in ref.[5] was applied only to the environment in which the relative humidity was less than 70%.

Figure 3. 2 Measured values and calculated values of full carbonization depth

In Figure3-2,when revised parameters of the humidity was modified from 0.7 to 0.98, the average value of the carbonization depth was 6.35 mm and the partial carbonization depth decreased with the increase of the humidity, as shown in Figure3.3.

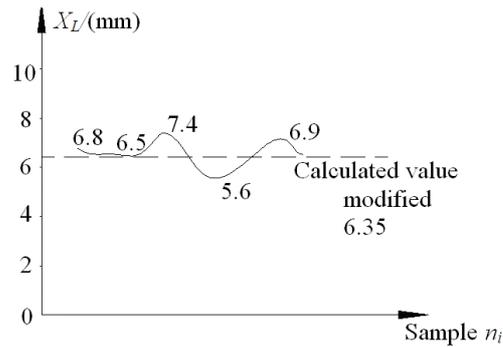
Figure 3. 3 Fitting curve of measured values of the partial carbonization depth
