The S. Marco Church in L'Aquila: Provisional Interventions after the 2009 Abruzzo Earthquake

The S. Marco Church in L'Aquila

The Provisional Strengthening Intervention

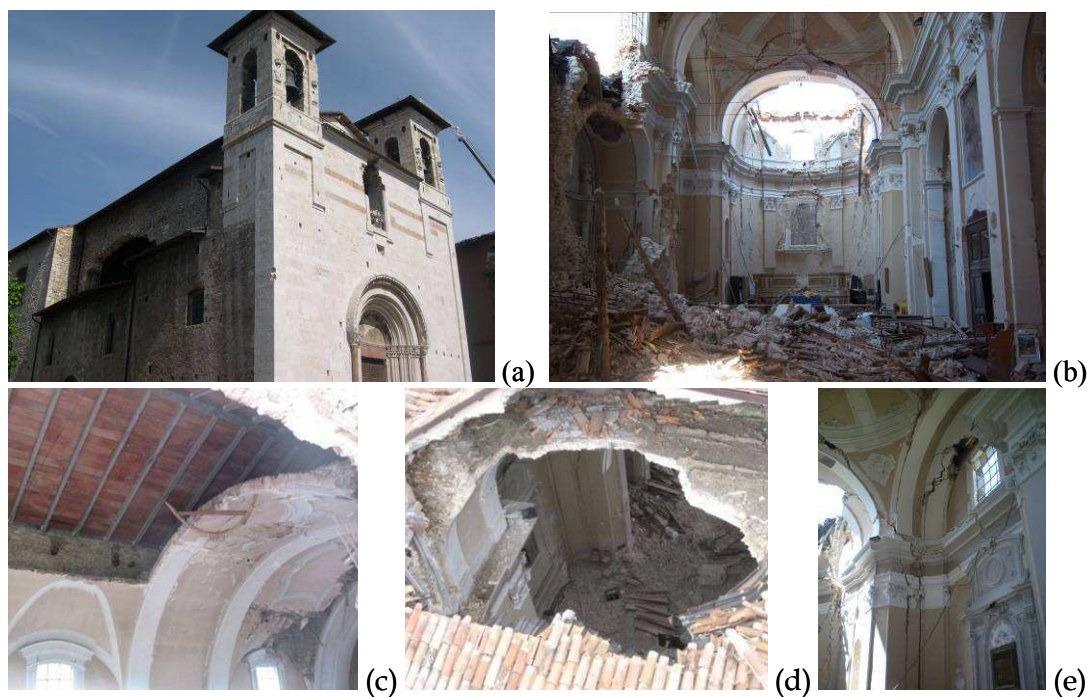
Figure 3: St. Mark church after the 2009 earthquake: (a) external and (b) internal views; (c) collapse of the nave vaults, (d) of the apsidal vaults and (e) severe damage in the pillars sustaining the dome

Even if the external appearance of the church seems to indicate an almost untouched structure, the inner view of the church clearly reveal the seriousness of the situation (Fig. 3). The most severe damages corresponded to the total collapse of the apse vault, of a wall portion located on the upper part of the longitudinal left walls of the nave, part of the chapels adjacent to this last, of some of the arches that support the nave vault and the main part of the nave vault. It is also worth noticing the separation between the internal and external masonry layers of the longitudinal right wall, probably due to the lack of interlock, as they belong to two different constructive phases, as well as the separation between the whole wall and the right side chapels.

The dome over the presbytery presents an advanced crack pattern map. The supporting structure is compromised: one of the arches that support this dome collapsed, while the other three are heavily damaged. As for the main façade, it is mainly affected by in-plane shear damage passing through the entire thickness of the wall.

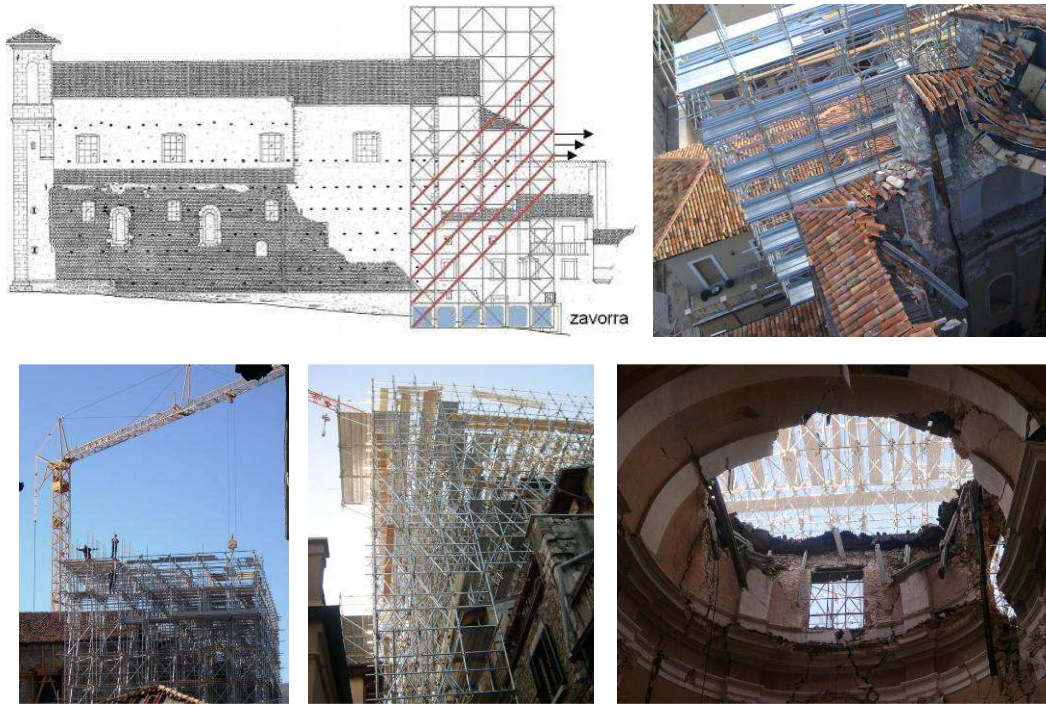
Figure 4: St. Mark church in L'Aquila: erection of the structural scaffolding in the apsidal area

The initial intervention entailed the construction of a sound scaffolding made by hollow pipe steel trusses (Fig. 4), constituting a portal spanning across the church, in order to inhibit the prosecution of the overturning of the apses and transepts walls. Two lattice towers were built on the two sides of the church, subsequently connected at their top by an open web girder, in its turn connected to the masonry structures of the church.

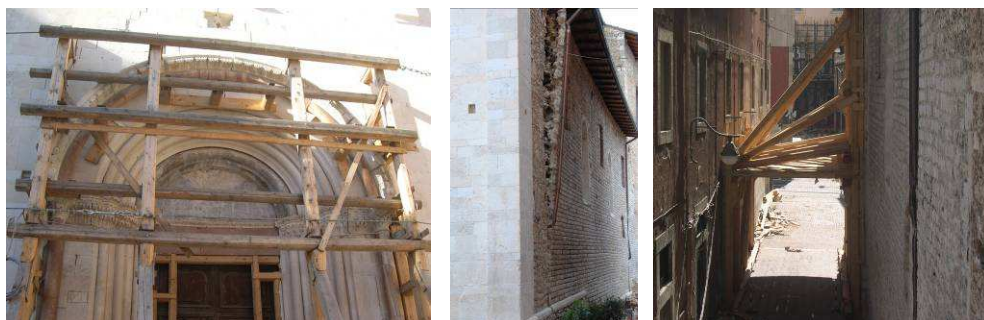
Figure 5: St. Mark church in L'Aquila: strengthening interventions in the façade area

In the façade area, wooden struts were employed in order to counteract the overturning of a remarkable part of the right wall external veneer, and to sustain the stone elements of the valuable church portal, disconnected by the seismic motion (Fig. 5). The façade was hooped on two levels with steel cables, also positioned to avoid the shear damage progression. Finally, several openings were propped by means of wooden trusses, and the façade bell-towers were hooped at the level of the belfry.

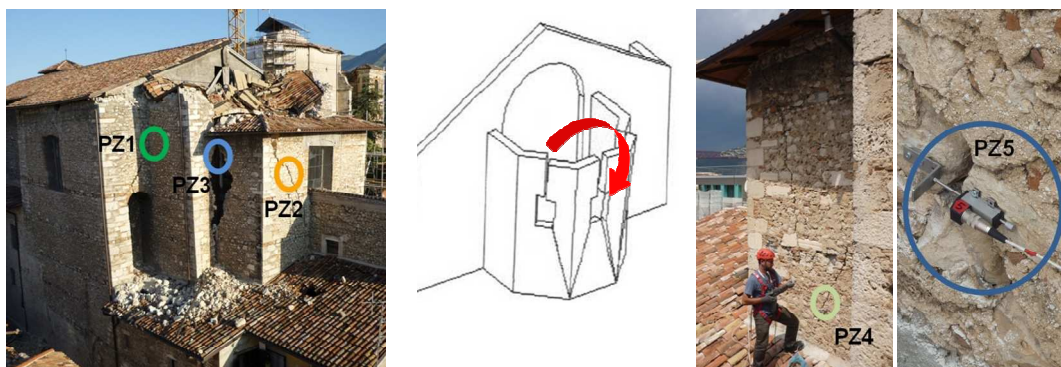
Figure 6: view of the apsidal area of St. Mark church displacement and T-RHumidity sensors positioning

The monitoring system is continuously acquiring data, and stores hourly the readouts coming from 5 linear displacement transducers positioned in the external area of both apse and transept, where the worst damage scenario is observed (Fig. 6). Data are correlated to the environmental parameters recorded by a temperature – relative humidity sensor positioned at the base of the scaffolding.

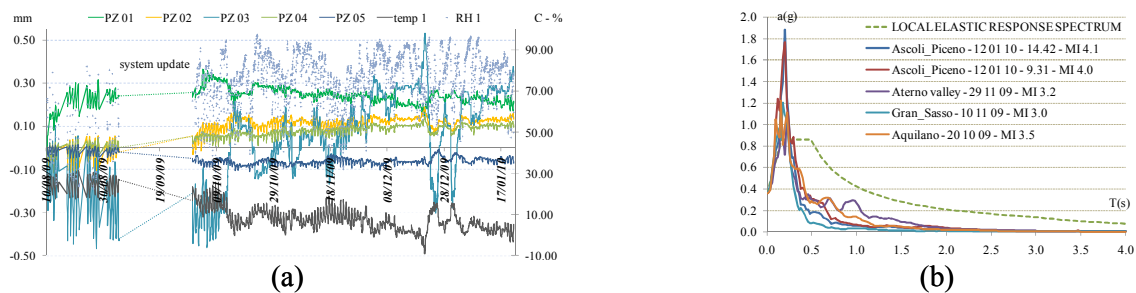
A couple of acceleration sensors is located at the base of the structure, in order to record any relevant data in terms of seismic events – also of low-moderate energy - and other two sensors are positioned at the top of the North wing of the transept, to store the structural response (amplification) of the church. The system is able to automatically store the data when the acceleration in one of the sensors exceeds a predefined threshold, both in time and frequency domain, and to periodically record the data (e.g. at a 12-24 hrs intervals) with the aim of the repetition of the dynamic identification, to measure possible variations in the modal parameters of the structure with the progression of the strengthening interventions. Sensors, both at the base and at the top, are positioned orthogonally to each other, measuring accelerations in the horizontal plane. The monitoring system was installed the 10th of August 2009. Displacement transducers data – up to February 2010 - are plotted in the graph of Fig. 7a. In the first months of observation no worrying displacement-trends were noticed, thus excluding the worsening of the crack pattern, and confirming the effectiveness of the adopted provisional interventions. The elaborated response spectra of some recorded minor seismic events in the L'Aquila area (Fig. 7b), scaled to the local peak ground acceleration as given by the Italian seismic code (Norme Tecniche per le Costruzioni – Ministerial Decree 14/01/2008), corresponding to the value of 0,364 g, indicate a local resonance with very high peaks around the frequency of 5 Hz (especially in the far source seismic events), in a frequency band where several structural eigenvalues are noted.

Figure 7: St. Mark monitoring system: (a) plots of the displacement sensors data vs. time; (b) scaled to the local PGA value horizontal elastic response spectra calculated from the recorded accelerograms
