# THE DETERMINATION OF CAUSES FOR DEFECTS OCCURRING IN THE SEVENTEENTH-CENTURY CHURCH BUILDING IN PRÓSZKÓW, OPOLE PROVINCE, POLAND

*Dariusz Bajno*<sup>1</sup>

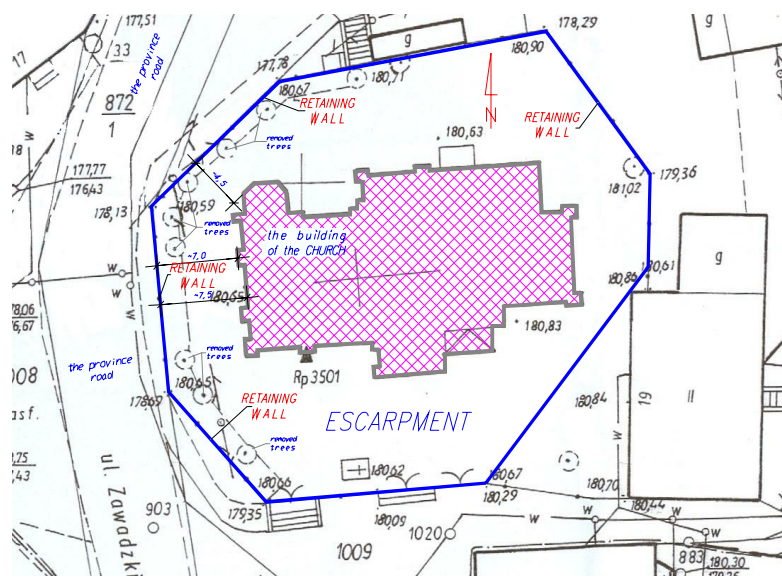
The basis for the construction of the church in its present shape and form were the foundations of a previously existing parish church from 1578, which had been severely damaged in a fire [6]. This is a detached building set up on an elevation (escarpment) in the immediate vicinity of a very busy provincial road on the Opole-Prudnik route [Fig. 1].

Fig. 1 Location of the church building on the escarpment

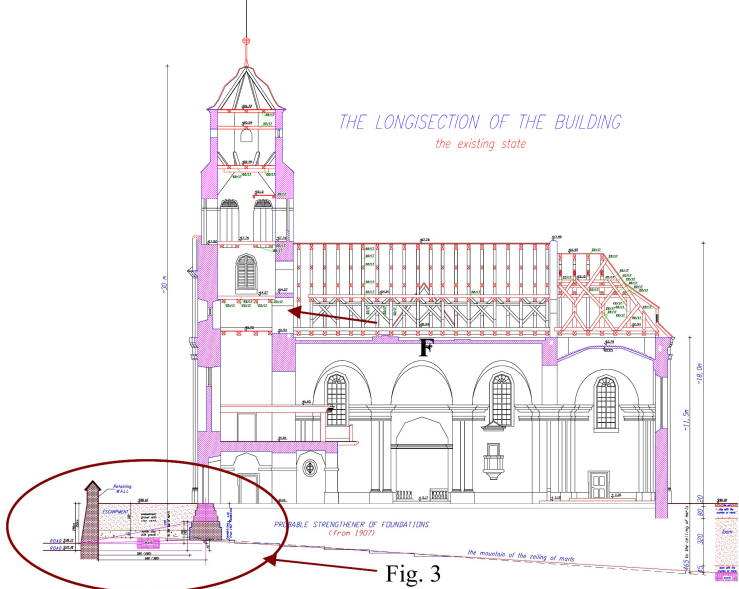
Due to the inability to carry out the proposed scope of reinforcing works, the only remaining possibility was to check the degree of safety regarding the stability of the foundation of the church as is, i.e. without any reinforcements (Fig. 2, Fig. 3).

Fig. 2 Longisection of the building

The depth of the foundations of the church building (after their reinforcement in 1907) can reach 2.3 meters below ground level or even further; thus the extent of their impact on the retaining walls of the escarpment (with the maximum height of 2.9 m) will be significantly reduced as compared to the previous situation. The distance of the foundation axes from the inner edges of retaining walls varies here between 6.8-3.8 m (5.8-2.8 m – internal dimension between internal surfaces of these elements). The pit on the underside of the foundation existing here originally in relation to the elevation of the adjacent road was at the level of 1.40-1.95 m, whereas after the completion of reinforcing work, the values dropped, respectively, to 0.22-0.70 m. This arrangements provides greater opportunity to maintain the stability of the escarpment. This situation is shown in Fig. 2, 3.

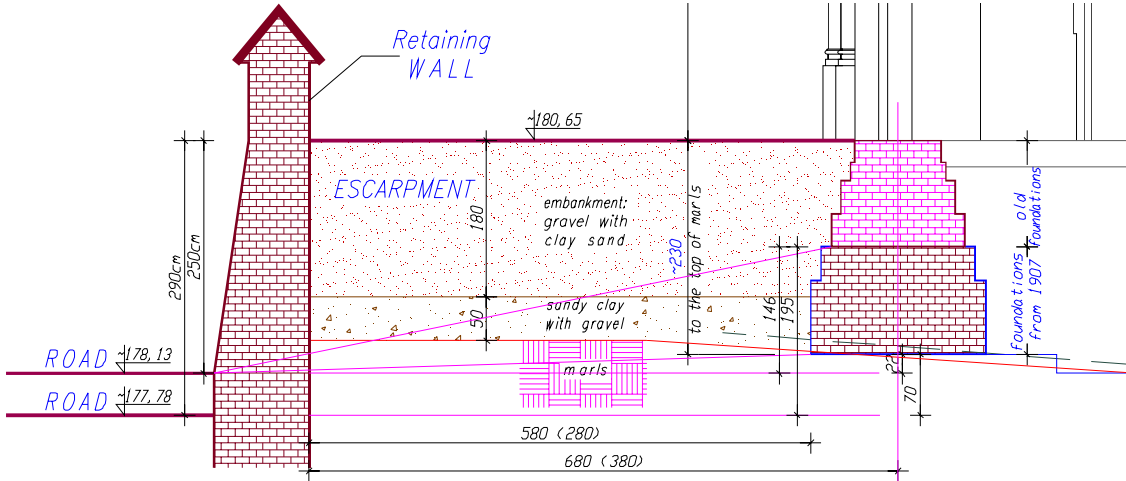
Fig. 3 Location of the foundation at the wall of the escarpment

If the escarpment was damaged in the perimeter, in the width of about 2.0 m, then we would have to deal with a slightly different situation in which the distance of the edges of church tower's foundations from the new edge of the escarpment would considerably reduce outside of its natural wedge and, therefore, the resistance of the solid lump remaining after de-bonding would drop. It should be emphasised that there is a real threat of damage to the church building in the place where it is closest to the escarpment, with its highest elevation, and in the immediate vicinity of the intensive dynamic impacts caused by vehicle traffic on the provincial road.

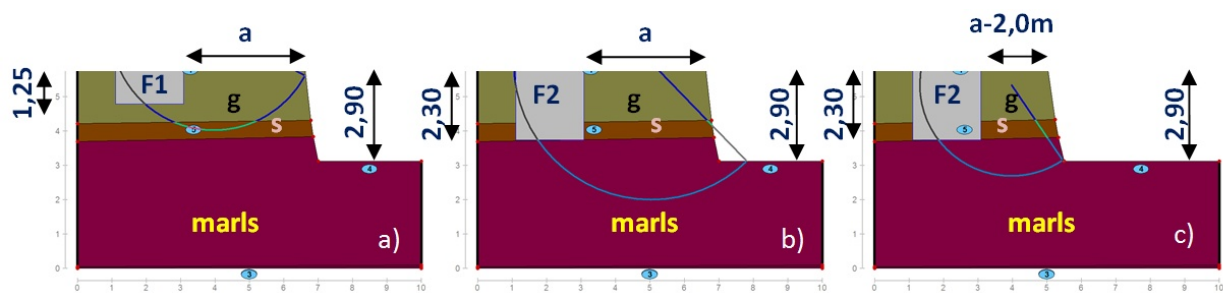
Below, diagrams on Fig. 4a, 4b and 4c show three models accepted for calculations of the escarpment stability on which the foundations of the church are situated. Fig. 4) shows the current condition of the escarpment with the foundation (F-1) with the penetration depth of about 1.25 m below ground level, Fig. 4b presents the current condition of the escarpment with the foundation (F-2) with the penetration depth of about 2.30 m below ground level, whereas Fig. 4c shows the anticipated condition of the escarpment with the foundation (F-2) as above after its partial landslide.

**Fig. 4** a) F-1, level of foundations before 1907, b) F-2, level of foundations after 1907, c) F-2, level of foundations after 1907 – damaged (reduced) escarpment

The stability calculations were done using the Fellenius method [16, 17] assuming that for a given geometry of the escarpment, there is one most dangerous slip surface characterised by the lowest safety factor. Table 1 summarises the characteristic parameters of the selected weakest points of the escarpment.

Safety factor	$F_1^*)=M_u/M_w$	$F_2^*)=M_u/M_w$	$F_3^*)=M_u/M_w$
$F_{\max\max}$	0.80	1.13	0.98
$F_{\max\min}$	0.90	1.27	1.09
$F_{\min\max}$	0.63	0.90	0.78
$F_{\min\min}$	0.70	1.01	0.87
<b>Soil volume <sup>**)</sup> [m<sup>3</sup>]</b>	8.23	19.66	11.55

\*) – safety (confidence) factor = the ratio of the retaining moment of the escarpment lump in respect of the centre of rotation to the moment of rotating forces – should be not less than 1.0, recommended to be greater than 1.30 – respectively for the tested case no. 1,2 and 3.
