CHARACTERISTIC DAMAGE CONCENTRATION: A NEW DAMAGE INDEX FOR HISTORIC INTERIORS

Debra F. Laefer¹, Denis Murphy²

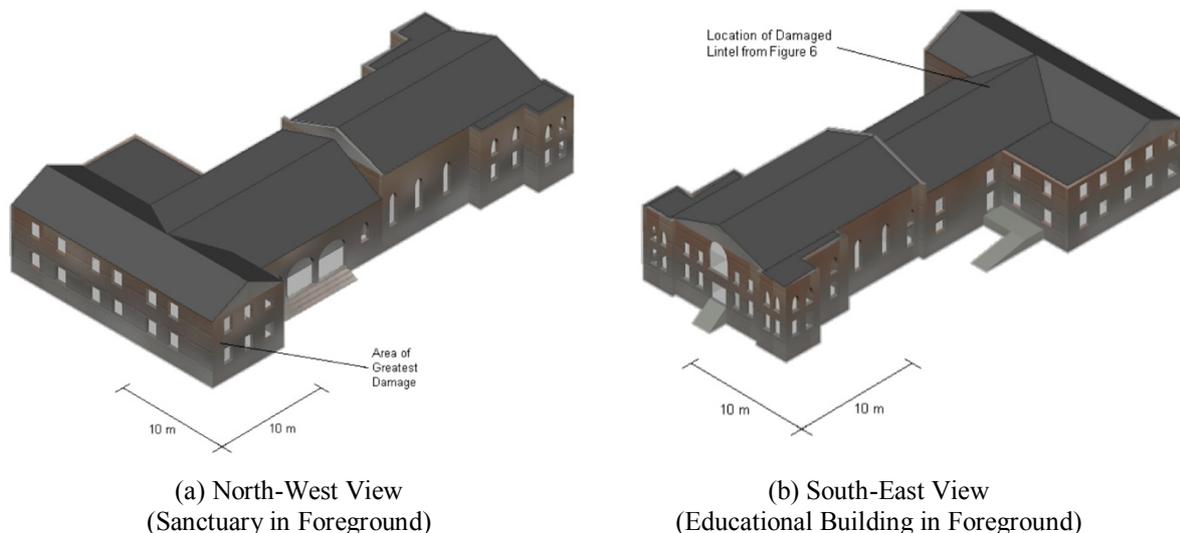
Fig. 2 AutoCAD Model of the Fountain Presbyterian Church with area of greatest damage shown

In April 2004, the only damage in the Sanctuary building was reported as water-based in the first floor room on the front left of the building. Laefer [7] stated that this “may have been the result of an opening in the roof”. In contrast, extensive damage was reported for the Education building with “(h)eavier damage on the walls nearest the quarry... the largest cracks exceeding $\frac{1}{2}$ an inch (12.5 mm)

in opening”. Laefer [7] described these cracks as “clearly structural in nature, ...will require rebuilding, and may be indicative of an imminent life-safety issue” and characterized the Education building as a seriously damaged structure. Blast-induced liquefaction was proposed as the most likely cause, despite blasting records showing peak particle velocity levels within generally considered safe limits[8.9].

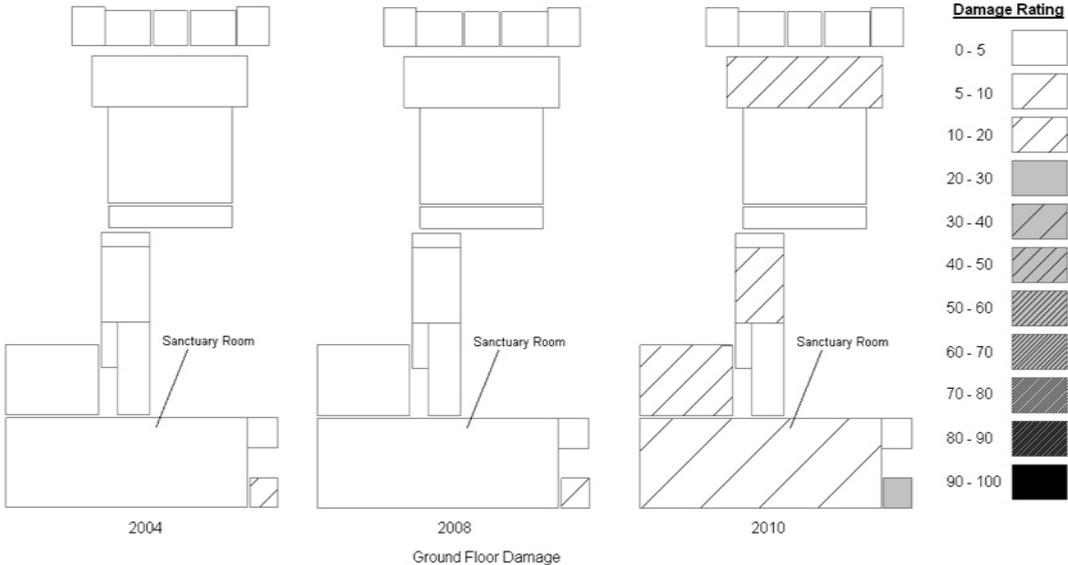
Fig. 3a Damage Distributions for the ground floor rooms from the 2004, 2008, and 2010 Surveys

As shown in Figures 3 (a) and (b), mapping of building damage charts a clear progression for severity and extent, from 2004 and 2010 and may serve as a means to identify at areas of further risk. The absence of damage where the Educational building connects to the Sanctuary would not appear to support simple differential settlement between the two portions of the building due to a four-decade difference in construction periods. This escalation of damage appears to represent an ongoing problem.
